TMS-NTC-14024
February 26, 2014

Re: Toyota Safety Recall 13V-442 Preliminary Dealer Notification Letter

Safety Recall D0T (D1T) *Preliminary Notification*
Certain 2012 – 2013 Model Year Avalon, Camry, Camry Hybrid, Venza, and
Certain 2013 Model Year Avalon Hybrid
HVAC Assembly

**TECHNICAL INSTRUCTIONS
FOR
SAFETY RECALL D0T
HVAC ASSEMBLY
CERTAIN 2012 – 2013 MODEL YEAR CAMRY & CAMRY HYBRID**

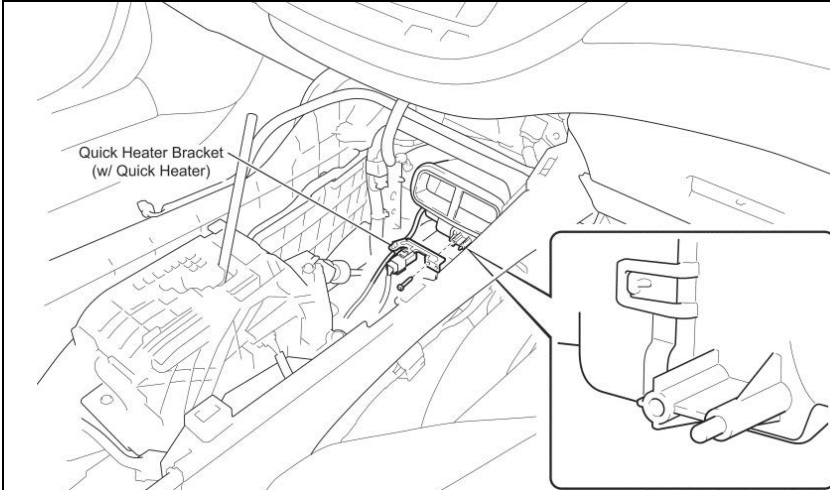
WITHOUT SCREW DESIGN

This is the **OLD** case design. **Additional inspection is required. Proceed to STEP 3.**

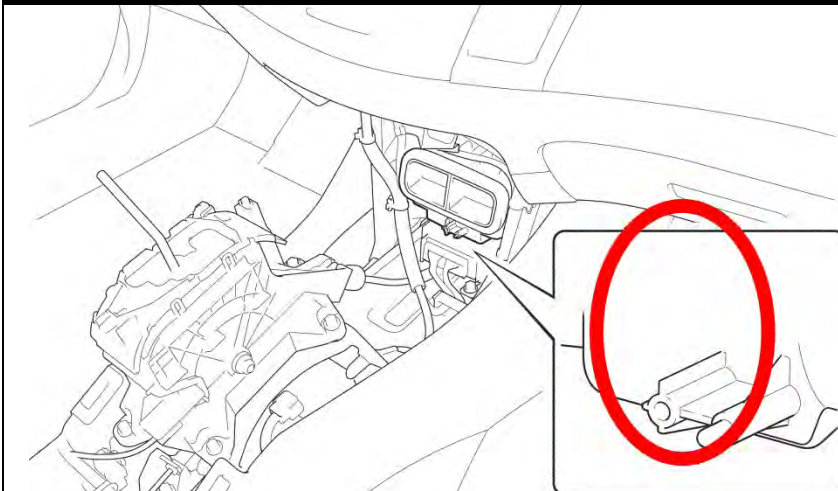
WITHOUT SEAM DESIGN – 2012MY ONLY

This case design will only be found on **SOME** 2012 model year Avalon vehicles. This case design **IS NOT** affected. No further action required. Campaign Complete.

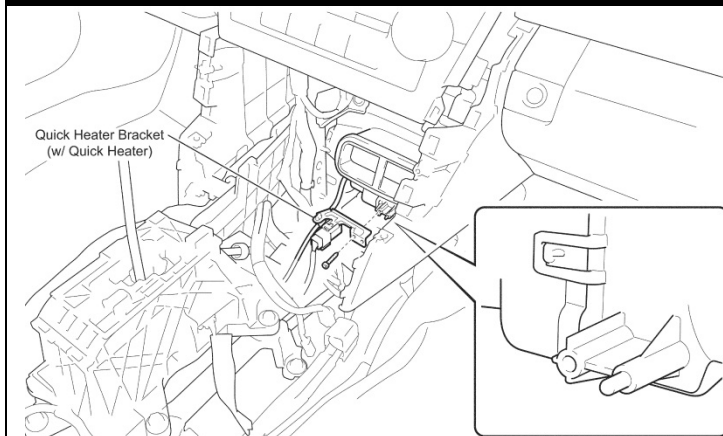
WITHOUT SCREW DESIGN

This is the **OLD** case design. Additional inspection is required. Proceed to STEP 3.

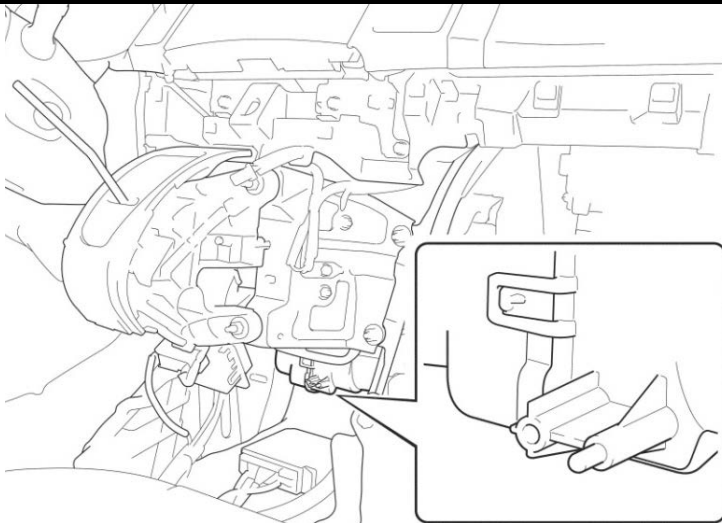
WITHOUT SCREW DESIGN

This is the **OLD** case design. Additional inspection is required. Proceed to STEP 3.

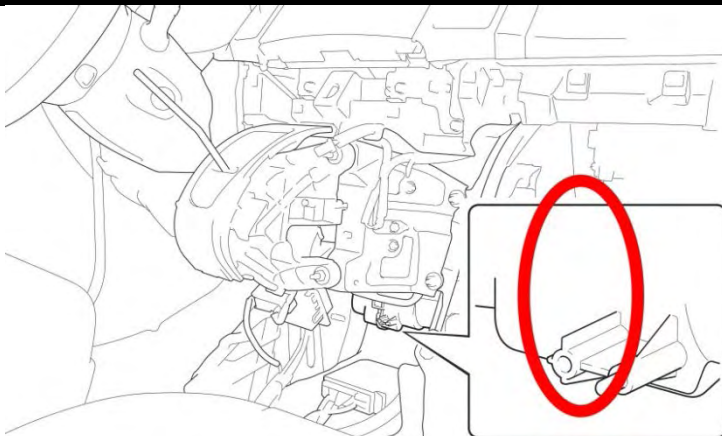
WITHOUT SEAM DESIGN – 2012MY ONLY

This case design will only be found on **SOME** 2012 model year Venza vehicles. This case design **IS NOT** affected. No further action required. Campaign Complete.
