**RE: Defect Information Report – Supplemental Report No. 1  
13V-538, FL-653, Axle Nut Lock Ring  
Dealer Notice**

December 2013  
FL653A  
NHTSA #13V-538

## Subject: Meritor Rear Axle Locking Snap Rings

**Models Affected: Specific Freightliner Cascadia vehicles manufactured August 14, 2012, through December 5, 2012, and equipped with ConMet Preset Plus Hubs.**

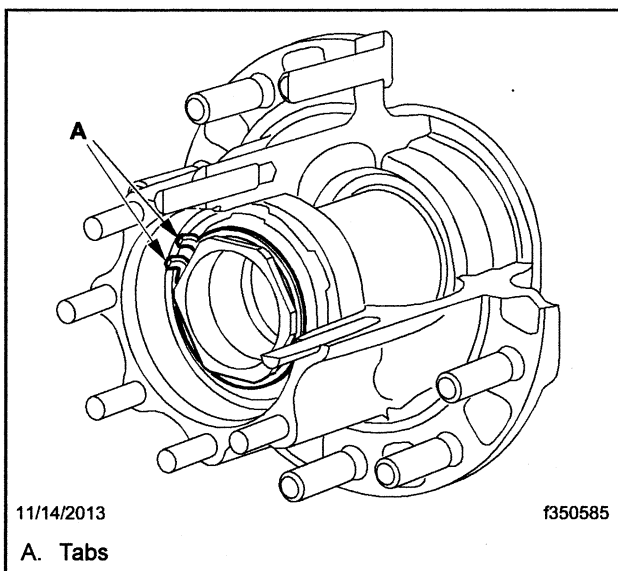
**Fig. 2, Lock Ring, ConMet PreSet Plus Hub**

7. Remove the drive axle shaft.
8. Remove and discard the gasket.
9. Check for the presence of a lock ring. See **Fig. 2**.  
If the lock ring is present, go step 12.  
If the lock ring is not present, continue to the next step.
10. Check the torque of the spindle nut to determine if it is 500 lbf-ft (678 N·m).  
If it is below 500 lbf-ft (678 N·m), replace the hub and check the spindle for damage. Go to Hub Replacement and Spindle Inspection on page 8.  
If it is 500 lbf-ft (678 N·m), continue to the next step.

11. Install the lock ring, as follows.
  - 11.1 One of the holes in the face of the spindle nut will line up with a hole in the washer. Insert the lock tab of the lock ring through aligned holes.
  - 11.2 Using the tabs, seat the lock ring in the machined grooves of the spindle nut. See **Fig. 2**.
12. Install a new gasket and the drive axle shaft. The splined end of the axle shaft must seat before the drive axle flange will fit over the studs.
13. If needed, install the tapered dowels and washers on the drive axle studs. Install the drive axle stud nuts and washers. Using the sequence shown in **Fig. 3**, tighten the nuts to the torque values given in the table in **Table 3**.
