**RE: Defect Information Report – Supplemental Report No. 3
13V-538, FL-653, Meritor Rear Axle Nut Lock Ring
Revised Dealer Notice**

June 2014
FL653A-C
NHTSA #13V-538 (FL653AB)
NHTSA #14V-242 (FL653C)
REVISED NOTICE

Subject: Meritor Rear Axle Locking Snap Rings

Models Affected: Specific Freightliner Cascadia vehicles manufactured August 6, 2012, through December 6, 2012, and equipped with ConMet Preset Plus Hubs.

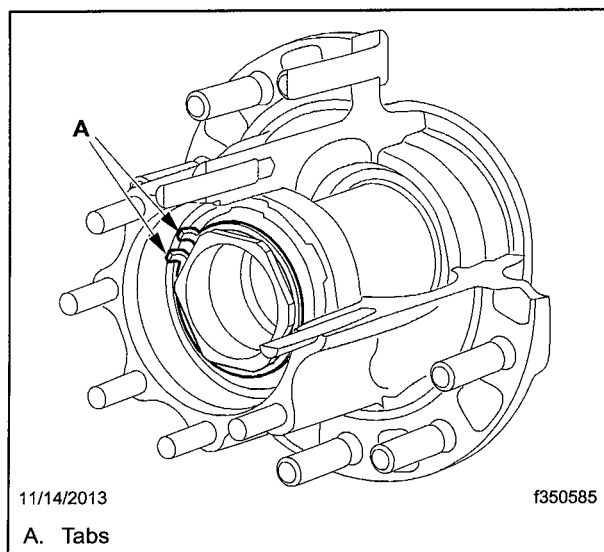
Fig. 2, Lock Ring, ConMet PreSet Plus Hub

6. If so equipped, remove the tapered dowels and washers from the drive axle flange.
7. Remove the drive axle shaft.
8. Remove and discard the gasket.
9. Check for the presence of a lock ring. See **Fig. 2**.
If the lock ring is present, go step 12.
If the lock ring is not present, continue to the next step.
10. Check the torque of the spindle nut to determine if it is 500 lbf-ft (678 N·m).
If it is below 500 lbf-ft (678 N·m), replace the hub and check the spindle for damage. Go to Hub Replacement and Spindle Inspection on page 8.
If it is 500 lbf-ft (678 N·m), continue to the next step.

When opening the lock ring to install or remove it, use the tabs, and be careful not to deform it permanently. If the lock ring is damaged or bent, replace it with a new one.

11. Install the lock ring, as follows.
 - 11.1 One of the holes in the face of the spindle nut will line up with a hole in the washer. Insert the lock tab of the lock ring through aligned holes.
 - 11.2 Using the tabs, seat the lock ring in the machined grooves of the spindle nut. See **Fig. 2**.
12. Install a new gasket and the drive axle shaft. The splined end of the axle shaft must seat before the drive axle flange will fit over the studs.
13. If needed, install the tapered dowels and washers on the drive axle studs. Install the drive axle stud nuts and washers. Using the sequence shown in **Fig. 3**, tighten the nuts to the torque values given in the table in **Table 3**.
