September 22, 2014

SUBJECT: STOP SALE / DEMONSTRATION / DELIVERY HOLD

Safety Recall 13S12 – Supplement #3

All 2013 Model Year Escape Vehicles Equipped with a 1.6L Engine
Risk of Localized Overheating of the Engine Cylinder Head that May Lead to Oil Leak
Fires

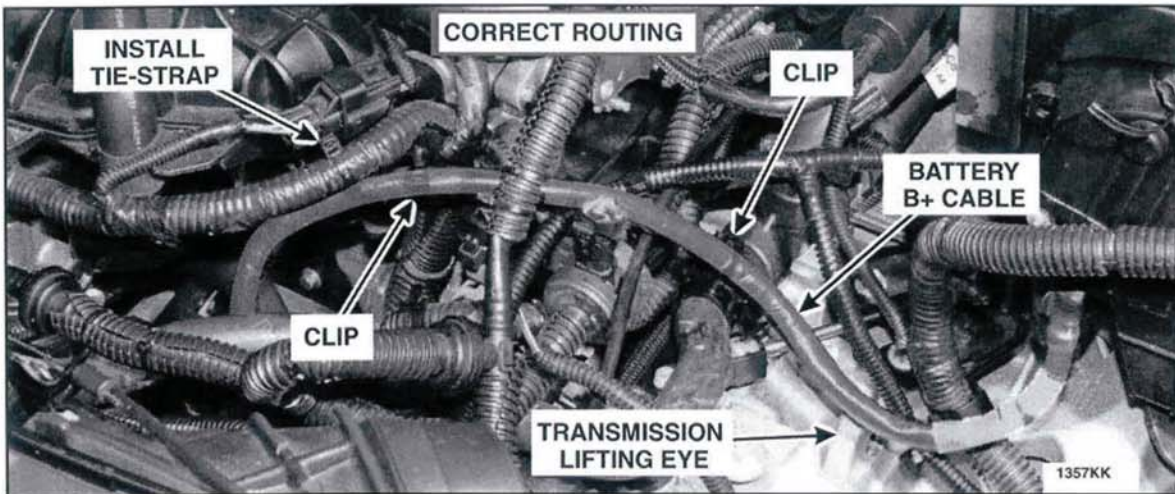
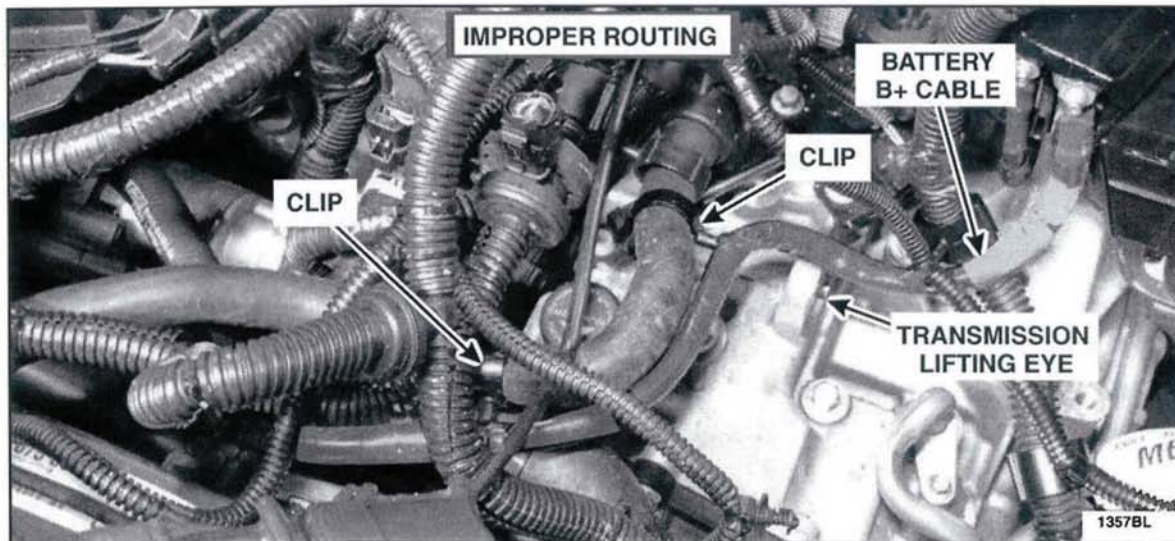
- If the battery cable is damaged, replace it prior to proceeding.
- A **properly routed** cable can be identified by having the cable routed from the generator across the front of the engine and with the cable secured to the main engine wiring harness with a zip tie near the forward left side of the intake manifold. See Figure M1.
- An **improperly routed** cable can be identified by the cable being routed forward of the engine near the radiator, and is not attached to the main engine wiring harness with a zip tie. See Figure M2.

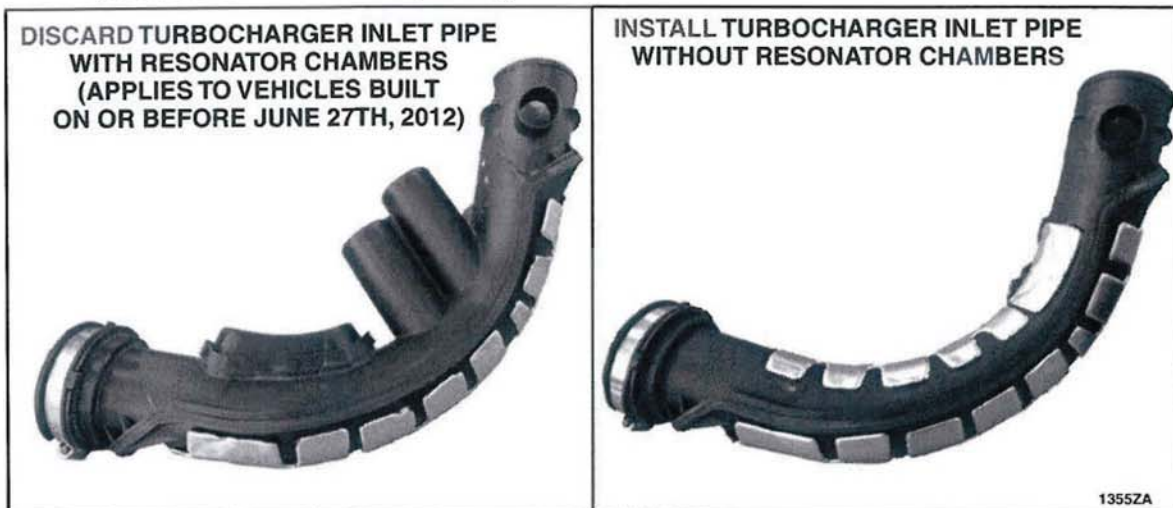
FIGURE N1

NOTE: For vehicles built on or before June 27, 2012 having a turbocharger inlet pipe with resonator chambers, discard the turbocharger inlet pipe. See Figure N1 in Procedure N, Page 52 of 55.

NOTE: On vehicles built on or before June 27, 2012, install the new design turbocharger inlet pipe (without resonator chambers) See Figure N1.
