Michael A. Berardi  
Director  
Service Engineering Operations  
Ford Customer Service Division

October 2, 2013

**SUBJECT: Regional Program 13R01**

Certain 2005 Through 2011 Model Year Crown Victoria, Grand Marquis, and Town Car Vehicles Not Covered Under Safety Recall 13S08  
Steering Column Shaft

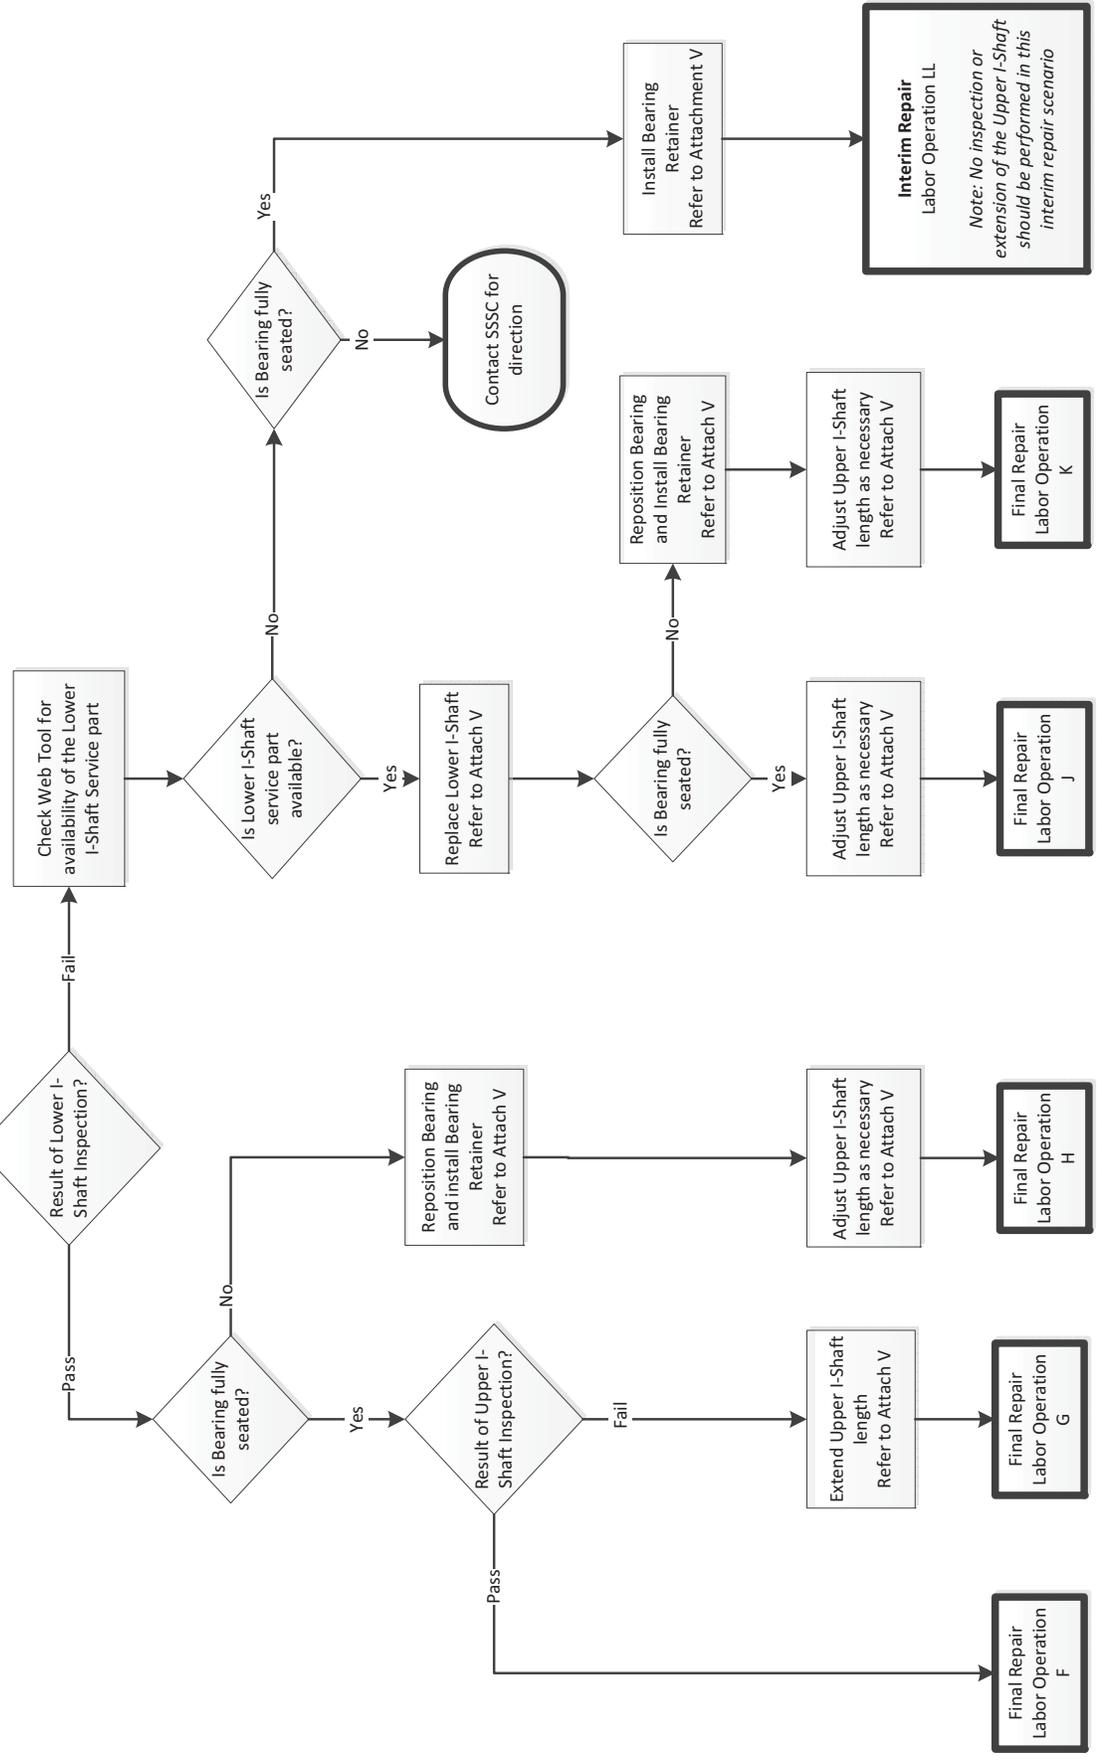
Perform the following inspections:  
 - Inspect Lower I-Shaft  
 - Inspect Bearing Position  
 - Inspect Upper I-Shaft length  
 Refer to Attachment IV for Inspection Procedures

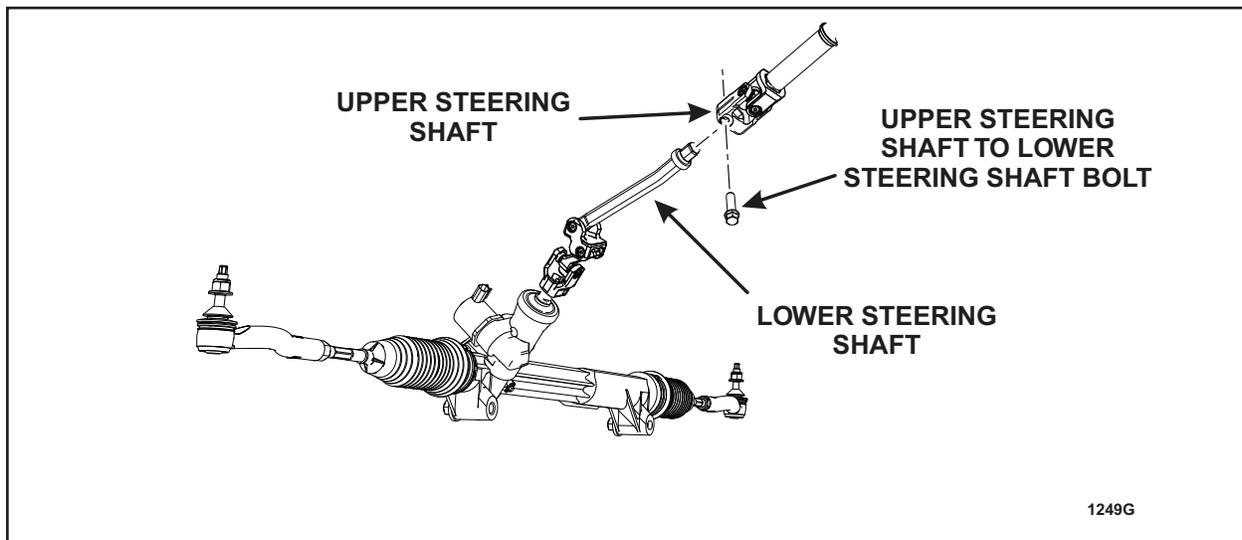
**FIGURE 1**

1. Inspect the lower steering shaft joints for binding or seizure, as follows:
  - a. Use a steering wheel holding device (such as Hunter® 28-75-1 or equivalent) to hold the steering wheel in the straight-ahead position.
  - b. Remove and discard the upper steering shaft to lower steering shaft bolt and disconnect the lower steering shaft. See Figure 1.

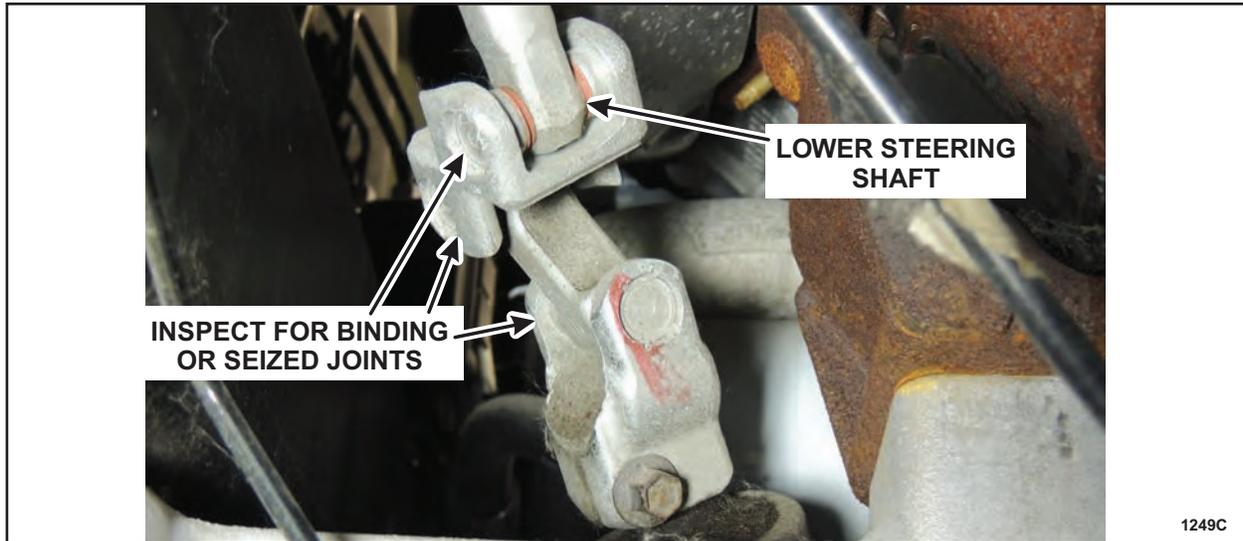
**FIGURE 2**

- c. Exercise the upper portion of the lower steering shaft throughout its range of motion. See Figure 2, on Page 2.
- d. If the lower steering shaft does not move freely and without binding, **it fails inspection.**

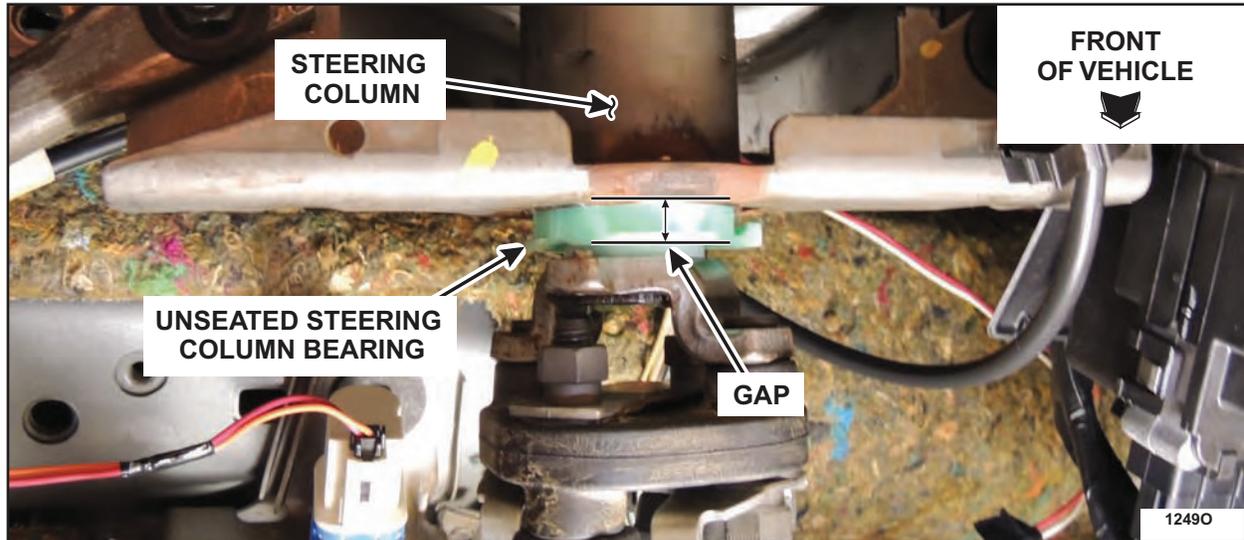
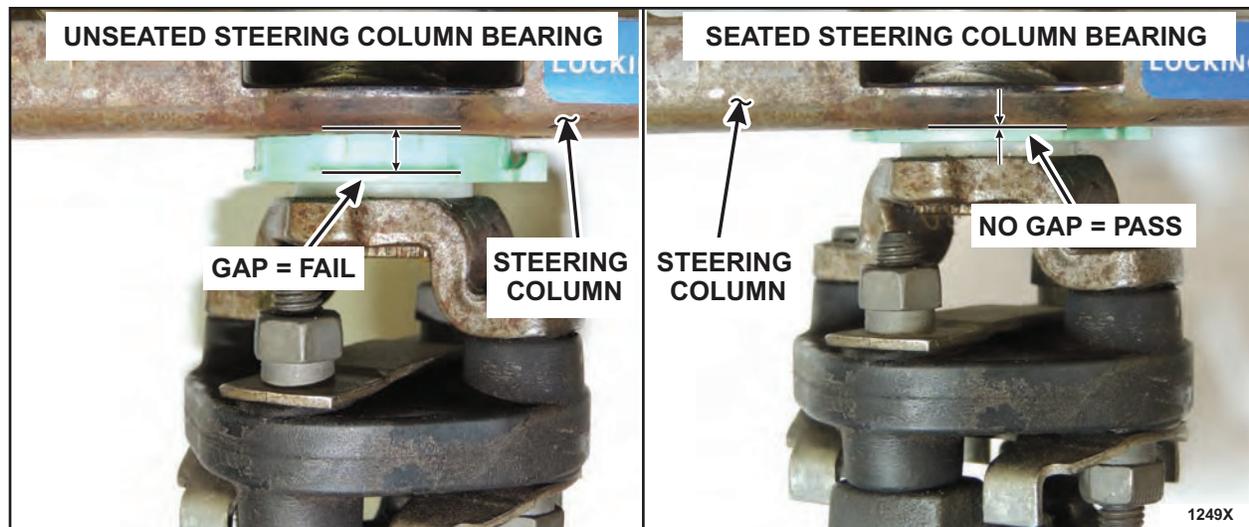
1. Inspect the steering column for an unseated steering column bearing. See Figures 3 and 4.

- If the steering column bearing is unseated, **it fails inspection.**

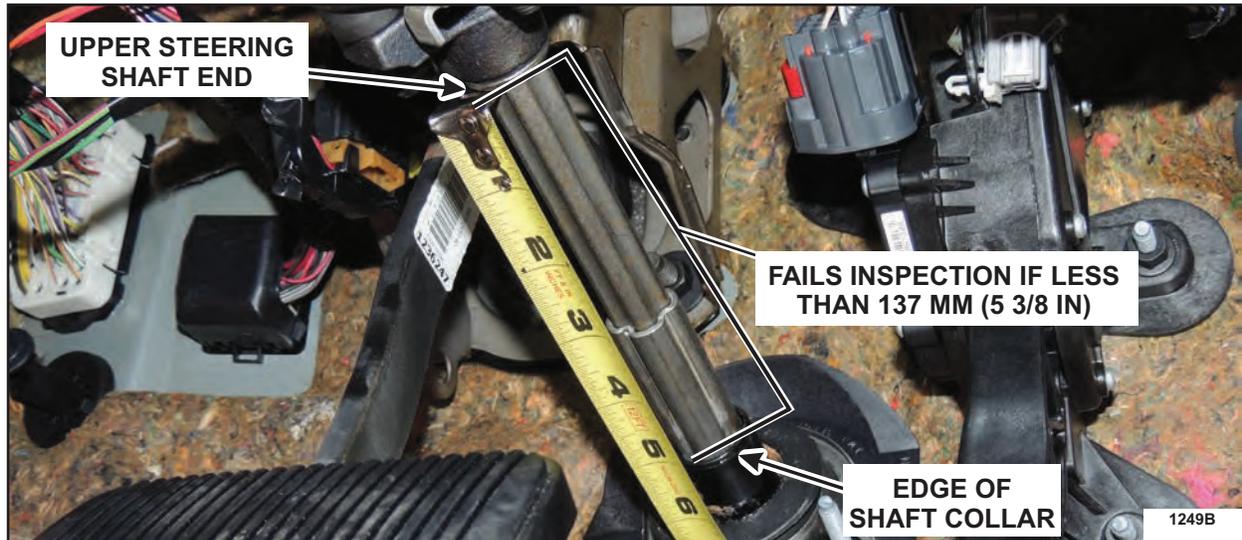
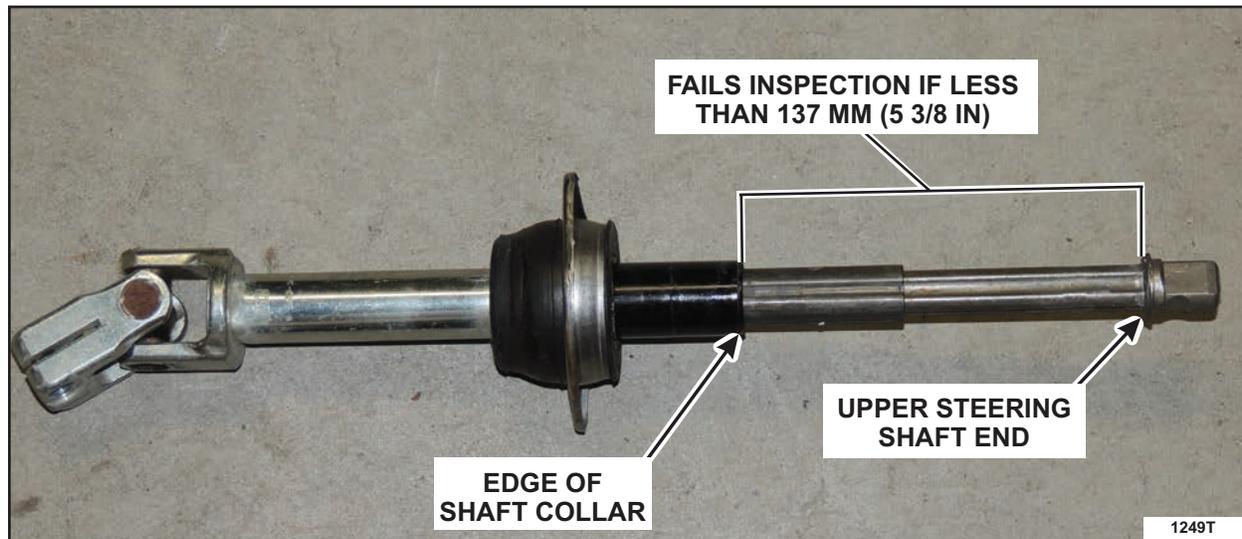
1. Measure the distance between upper steering shaft end and the edge of the shaft collar, to check for a collapsed upper steering shaft. See Figures 5 and 6.

- If the upper steering shaft measurement is less than 137 mm (5 3/8 in), **it fails inspection.**

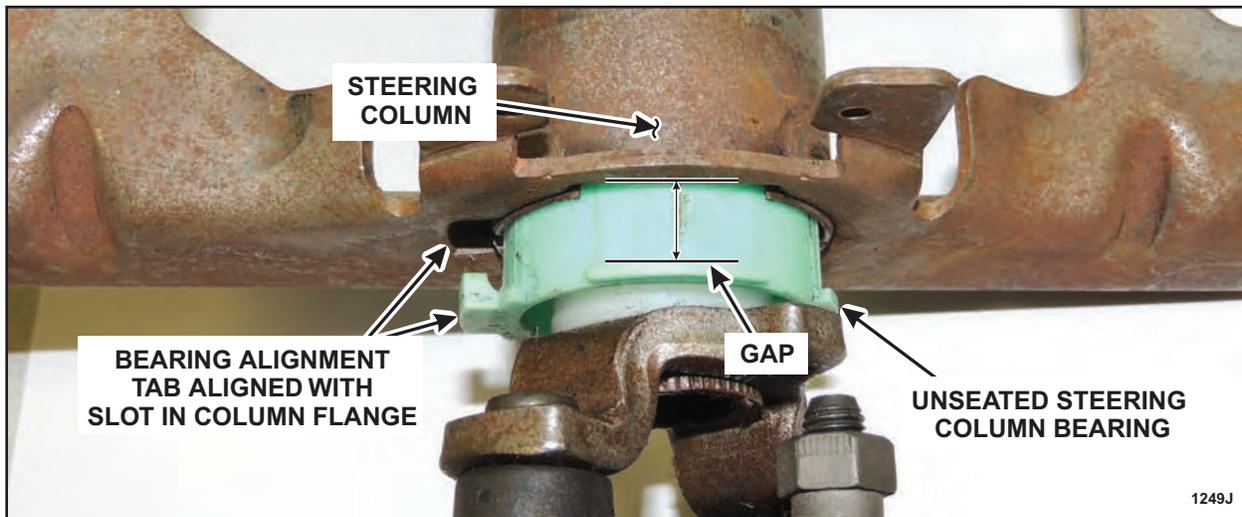
FIGURE 8

**NOTE:** In some instances the steering column bearing orientation tab may have broken off. If the tab has broken off, the bearing is still usable and can be seated within the steering column in any orientation.

2. Align the bearing alignment tab with the slot in the column flange. See Figure 8.
