IMPORTANT SAFETY RECALL  
NHTSA RECALL #13V-591  
January 2014

### **PREVOST SAFETY RECALL CAMPAIGN SR13-92 "ADDITION OF AN EMERGENCY EXIT WINDOW"**

## ADDITION OF AN EMERGENCY EXIT WINDOW 9700 (B13R)

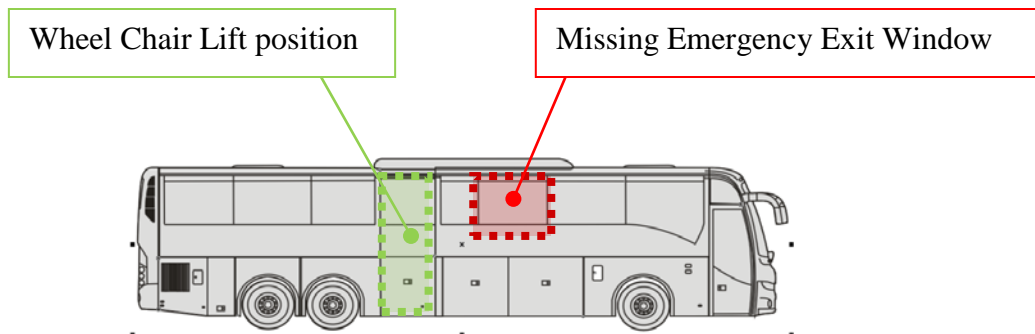
On the vehicles involved in this safety recall, the quantity of emergency exit windows is insufficient to comply with the requirements of FMVSS no. 217: "Bus Emergency Exits and Window Retention and Release".

If the vehicle is equipped with a wheel chair lift *and does not* have an emergency exit window as shown in the figure above, please contact your Prevest Service Center to schedule an appointment at your earliest convenience to have an additional emergency exit window installed free of charge. Please mention Safety Recall SR13-92. A complete list of Prevest service points is available on [www.prevestcar.com/network](http://www.prevestcar.com/network).

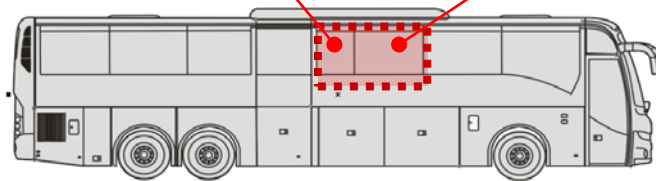
Small fixed Window  
to be removed and  
re-installed.

Fixed Window to be  
replaced by an  
emergency window.
