PRODUCT SAFETY RECALL

SUBJECT: Rear Suspension Bolts May Not Be To Proper Torque Specification

MODELS: 2013 Chevrolet Malibu

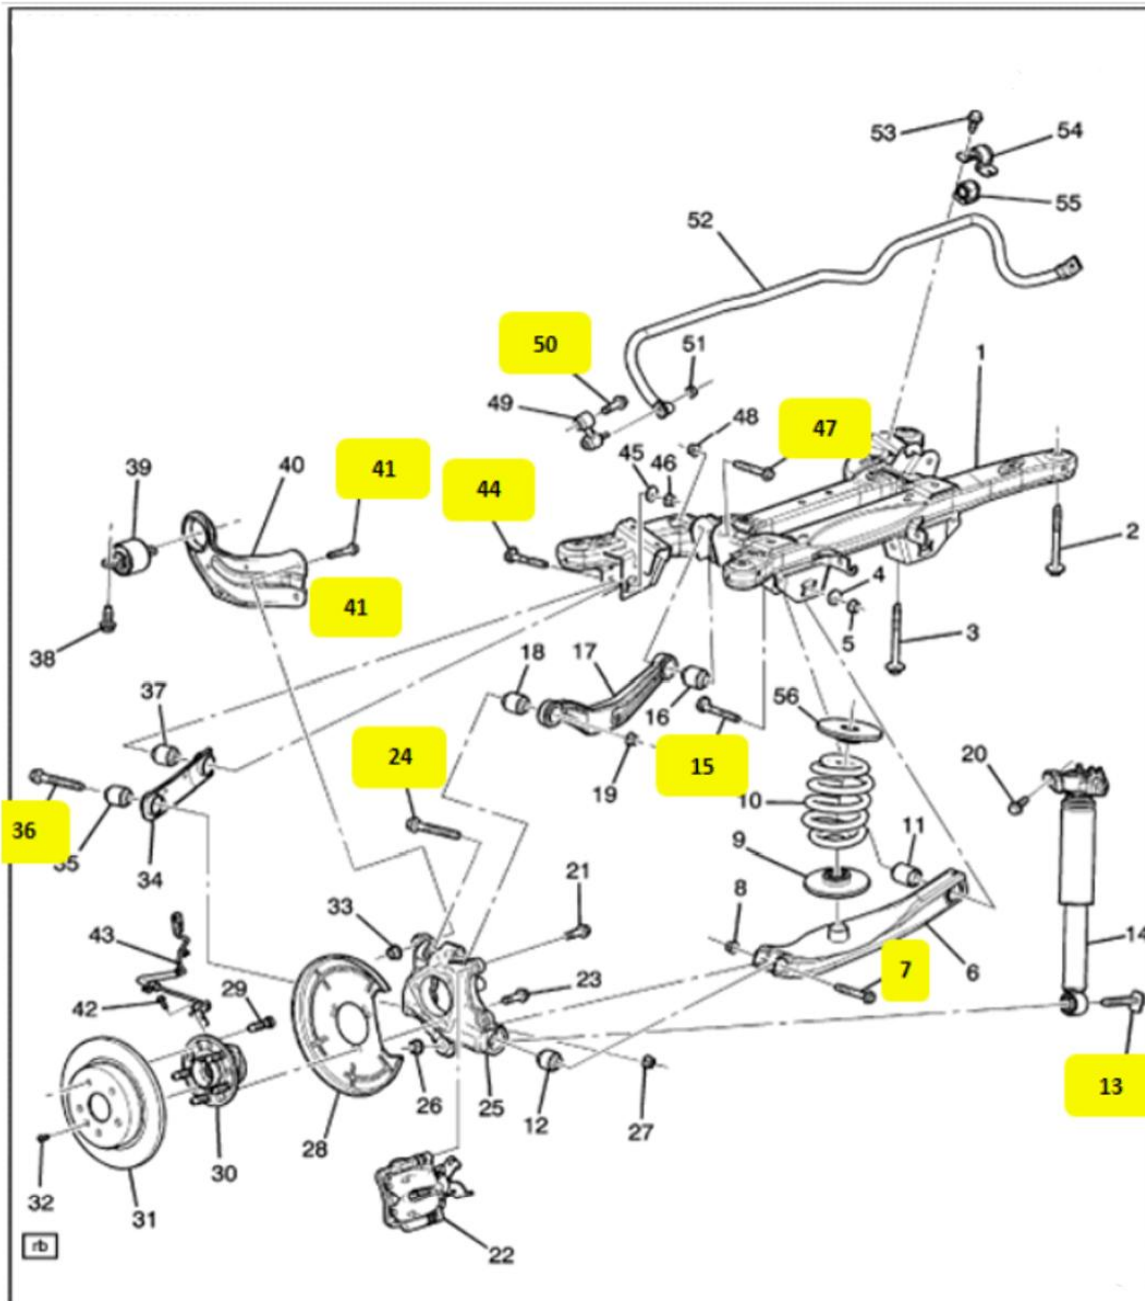
Fastener Location Overview

3. Perform a static torque inspection on the 20 rear suspension fasteners listed in the *Static Torque Specification Table* in this bulletin.
 - Ensure the 20 fasteners meet the minimum static torque specification provided in the table. Refer to the table to determine if torque must be applied to the bolt or nut.

- Replace ALL fasteners that do NOT meet the minimum torque specification with a new fastener. The fastener part number is provided in the *Parts Information* section of the bulletin.
