Recall Bulletin

PRODUCT SAFETY RECALL

SUBJECT: Supplemental Restraint System (SRS) Electronic Control Module (ECM)

MODELS: 2003-2004 Pontiac Vibe

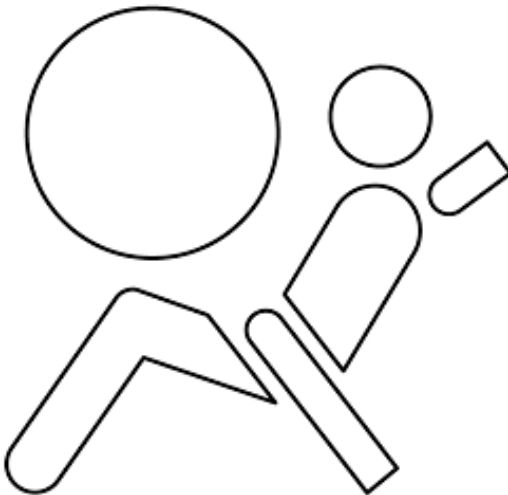
3352671

- a) Verify that the warning indicator comes on when the ignition switch is turned on.

- b) After the ignition has been on for approximately 6 seconds check the behavior of the warning indicator.

Condition #1: Light Remains On, **OR** Light Blinking, **OR** Light Does Not Come On.

Condition #2: Light Goes Off.

Corrective Action: Replace the Sensing and Diagnostic Module (SDM) and install the sub harness. Proceed to **STEP 2. CHECK FOR DTCs.**

Corrective Action: Install the sub harness. Proceed to **STEP 2. CHECK FOR DTCs**

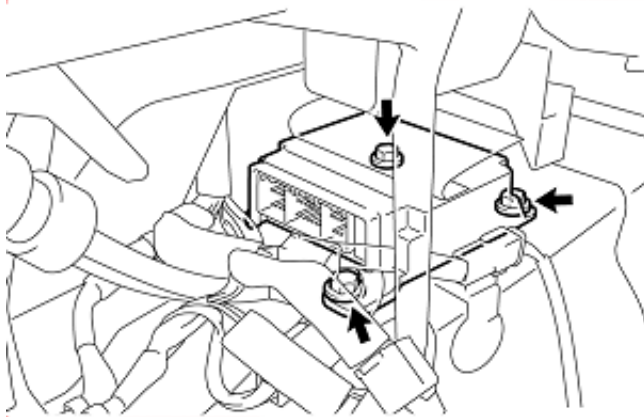
(Required IF Vehicle Exhibited Condition #1 Above)

- Remove the 3 bolts and the SDM.
- Install a NEW SDM, then continue to STEP 12.

TIGHTEN to 13ft. lb (17.5 N·m)

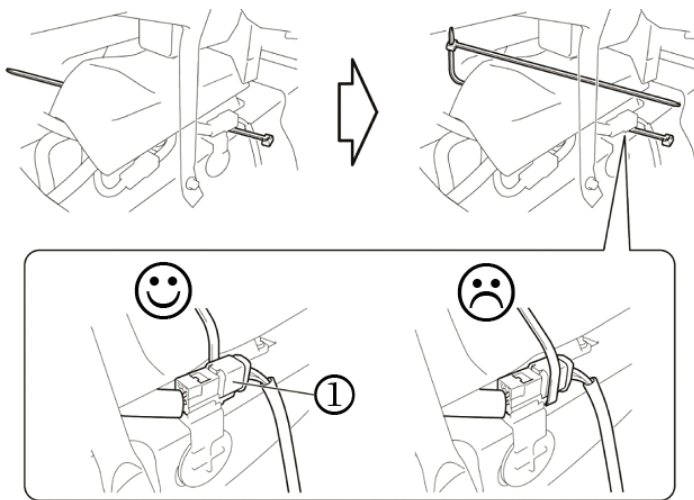
3352713

- **DO NOT bind the SDM harness/connector with the cable ties.**
- **If the cable tie or sheet is affixed incorrectly, the sub harness may not be fixed properly.**

- e) Pass a cable tie through the space under the SDM (1), then connect another cable tie.
- f) Join the cable ties and secure the sub harness, water guard, and SDM together.

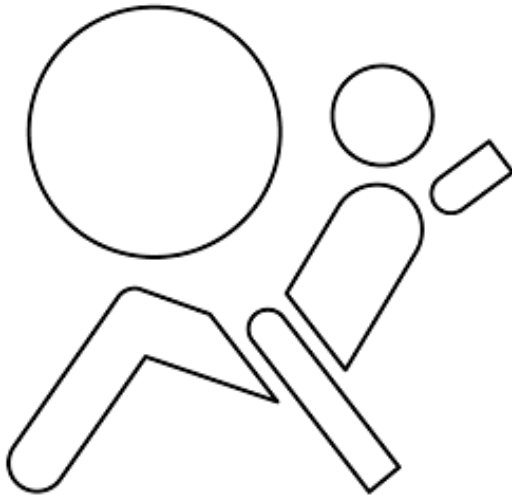
33527671

- a) Confirm that the warning indicator illuminates when the ignition is switched on.
- b) Confirm that the warning light will go off after about 6 seconds have elapsed after IG on.

- **After the 6 second illumination of the warning indicator, if the indicator goes off then back on or remains on, check for DTCs.**
- **Consult with the customer to determine if they would like to diagnose/repair any remaining concerns.**
