SI B34 04 13
Brakes

Recall Campaign 13V-045: Inspect Brake Booster Vacuum Supply Line

E70 with N62TU engine

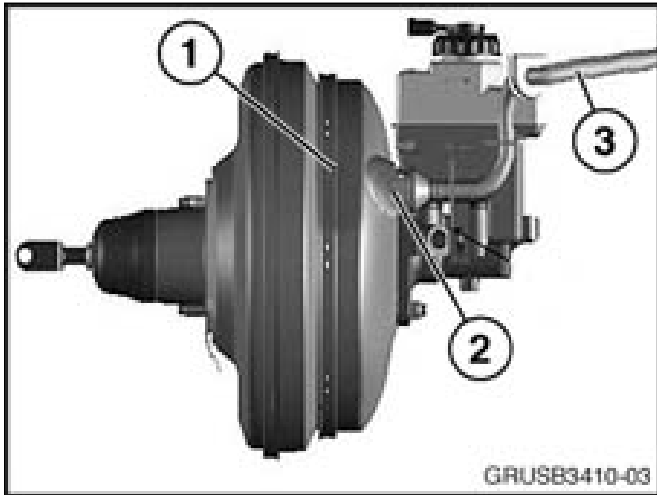
1. Remove the brake booster vacuum supply line/pipe (3) together with the non-return valve (2) from the brake booster (1).

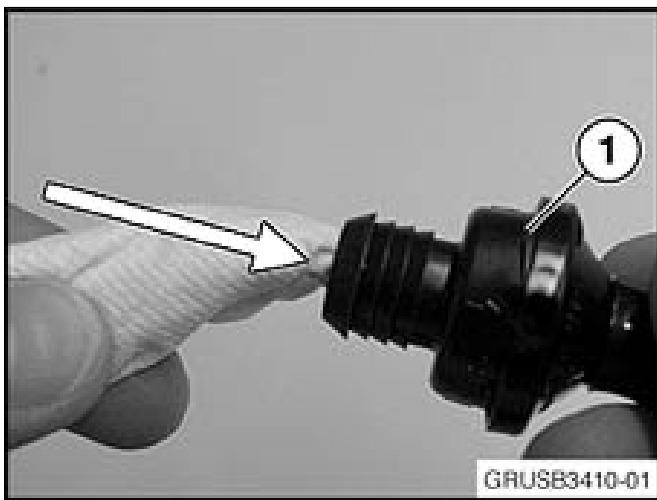
2. Check the brake booster vacuum supply line/pipe at the non-return valve upstream from the brake booster for oil contamination. Insert a tightly rolled-up corner of a non-reusable lint-free white shop towel (see arrow) into the non-return valve (2). If the towel does not indicate any engine oil residue, proceed to step 4.

3. If the non-return connection exhibits contamination with engine oil, proceed to step 5.
