# North America

**SUBJECT:** Voluntary Safety Recall Campaign Number 13V-053 Allison 3000RDS Automatic Transmission Oil Cooler Hose Leakage

Department: Service  
Section: Transmission  
Model(s): Allison 3000RDS  
Model Year(s): 2011, 2012 and 2013  
Effective Date: May 1, 2013  
Form #: Recall Bulletin 13V-053  
Rev #: N/A  
Supersedes: N/A

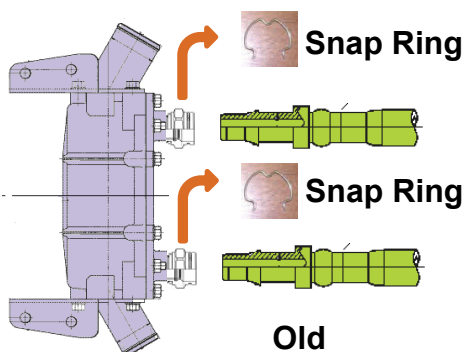
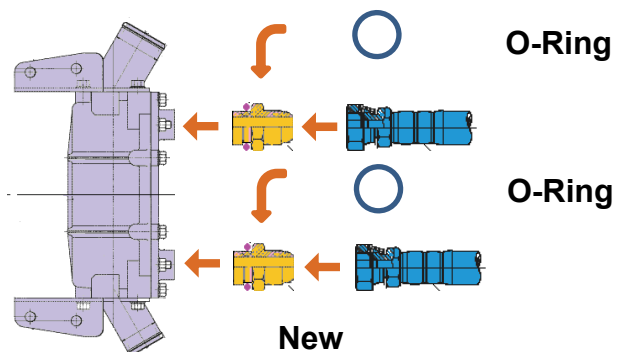
1. If the hose connection is the **NEW** style, then the campaign has been completed or already performed at the factory. See **NEW** design shown on bottom of page 3.
2. If the vehicle has the **OLD** design “clip” type connector, then verify through the AS400 that the campaign is required.
