RECALL CAMPAIGN BULLETIN

NTB13-034

VOLUNTARY SAFETY RECALL CAMPAIGN 2013 LEAF OCS SENSORS

APPLIED VEHICLES: 2013 Leaf (ZE0)

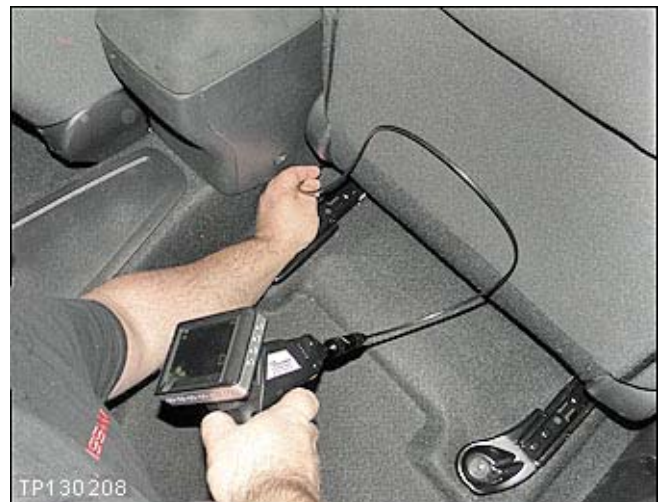
Figure A

2. Use borescope (J-50079 or equivalent) to read the lot code on the side of the inboard seat-track.

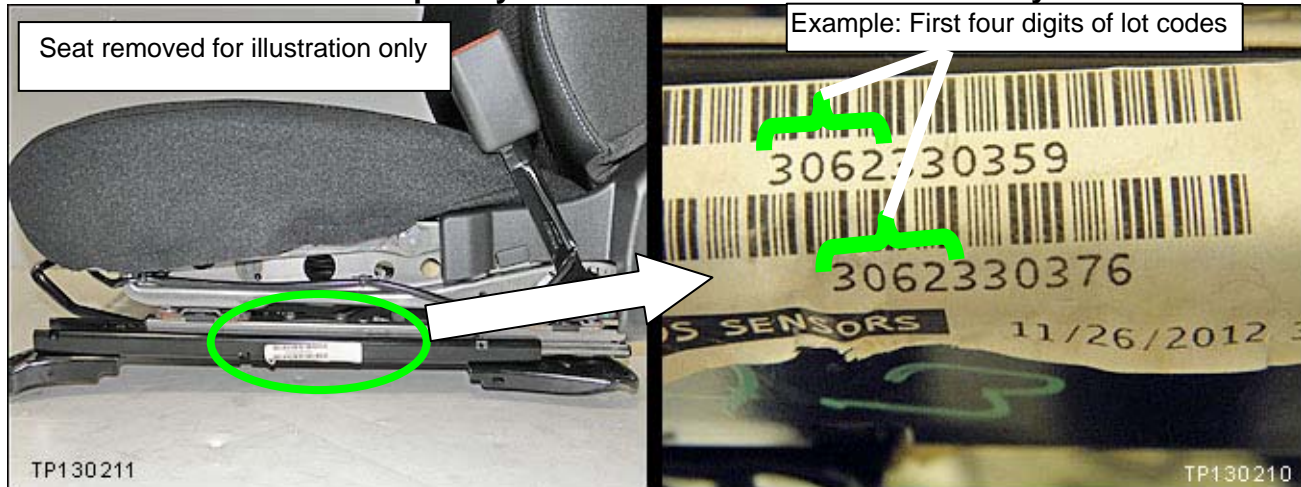
Figure B

OCS sensor lot code example – your vehicles lot code numbers may be different.

- In the **example** above, the first four digits are “3062” for both sensors.

NG: Lot code is in this range: 2472 to 3102

- If the first four digits of the lot code are 2472 to 3102, replace the sensor.

NOTE: Only replace a sensor if its lot code is in the above range. Some vehicles may require only one new sensor; some may require two new sensors.
