# RECALL CAMPAIGN BULLETIN

NTB13-034b

## VOLUNTARY SAFETY RECALL CAMPAIGN 2013 LEAF OCS SENSORS

**APPLIED VEHICLES:** 2013 LEAF (ZE0)

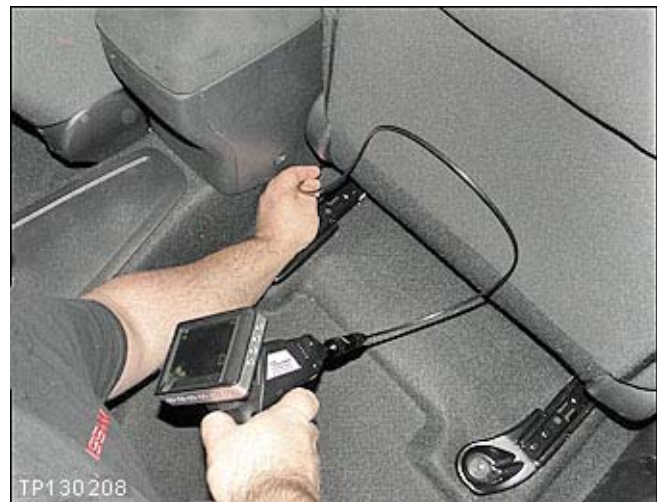
Figure A

2. Use borescope (J-50079 or equivalent) to read the lot code on the side of the inboard seat-track.

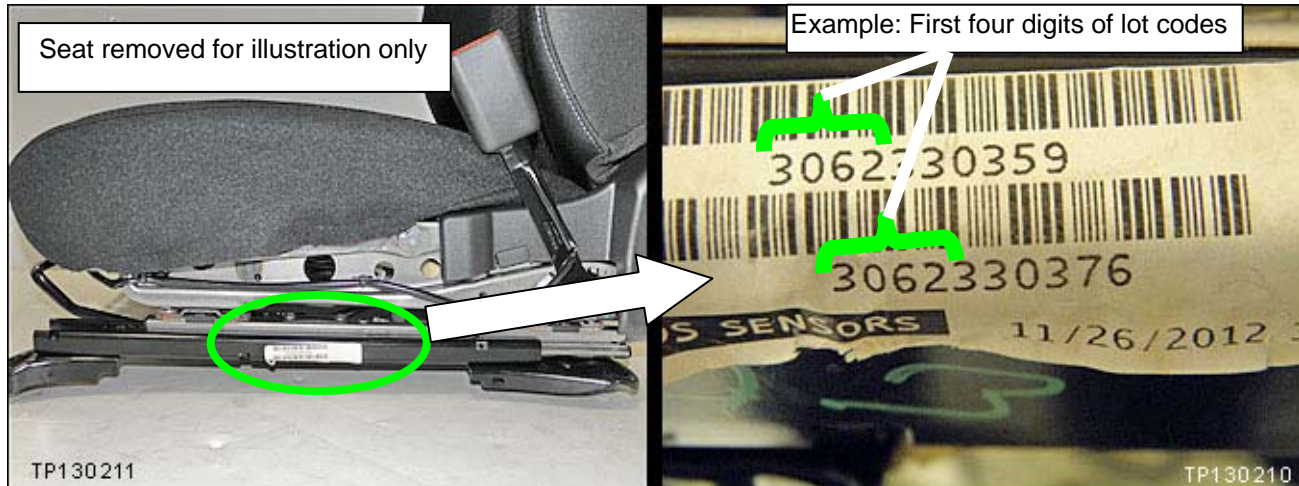
Figure B

**OCS sensor lot code example – your vehicles lot code numbers may be different.**

3. Write the first four digits of the lot code **for each sensor** on the repair order.
  - In the **example** above, the first four digits are “3062” for both sensors.
4. Use the flow chart on the next page to determine if the OCS sensors are NG or OK.
  - **Both sensors must be checked.**
