# RECALL CAMPAIGN BULLETIN

NTB13-035c

## VOLUNTARY SAFETY RECALL CAMPAIGN 2013 PATHFINDER OCS SENSORS

**APPLIED VEHICLES:** 2013 Pathfinder (R52)

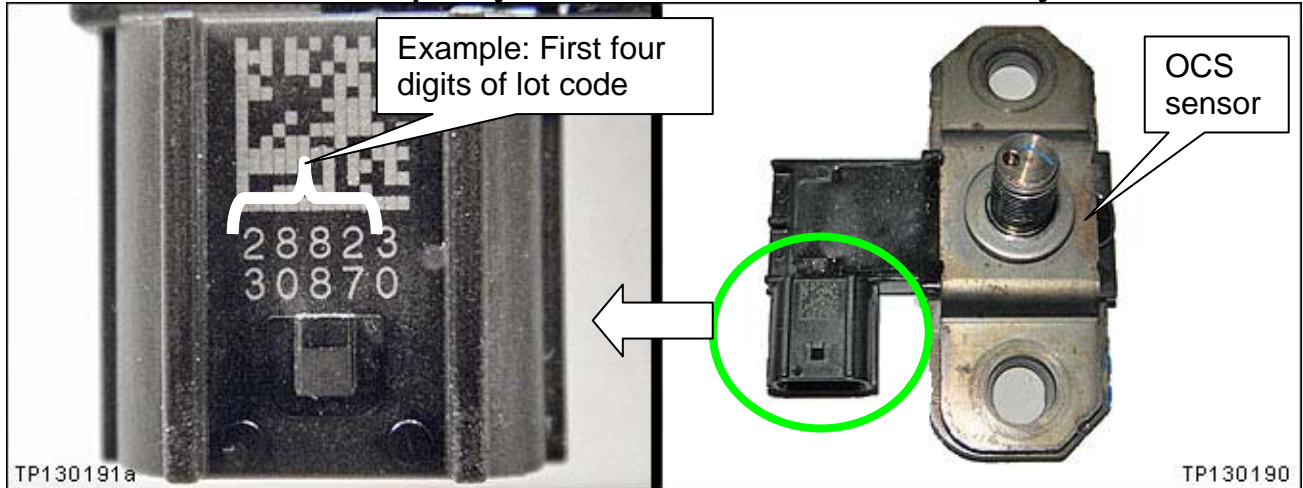
Figure 16

**OCS sensor lot code example – your vehicle’s lot code numbers may be different.**

e. Write the first four digits of the lot code on the repair order.

f. Go to page 14 and use the “**Lot Code**” **Flow Chart** to determine if the front OCS sensor is NG or OK.

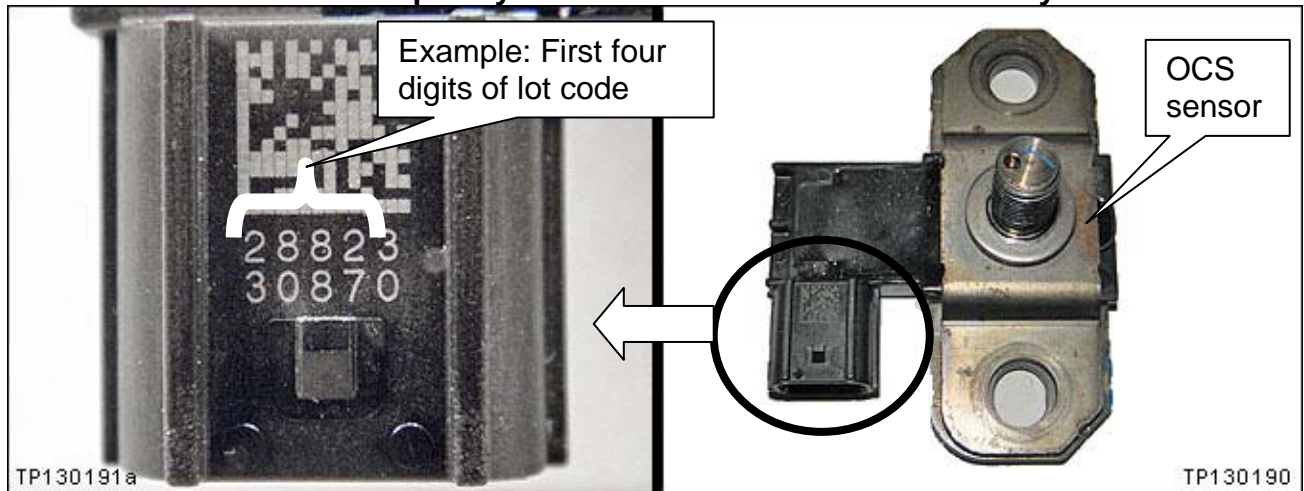
Figure 20

**OCS sensor lot code example – your vehicle’s lot code numbers may be different.**

- e. Write the first four digits of the lot code on the repair order.
- In the **example** above, the first four digits are “2882”.
- f. Go to page 14 (next page) and use the “**Lot Code**” **Flow Chart** to determine if the rear OCS sensor is NG or OK.
- Use the “**Lot Code**” **Flow Chart** before continuing to step 13.
  - **NOTE: Both sensors must be checked.**

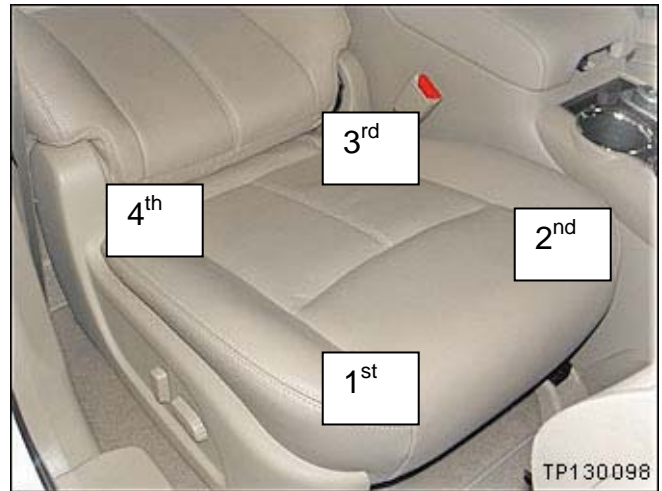
Figure 26

- In steps 18 and 19 you will be tightening the 14 mm nuts that hold the seat frame to the seat tracks.
- Torque the nuts in the order shown in Figure 26.

- **This is a critical torque specification.**
- **Make sure the torque wrench is properly calibrated.**
- **Make sure to torque these nuts as indicated.**

18. From under the front of the seat, torque the front 14 mm nuts:

1<sup>st</sup>, torque outboard side.

2<sup>nd</sup>, torque inboard side.

- Torque nuts to:  
45 N•m (4.56 kg-m, **33 ft-lb**)

19. From the top of the seat cushion, torque the rear 14 mm nuts:

3<sup>rd</sup>, torque inboard side.

4<sup>th</sup>, torque outboard side.

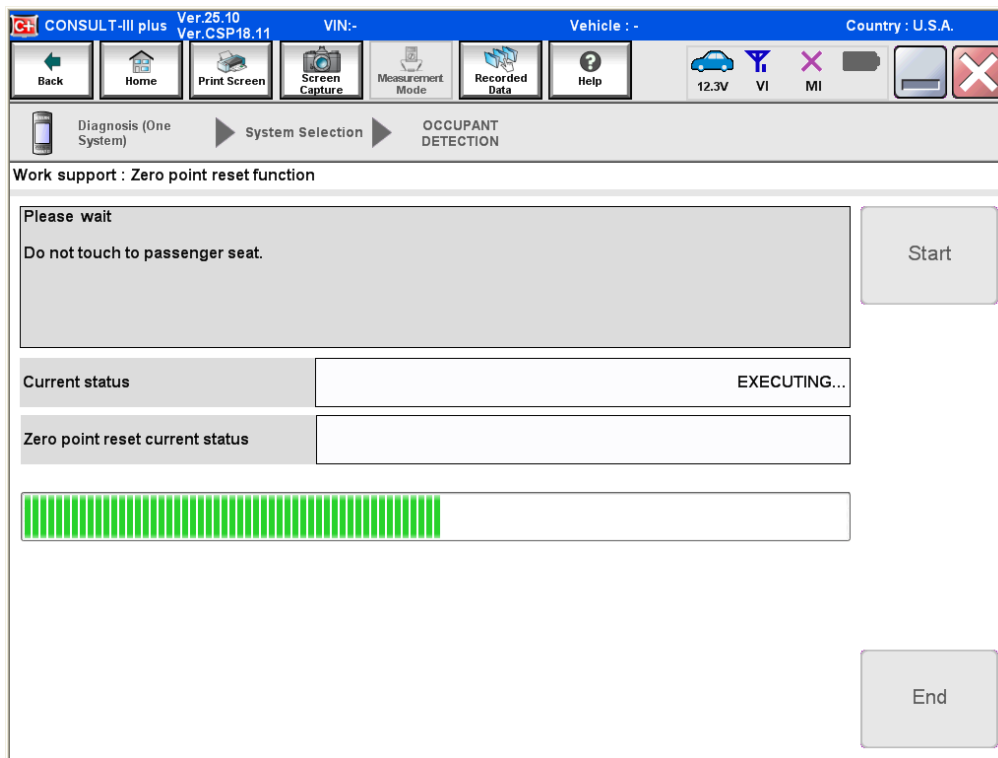
Figure Z6

**NOTE:** If Zero Point Reset will not complete, it is likely that something in the Service Procedure was not followed exactly as instructed.

**NOTE:** DTC B1020 is an indication that the 14 mm nuts may be torqued incorrectly.

- a. Turn the ignition OFF.
- b. Make sure all electrical connectors under the seat are **securely connected**.
  - Body harness to seat harness.
  - OCS sensors
  - OCS Control Unit.
- c. Try Zero Point Rest again.
- b. If it still will not complete, an installation process or step was not followed exactly as specified.
  - Recheck / re-perform the OCS sensor installation process.
  - **Pay special attention to the 14 mm nut torque (page 17, steps 18 and 19).**
