Applies To: **2005 Pilot** – Check the iN VIN status for eligibility

**March 16, 2013**

## Safety Recall: VSA System Unexpectedly Activates

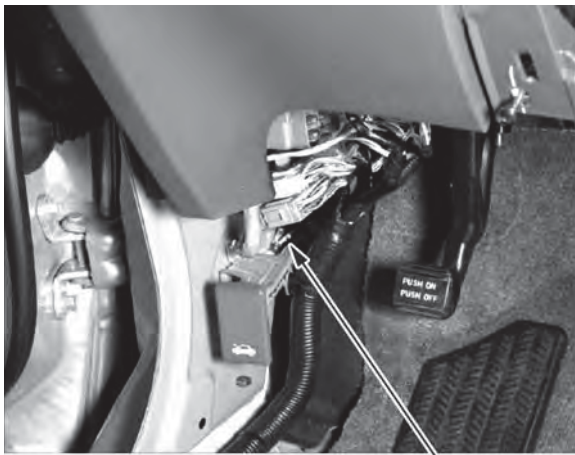
- Damage to an internal component could cause the VSA system to misinterpret the signal and may cause the VSA braking system to unexpectedly apply braking force.
- For vehicles with VINs beginning with 5FN, a ground bolt may be loose. Increased resistance caused by this loose ground bolt may cause the VSA braking system to unexpectedly apply braking force.

In addition, if the VIN begins with 5FN, inspect the ground bolt and tighten it to specification. If necessary, replace the bolt.

4. Remove the G302 bolt.

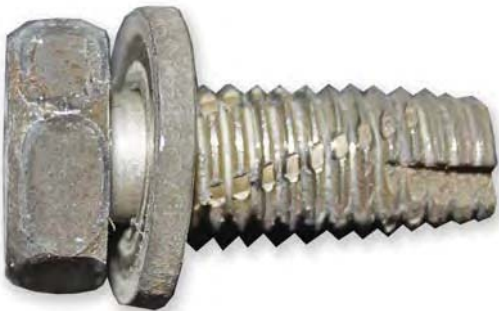
**GROUND BOLT**

5. Inspect the bolt for the following issues:

- Corrosion
- Damage
- Cross-threading
- The bolt is a regular bolt, not a ground bolt
  - If the bolt has any of the above issues, replace it before going to step 6.
  - If the ground bolt does not have any of the listed issues, it is OK. Go to step 6.
