# Recall Bulletin

## PRODUCT SAFETY RECALL

**SUBJECT:** Steering Wheel Fastener Inspection

**MODELS:** 2013 Buick Encore  
Equipped with Heated Steering Wheel

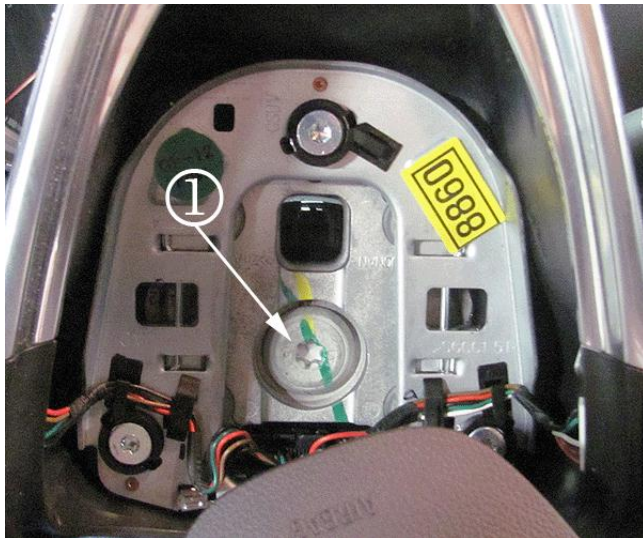
3352589

8. Push the spring fastener in the direction of the steering column to release the steering wheel inflator from the steering wheel.
9. Remove Driver Airbag Module (DAB). DO NOT disconnect the two yellow electrical connectors.

10. Inspect the hub area of the steering wheel for the attachment bolt (1).
  - If the attachment bolt (1) is NOT present, install a new attachment bolt, P/N 11610164. Tighten the bolt to **30 Nm (23 lb-ft)**. Proceed to Step 11 after installing the new attachment bolt.
  - If the attachment bolt is present, apply a torque of 25 N·m (18 lb-ft) and verify that the bolt does not rotate. If the bolt rotates, remove it and replace it with P/N 11610164. Tighten the bolt to **30 Nm (23 lb-ft)** using a torque wrench.
