Recall Bulletin

PRODUCT SAFETY RECALL

SUBJECT: Steering Wheel Fastener Inspection

MODELS: 2013 Buick Encore

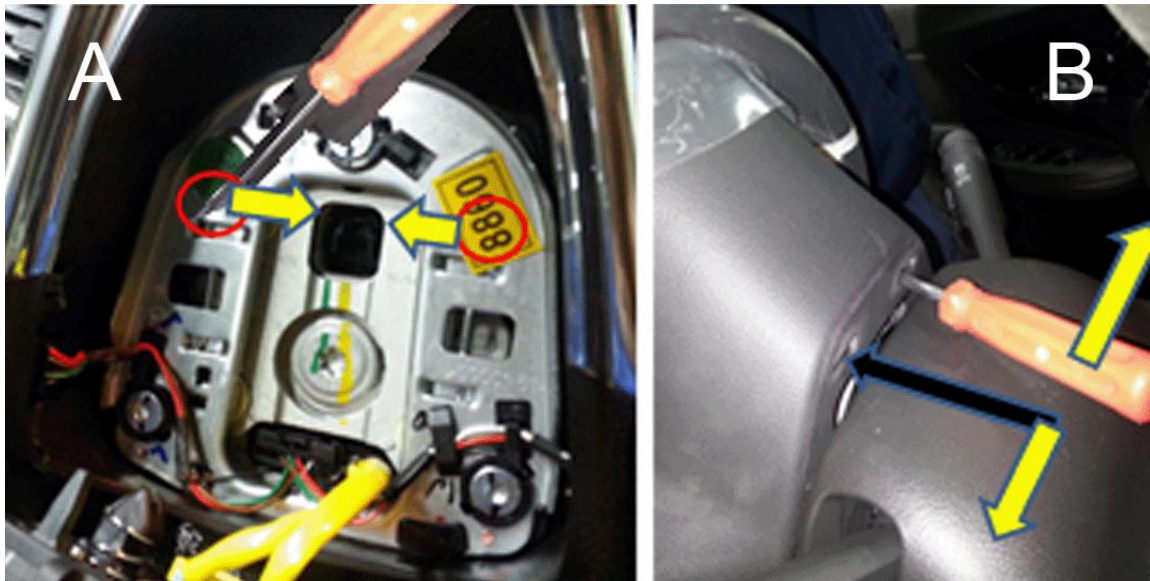
3397715

Front side of steering wheel shown in portion “A” of illustration.. Insert screw driver through the rear left and right side of the the steering wheel as shown in portion B of illustration.

4. Remove the steering column lower trim cover. Refer to *Steering Column Lower Trim Cover Replacement*.
5. Lower the steering column and move to the maximum rear end position.
6. Turn the steering wheel from straight ahead to 180 degree position.
