**TO:** All Dealer Principals, Service Managers and Parts Managers

**Subject:** 2100 Plus Muncie CS10 & CS11 PTOs

**Number: SB 265B DATE: 12/04/2013**

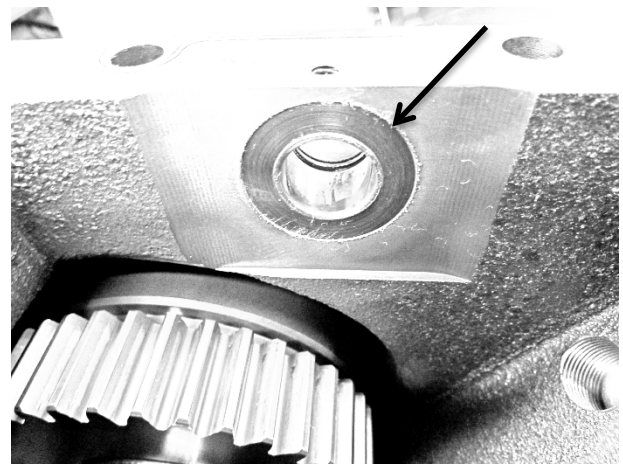
Inspection of the Housing. The area around the idler shaft shows little to no wear. This is an example of no wear.
