Reference: NHTSA Identification Number 13V-121

# **Safety Recall N10 / NHTSA 13V-121**

## **Underbody Transmission Tunnel Shield**

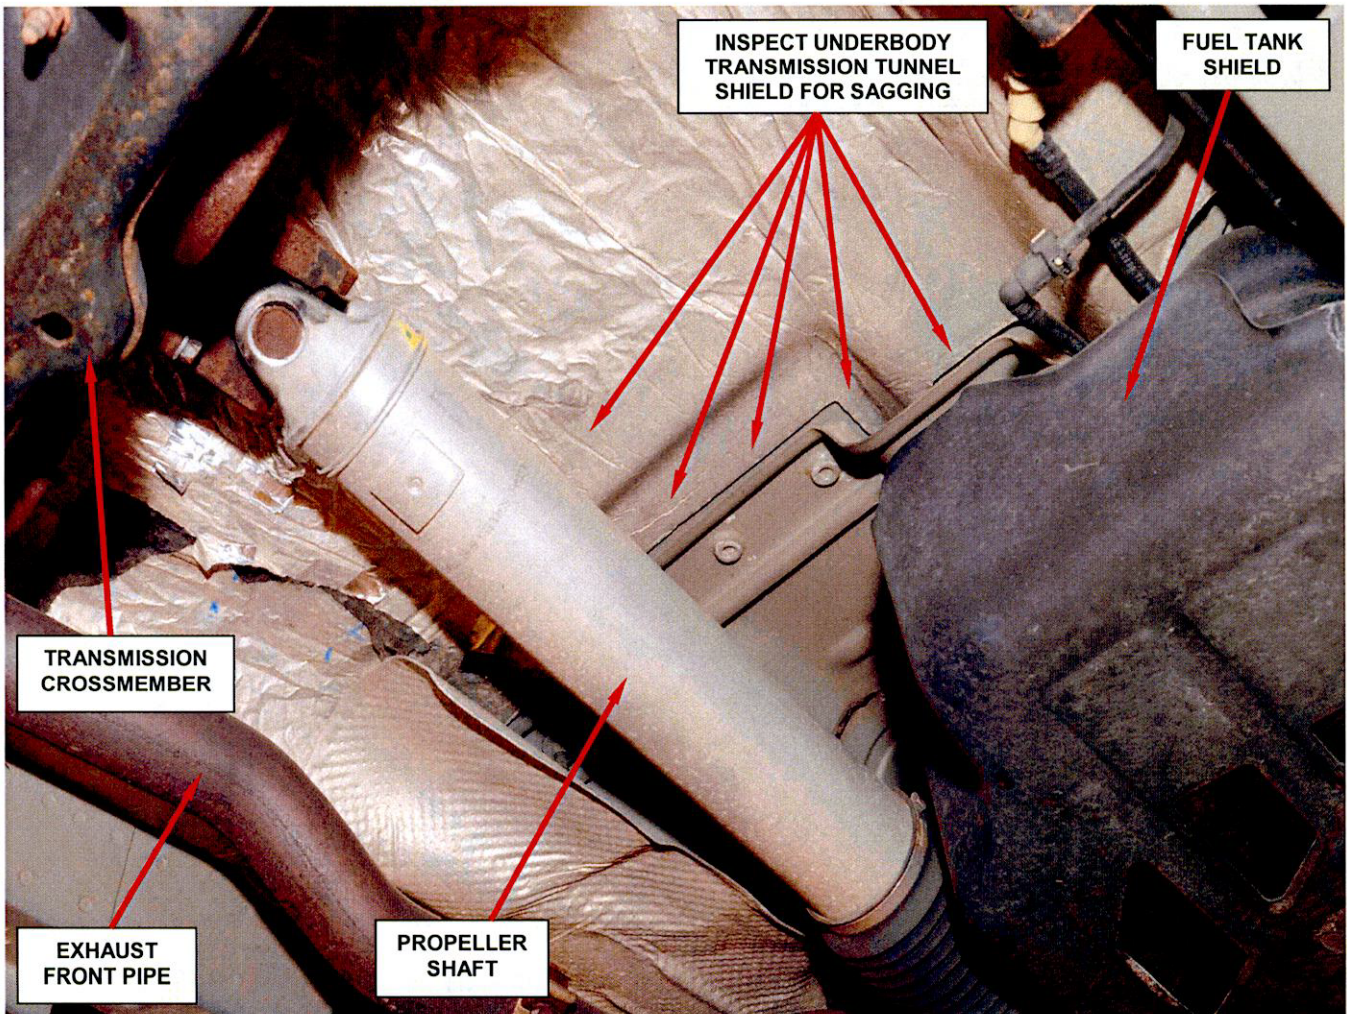
**Figure 1 – Inspect Underbody Transmission Tunnel Shield**

1. Lift the vehicle on an appropriate hoist.
2. Inspect the underbody transmission tunnel shield (Figure 1):
  - If the underbody transmission tunnel shield has not sagged and/or come in contact with the propeller shaft, continue with **Section C. Install Underbody Transmission Tunnel Shield Support Bracket.**
  - If the underbody transmission tunnel shield has sagged and/or has contacted the propeller shaft, continue with **Section B. Replace Underbody Transmission Tunnel Shield.**

The underbody transmission tunnel shield must be inspected for partial separation from the floor pan. If the shield partially separated from the floor pan, the shield must be replaced. All involved vehicles will also receive a shield support bracket.

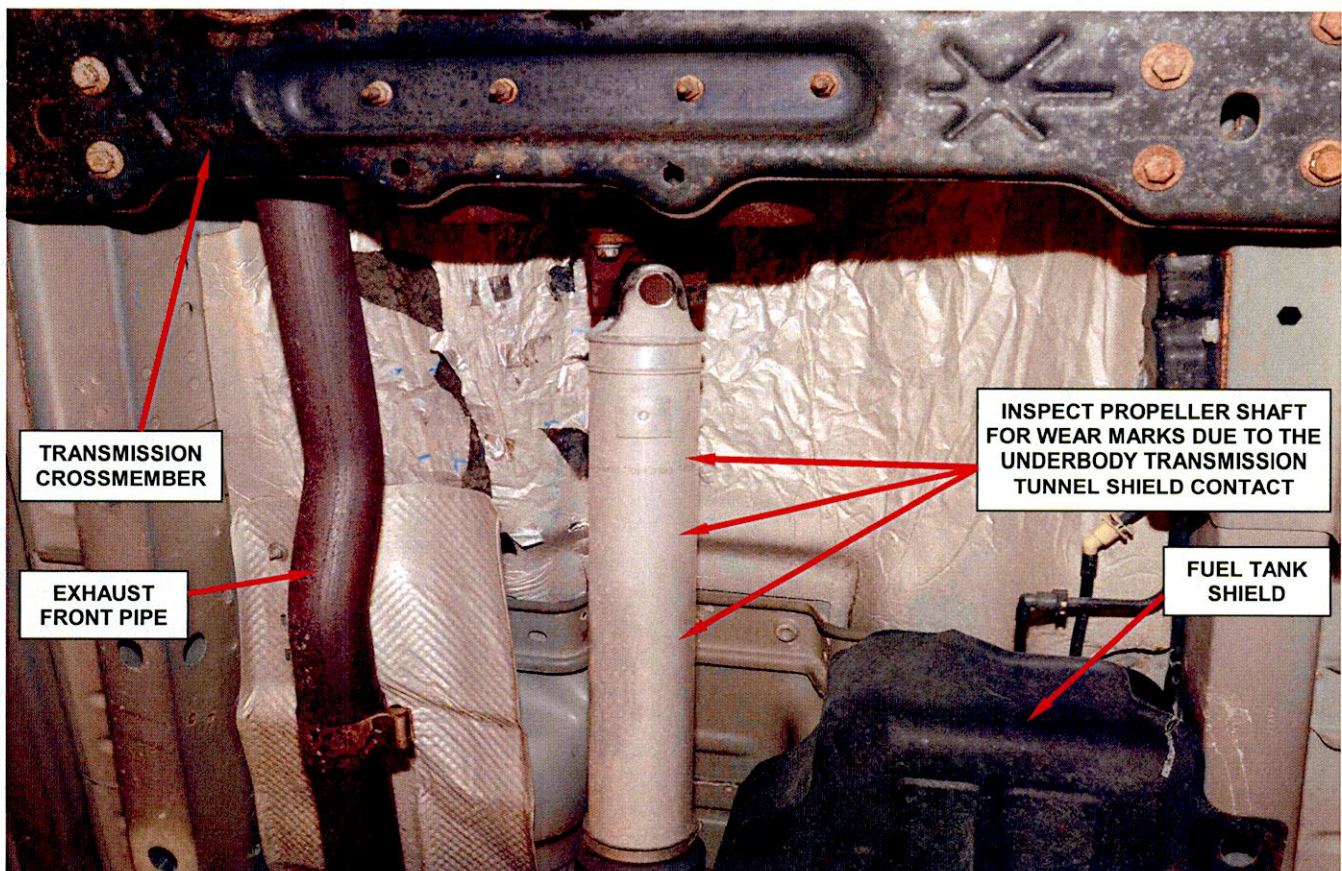
**Figure 2 – Inspect Propeller Shaft**

1. Inspect the propeller shaft for wear marks due to underbody transmission tunnel shield contact (Figure 2):
  - If the underbody transmission tunnel shield has created wear marks on the propeller shaft tube, the propeller shaft assembly must be replaced (Figure 2).
  - If the underbody transmission tunnel shield has not created wear marks on the propeller shaft tube, the propeller shaft assembly does not require replacement (Figure 2).
