SIB 65 15 13

## Recall Campaign 13V-172: Passenger Front Air Bag Module

This Service Information Bulletin (Revision 8) replaces SI B65 15 13 **dated July 2020**.

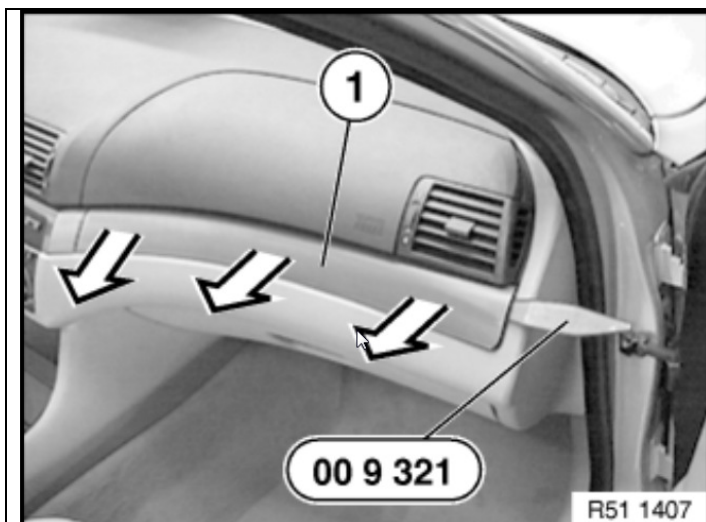
- Insert special tool 00 9 321 at the side and with the second special tool 00 9 321 next to the retaining pin.
- Unclip the decorative strip (1).

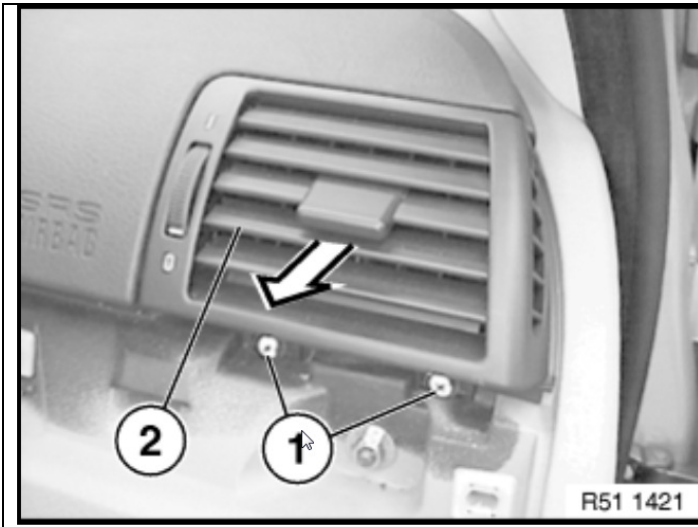
- Loosen the screws (1).
- Withdraw the fresh air grill (2) in the direction of the arrow.

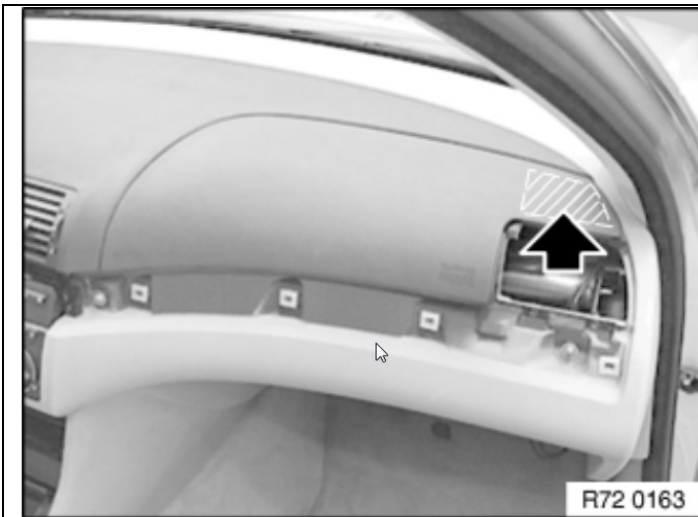
- Position of the retaining clip of the front passenger's airbag cover

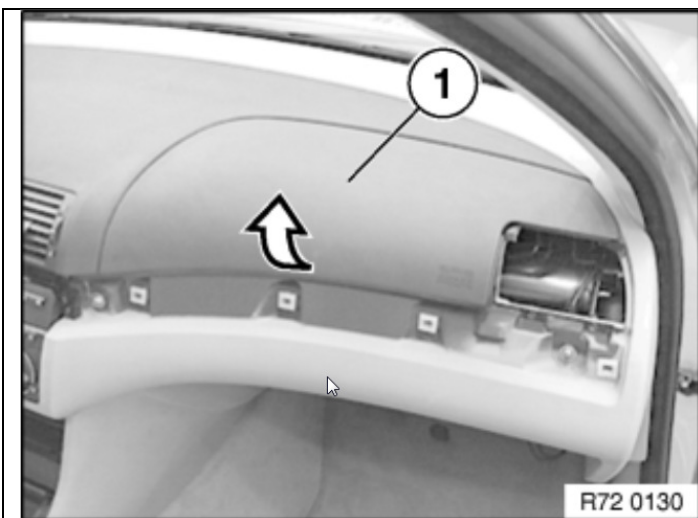
- Lever out the front passenger's airbag cover (1).

The retaining clip remains in the dashboard when removing the cover.

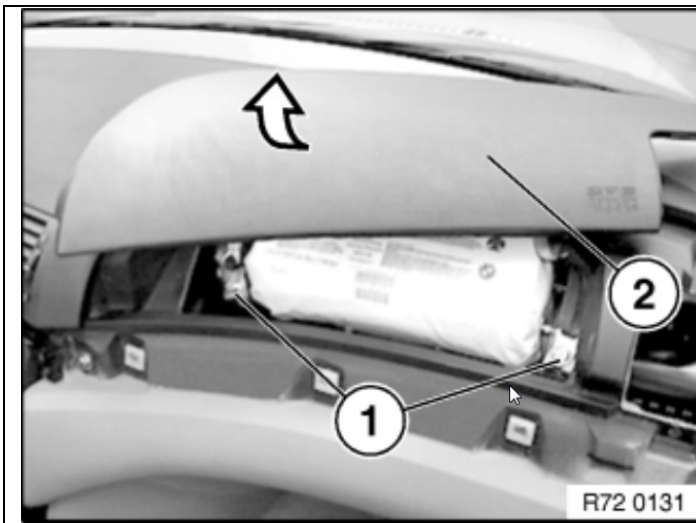
- Undo the screws (1) and place the front passenger's airbag cover (2) on top.

- Tightening torque for the retaining straps for the cover, passenger's airbag module on the instrument panel carrier: 9 Nm

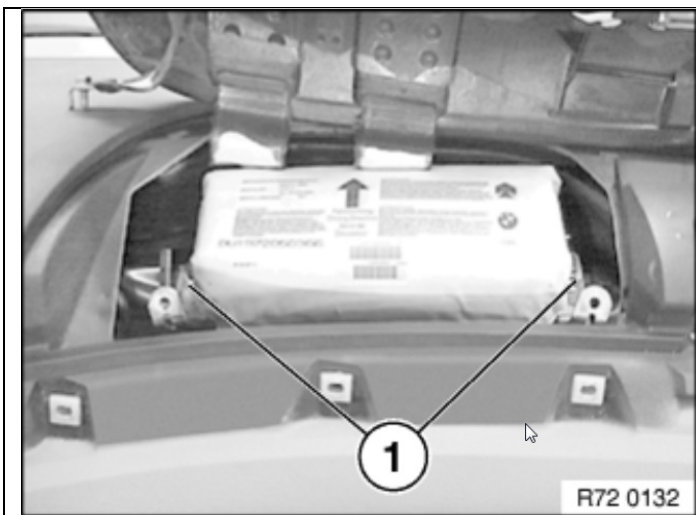
- Undo the screws (1) at the front passenger's airbag module.

- Tightening torque for the passenger's airbag module on the instrument panel carrier: M8 nut, 22 Nm

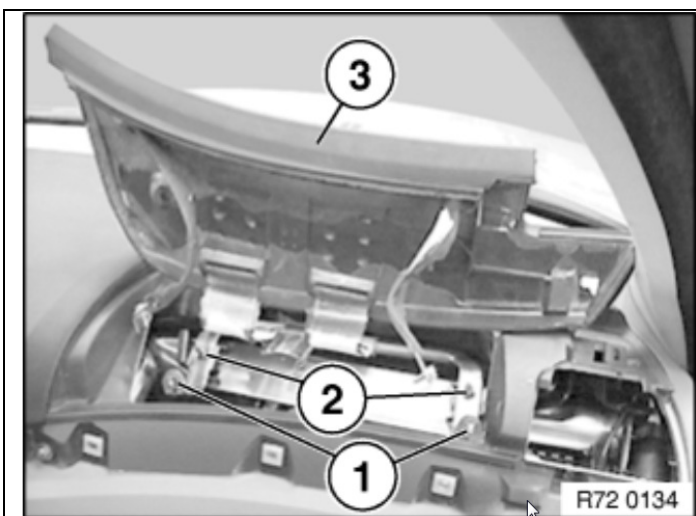
- Pull off the retaining tube (1) from the stud bolt (2) and completely remove the cover (3).
- Remove and replace the passenger's side airbag module.

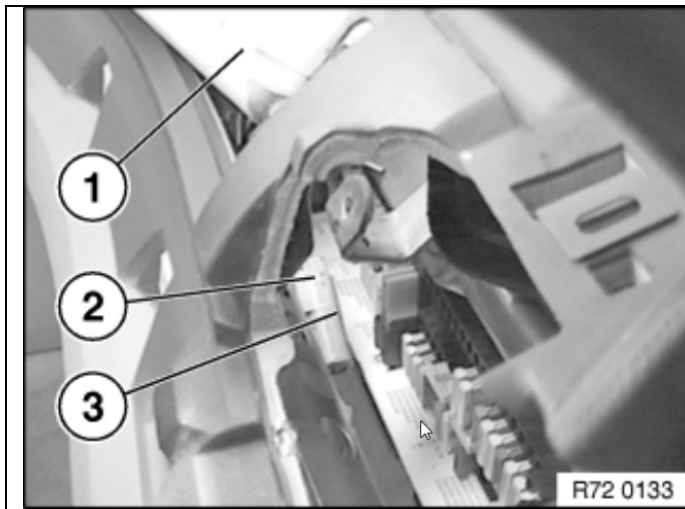
Do not tension the cable when removing the front passenger's airbag module (1)!

When lift front passenger's airbag module (1) and move sideways:

- Open the lock by pressing on the tab (2).
- Disconnect the plug connection (3).
- Remove the front passenger's airbag module (1).

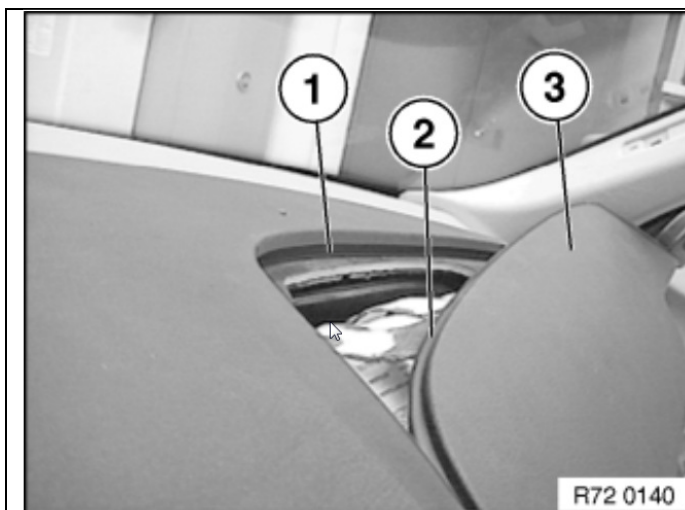
The front passenger's airbag cover (3) must engage into the all-round groove (1) of the dashboard with the lug (2).

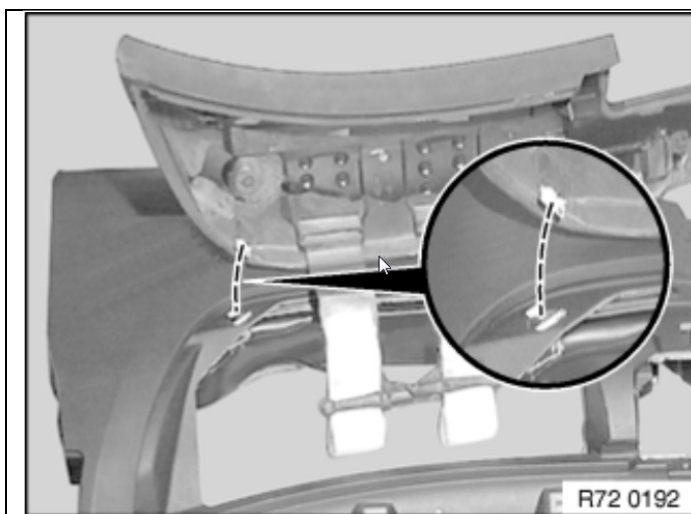
The additional retaining lug at the front passenger's airbag cover must engage in the retaining clip of the dashboard trim panel.
