SIB 65 15 13

## Recall Campaign 13V-172: Passenger Front Air Bag Module

This Service Information Bulletin (Revision 9) replaces SI B65 15 13 **dated May 2025**

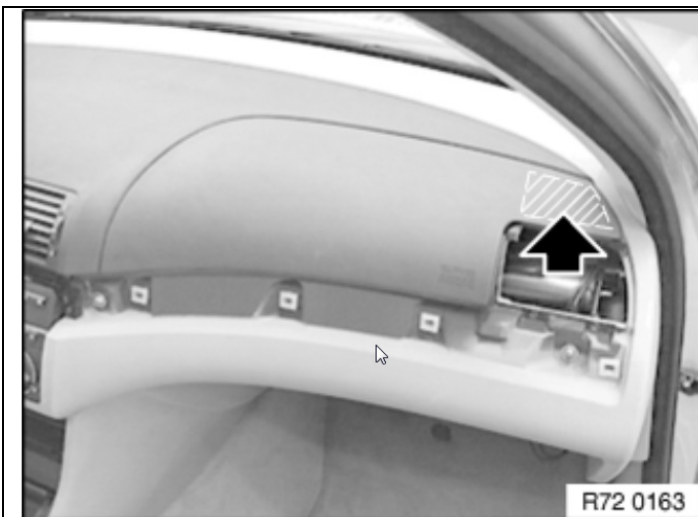
- Position of the retaining clip of the front passenger's airbag cover
