RECALL CAMPAIGN 13V-172: PASSENGER'S FRONT AIR BAG MODULE

This Service Information bulletin supersedes SI B65 15 13 **dated November 2018**.

E46 (3 Series Sedan) Produced from January 2002 to December 2002	E46 (3 Series Coupe) Produced from February 2002 to December 2002	E46 (3 Series Convertible) Produced from February 2002 to December 2002	E46 (3 Series Sports Wagon) Produced from January 2002 to December 2002
E46 (M3 Coupe) Produced from February 2002 to December 2002	E46 (M3 Convertible) Produced from February 2002 to December 2002

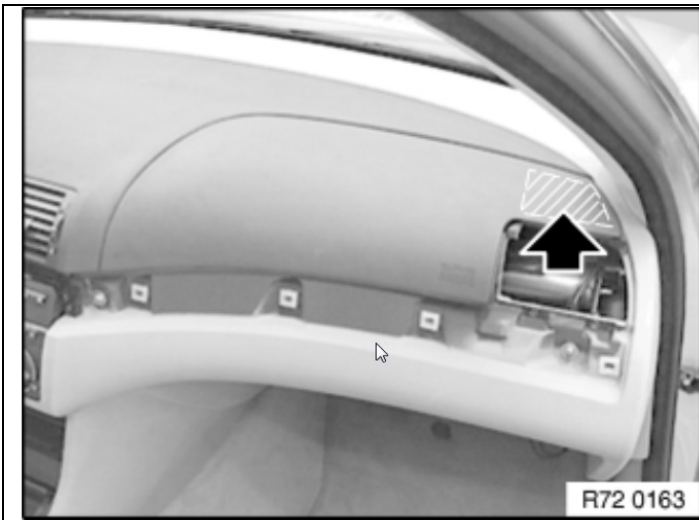
- Position of the retaining clip of the front passenger's airbag cover
