Recall Bulletin

PRODUCT SAFETY RECALL

SUBJECT: Loss of Battery Charge – Inspect Generator Control Module

MODELS: 2012-2013 Buick LaCrosse, Regal
2013 Chevrolet Malibu Eco
Equipped with eAssist

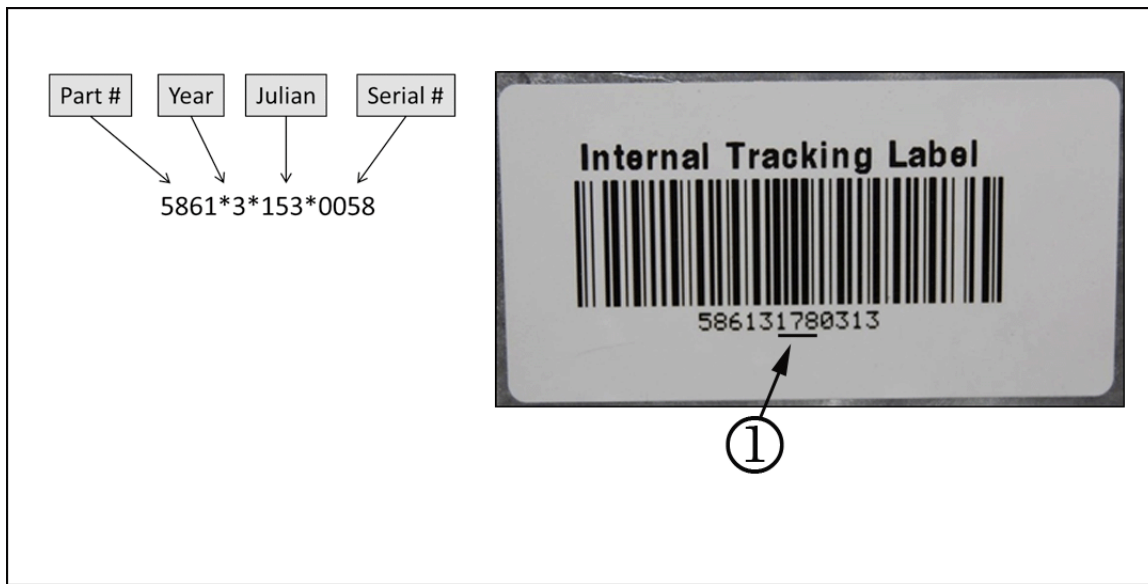
Generator Control Modules (GCM) with part number 24269448 or 24266403 require an inspection prior to installation in a vehicle. GCMs with part number 24267940 or 24267941 do NOT require inspection prior to installation in a vehicle.

Do NOT provide technicians with GCMs (p/n 24269448 or 24266403) that have a Julian date of 171 through 199. Determine the Julian date following the steps below. Return modules that fail the inspection according to Special Return Bulletin #G_0000171850.

2. Determine the Julian date (1) as shown above.
 - If the Julian date (1) is 171 through 199, proceed to step 3.
 - If the Julian date (1) is NOT 171 through 199, provide the GCM to the technician for installation in the vehicle.

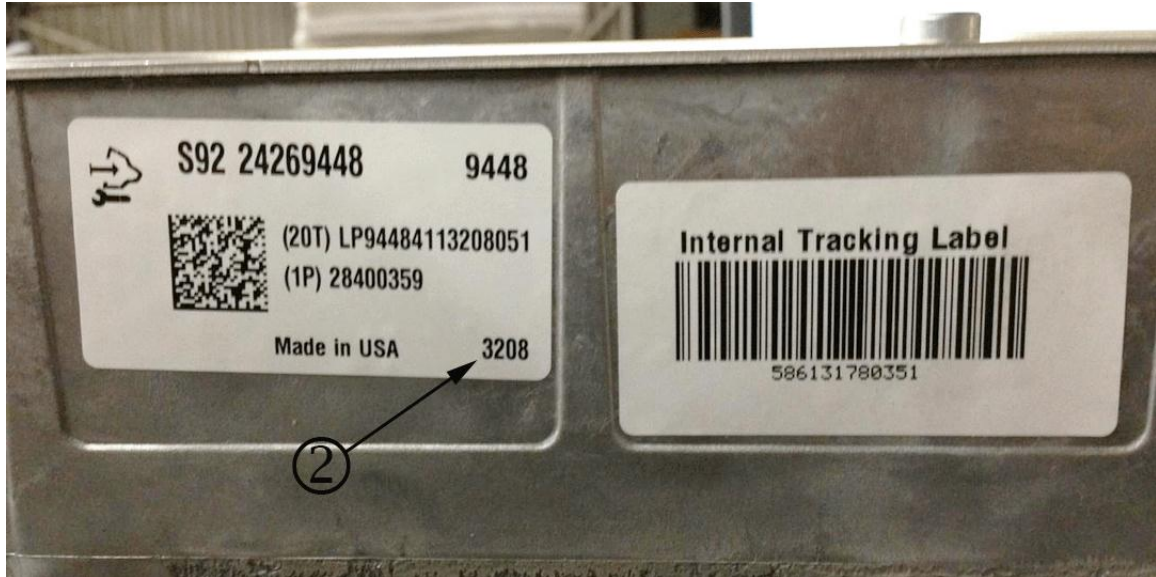
3. Locate the Flash label on the GCM.
 - If the number on the lower right-hand side of the label (2) is 3203 or lower, do NOT use the GCM. Obtain another module and perform the inspection again.
 - If the number on the lower right-hand side of the label (2) is 3204 or higher, provide the GCM to the technician for installation in the vehicle.

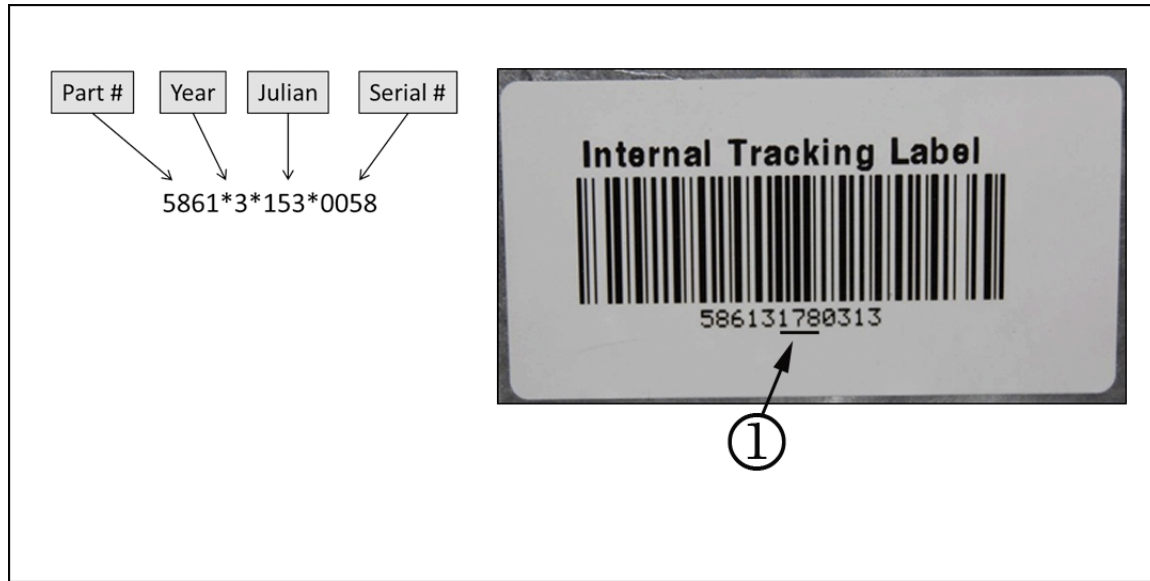
3600552

1. Locate the barcode label on the new GCM.
2. Determine the Julian date (1) as shown above.
 - If the Julian date (1) is 171 through 199, proceed to step 3.
 - If the Julian date (1) is NOT 171 through 199, install the GCM in the vehicle.
