Recall Bulletin

PRODUCT SAFETY RECALL

SUBJECT: Compressed Natural Gas (CNG) Fuel Tank Shut-Off Solenoid Connector

MODELS: 2011-2013 Chevrolet Express
2011-2013 GMC Savana
Equipped with CNG Fuel System

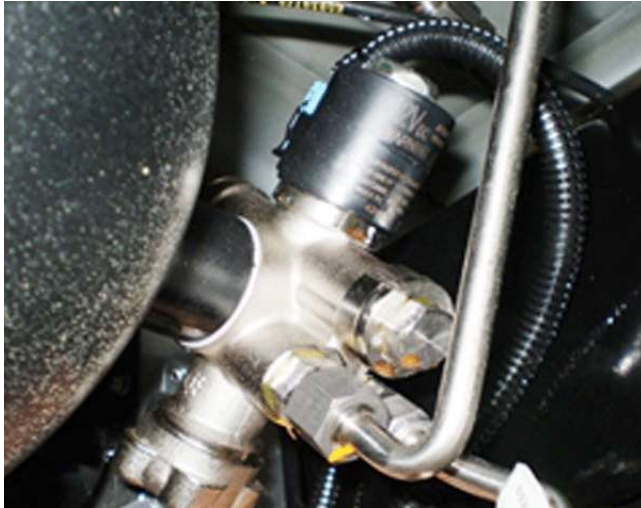
3457063

Electrical connector harness shown with no strain on the harness. Note that there is slack in the harness. If the harness does not have any slack, remove the tie strap and adjust the harness. Secure the harness with a new tie strap.

14. Verify that there is no strain on HPL solenoid electrical connector.
- If there is strain on the electrical connector harness, remove the connector tie strap and reposition the harness to relieve the wire strain. Install a new tie strap to secure harness.
 - If there is no strain on the electrical connector harness, proceed to step 15.

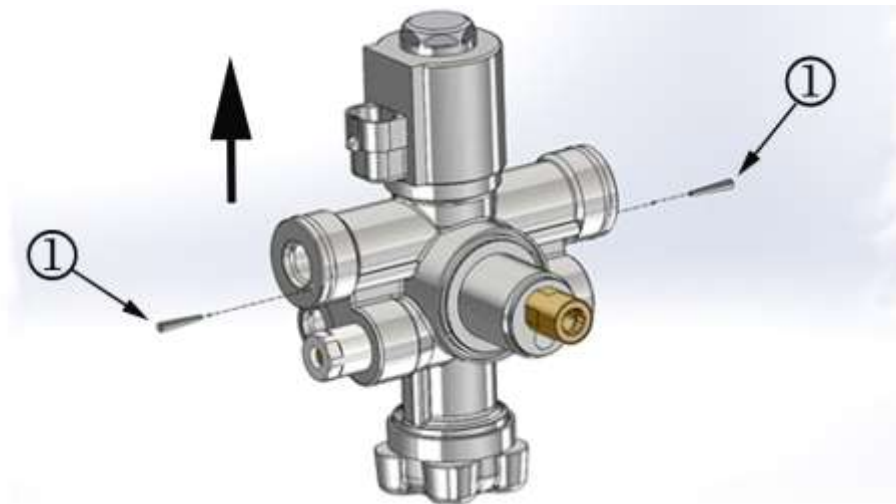
3530550

Connector must point upward.

15. Install two CNG cylinder tank valve plugs (1). Refer to the illustration. This step can be skipped for 2013 model year vehicles, which have plugs already installed.
16. Open the manual shutoff valve for the midship tank.

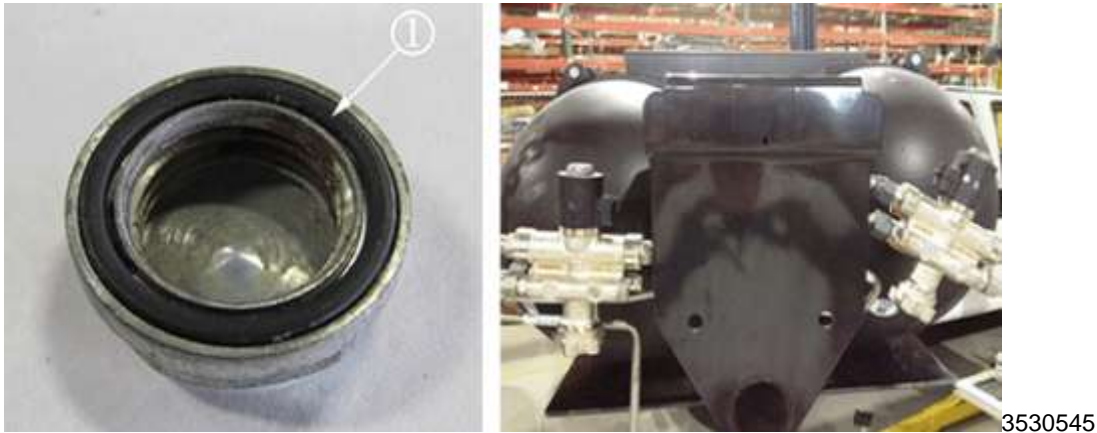
Note: Both HPL solenoid connectors should face each other after installation.
