# Recall Bulletin

## PRODUCT SAFETY RECALL

**SUBJECT:** Compressed Natural Gas (CNG) Fuel Tank Shut-Off Solenoid Connector

**MODELS:** 2011-2013 Chevrolet Express  
2011-2013 GMC Savana  
Equipped with CNG Fuel System

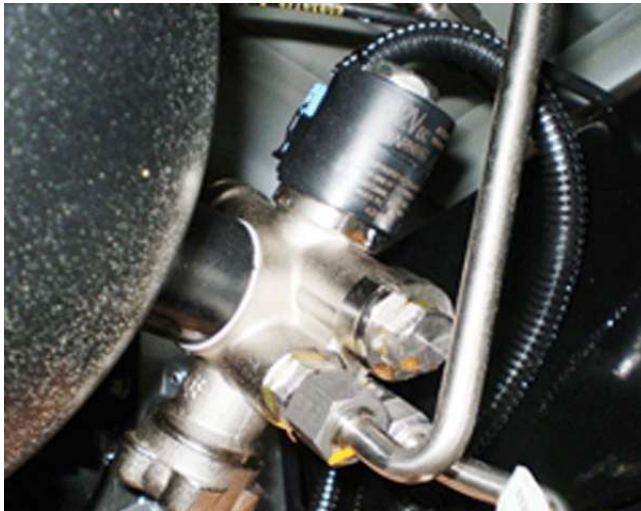
3457063

Electrical connector harness shown with no strain on the harness. Note that there is slack in the harness. If the harness does not have any slack, remove the tie strap and adjust the harness. Secure the harness with a new tie strap.

14. Verify that there is no strain on HPL solenoid electrical connector.

- If there is strain on the electrical connector harness, remove the connector tie strap and reposition the harness to relieve the wire strain. Install a new tie strap to secure harness.
- If there is no strain on the electrical connector harness, proceed to step 15.

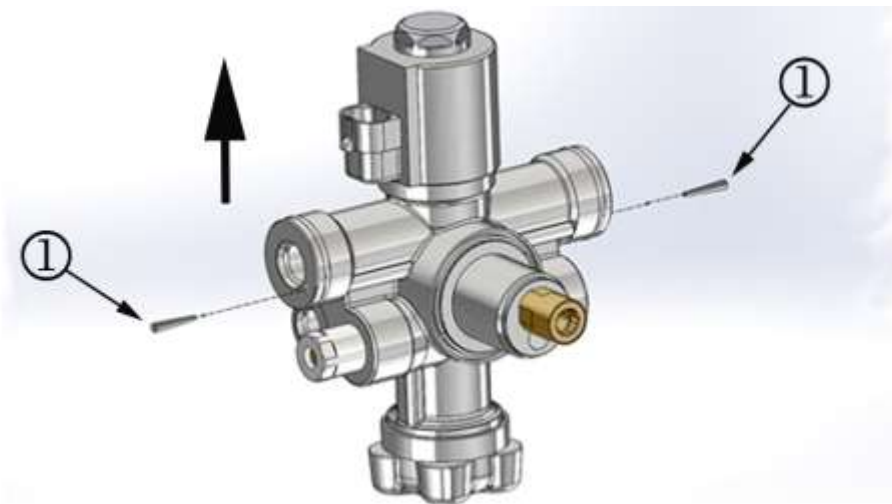
3530550

**Connector must point upward.**

15. Install two CNG cylinder tank valve plugs (1). Refer to the illustration. This step can be skipped for 2013 model year vehicles, which have plugs already installed.

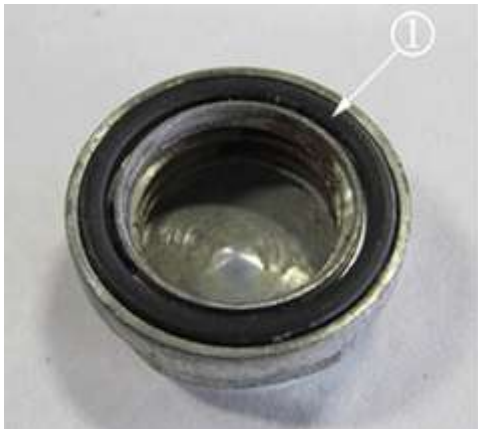
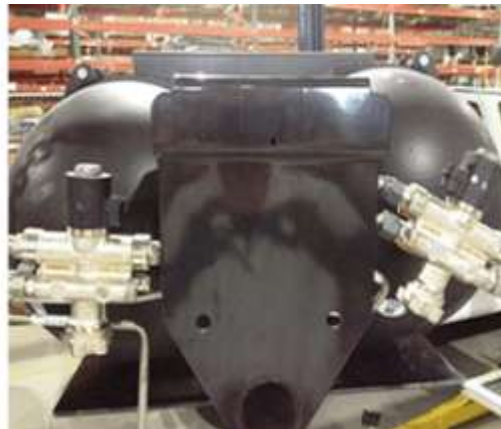
3530545

**Note:** Both HPL solenoid connectors should face each other after installation.

10. Apply a thin layer of Parker lube on the upper HPL solenoid retaining nut seal on both sides of the seal.
11. Place new seal in groove in nut.
12. Install the HPL solenoid coil retaining nut. Tighten the retaining nut to **6.5 Nm (57.5 lb-in)**.
13. Connect the HPL solenoid electrical connector.
