# Campaign Service

BULLETIN NUMBER:  
**SB13-04-S003**

### DRIVER DOOR SWITCH SHORT CIRCUIT #13V-248

- 2006-2007MY Isuzu Ascender Vehicles

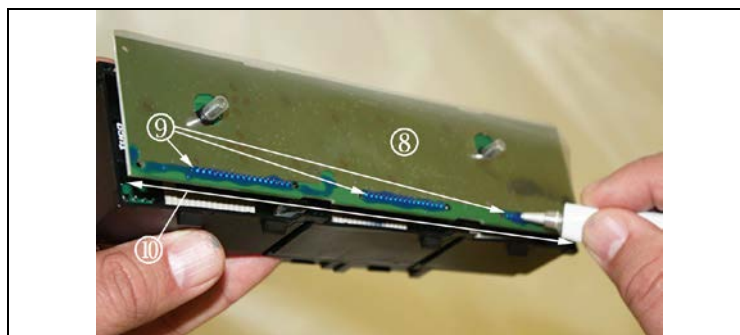
**Figure 7** – Note: Do NOT attach the ESD protective barrier (8) over the connector pins (9).

8. Remove the backing paper from the ESD protective barrier (8) and attach it to the contact board. Attach the ESD protective barrier (8) along the edge of the connector pins (9). See Figure 7.
9. Apply the protective coating to the top side of the contact board. Apply the protective coating over the entire length (10) of the contact board from the ESD protective barrier tape edge (8) to the contact board edge.

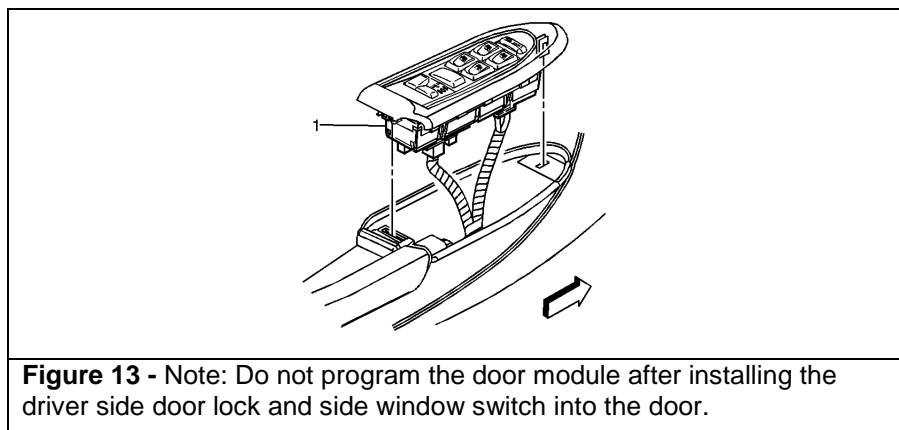
**Figure 13 - Note: Do not program the door module after installing the driver side door lock and side window switch into the door.**

17. Install the driver side door lock and side window switch into the door. Refer to *Door Lock and Side Window Switch Replacement - Driver Side* in the service manual.
18. Perform a functional test on the driver side door lock and side window switch. Test all switch functions to ensure the driver side door lock and side window switch functions as designed. Replace the driver side door lock and side window switch if it fails the functional test. Refer to *Door Lock and Side Window Switch Replacement - Driver Side* in the service manual then proceed to Step 19, "Applying the Campaign Label".
19. Applying the Campaign Label
  - a) Using a ball-point pen, fill in a campaign label (P/N 2-90028-700-0) with Campaign Number 13V-248, Isuzu service facility code and repair date.
  - b) Affix the campaign label onto the driver's side B-pillar.
