SAFETY RECALL BULLETIN

SUBJECT:			No: SR-13-007
2011 OUTLANDER SPORT/RVR PANORAMIC GLASS ROOF – SAFETY RECALL CAMPAIGN			DATE: July, 2013
			MODEL: 2011 Outlander Sport/RVR
CIRCULATE TO:	<input checked="" type="checkbox"/> GENERAL MANAGER	<input checked="" type="checkbox"/> PARTS MANAGER	<input checked="" type="checkbox"/> TECHNICIAN
<input checked="" type="checkbox"/> SERVICE ADVISOR	<input checked="" type="checkbox"/> SERVICE MANAGER	<input checked="" type="checkbox"/> WARRANTY PROCESSOR	<input checked="" type="checkbox"/> SALES MANAGER

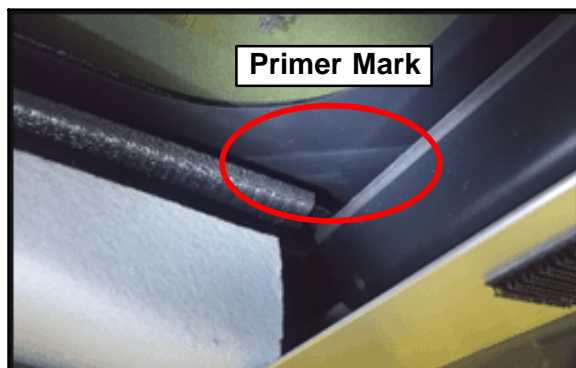
4. From the interior cabin, inspect the left rear or right rear corner of the panoramic glass roof with a flashlight to determine if primer was applied.

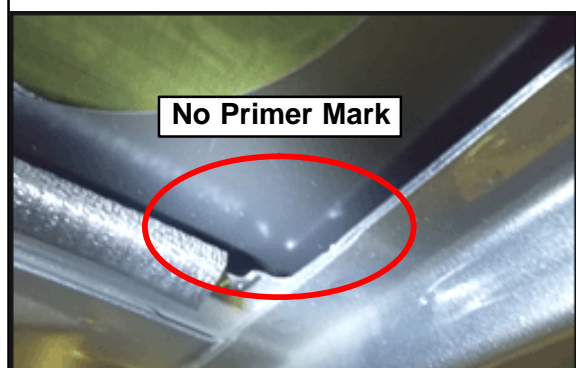
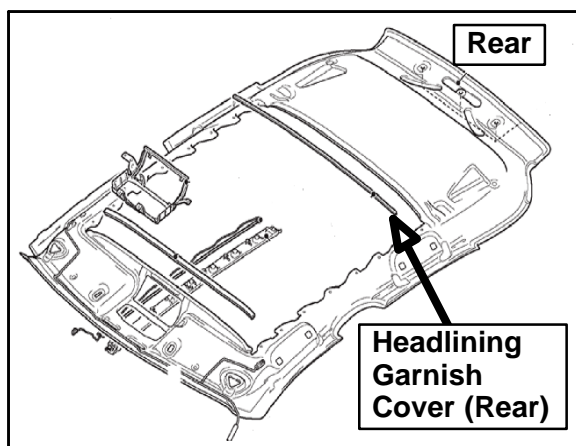
5. If you see the primer mark (thin white layer that intersects the rear corner at a 45 degree angle) on either the left or right side, primer was correctly applied during production. **Proceed directly to Step 12.**

If you do not see the primer mark, or it is difficult to determine if it is there, continue to Step 6.

NOTE: It may be difficult to see the primer mark. Please inspect from different viewing heights and angles and with your flashlight focused on the corner.

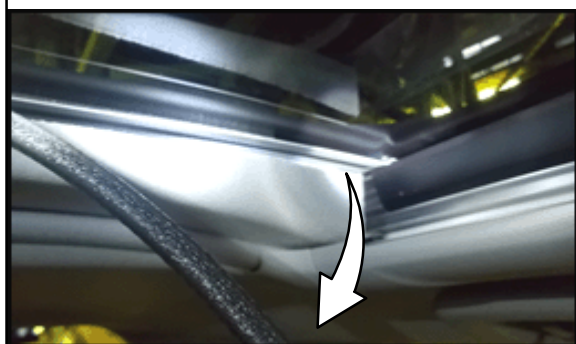
6. Use your hands and carefully separate approximately six inches (150mm) of the rear headlining garnish cover from the side edge.

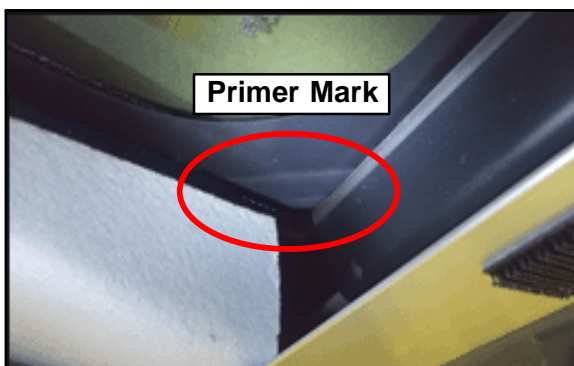
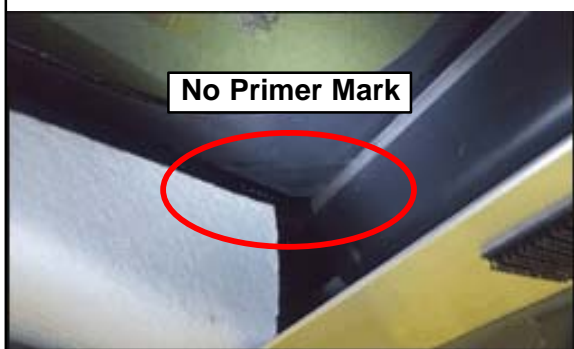
7. With the rear headlining garnish cover partially removed, it will allow greater viewing access to determine if the primer mark is there.

With your flashlight, inspect for the primer mark. If present, reinstall the cover back to its original position. **Proceed directly to Step 12.**

If you do not see the primer mark, or it is difficult to determine if it is there, continue to Step 8.

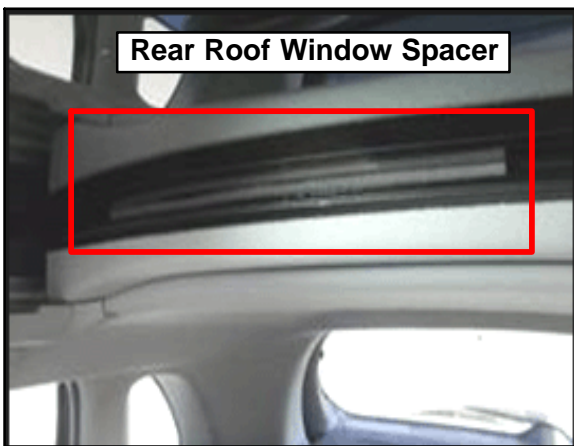
8. Carefully remove the entire rear headlining garnish cover. Search the area behind the removed cover to locate two rear roof window spacers (left and right side).

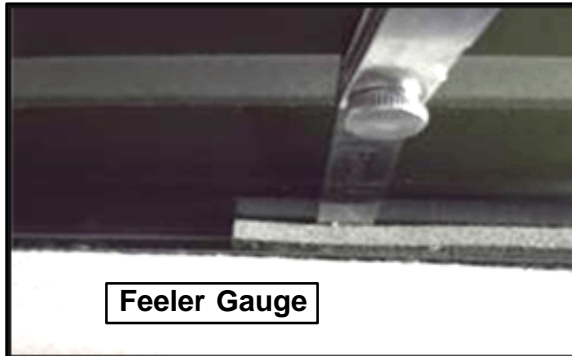
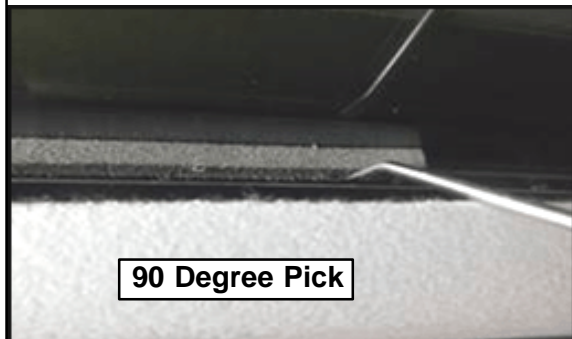
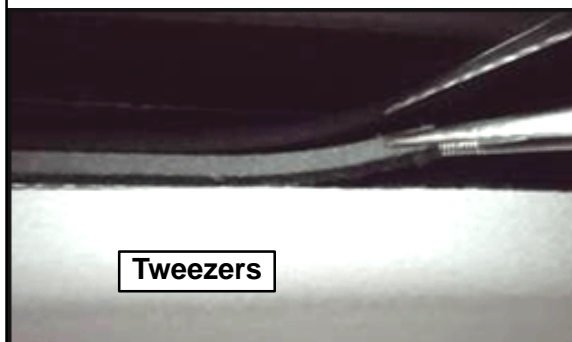
9. Carefully remove the two rear roof window spacers by using a thickness feeler gauge, a 90 degree pick, tweezers, or equivalent tool.

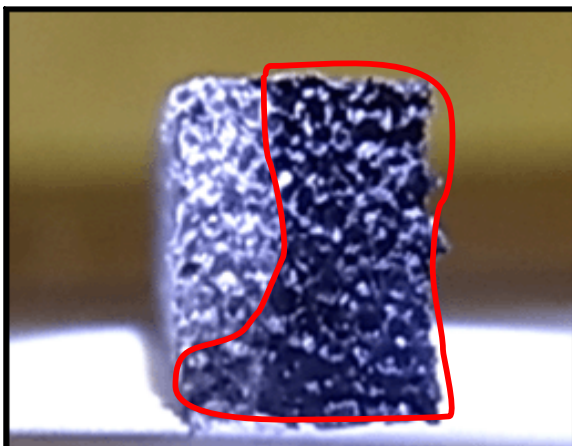
Primer

10. Inspect the ends of the roof window spacer. If you see two layers, one layer much darker and clearly distinguishable from the other (outlined in red), primer was correctly applied.

Reinstallation of the roof window spacers is not necessary. They are used during the factory installation process and no longer serve a function. Reinstall the rear headlining garnish cover and **proceed directly to Step 12.**

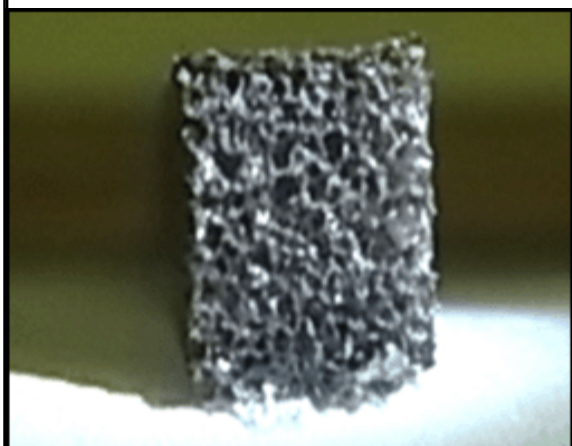
No Primer

If you see a consistent, monotone color to the spacer, primer was not applied. Continue to Step 11.

11. **After confirming with Tech Line that the primer was not applied to the panoramic glass roof during production**, follow the panoramic glass roof removal and installation procedures in Group 42A of the 2011 Outlander Sport service manual.
12. Campaign is complete. There are three allowed repair scenarios:
 - a. Primer application was confirmed in Step 5 (inspection only).
 - b. Primer application was confirmed in Step 7 or Step 10 (inspection and removal of cover/spacer).
 - c. After confirming with Tech Line that the primer was not applied, remove and properly reinstall the glass roof.
