Service Bulletin

Applies To: 2007-08 Fit - Check the iN VIN status for eligibility

Safety Recall: 2007–08 Fit Power Window Master Switch May Not Work

(Replaces 10-008 and 13-052, Safety Recall: 2007-08 Fit Power Window Master Switch May Not Work)

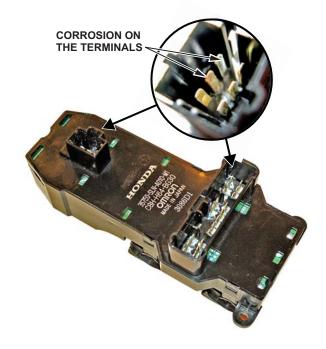
- 5. Check for corrosion or melting on the switch side and the harness side of the 3P and 20P connectors:
 - If there is no corrosion on the terminals and no melting on the connectors, go to step 6.
 - If any of the terminals have corrosion, or if any of the connectors are melted, replace the driver's door wire harness and the power window master switch, then go to step 6.
