Re: Toyota Safety Recall 13V-292 Dealer Notification - Remedy

Subject: Safety Recall D0K – **Remedy Available**
Certain 2012 Model Year Yaris Lift Back Vehicles
Power Steering Control Module

TECHNICAL INSTRUCTIONS
FOR
SAFETY RECALL D0K
POWER STEERING ECU ASSEMBLY REPLACEMENT
CERTAIN 2012 MODEL YEAR YARIS

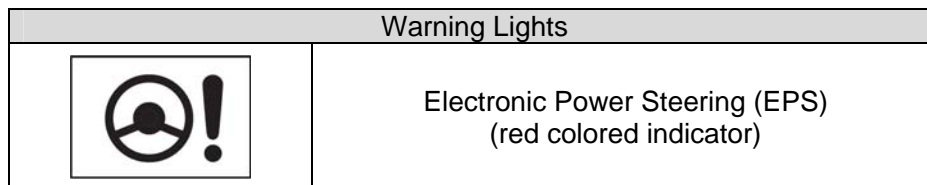
A3: There are no advanced warnings that this condition may occur. However, if the condition does occur, in addition to the increased steering effort, the Electronic Power Steering (EPS) warning light on the instrument panel will illuminate and a buzzer will sound to alert the driver that the system is not operating as designed.

Please note that the warning light shown above can also illuminate for conditions not related to this Safety Recall.

A3a: If you experience the condition or warning described above, please contact your local authorized Toyota dealer for diagnosis and repair. If the condition is related to this Safety Recall, the repair will be performed at **No Charge** to you

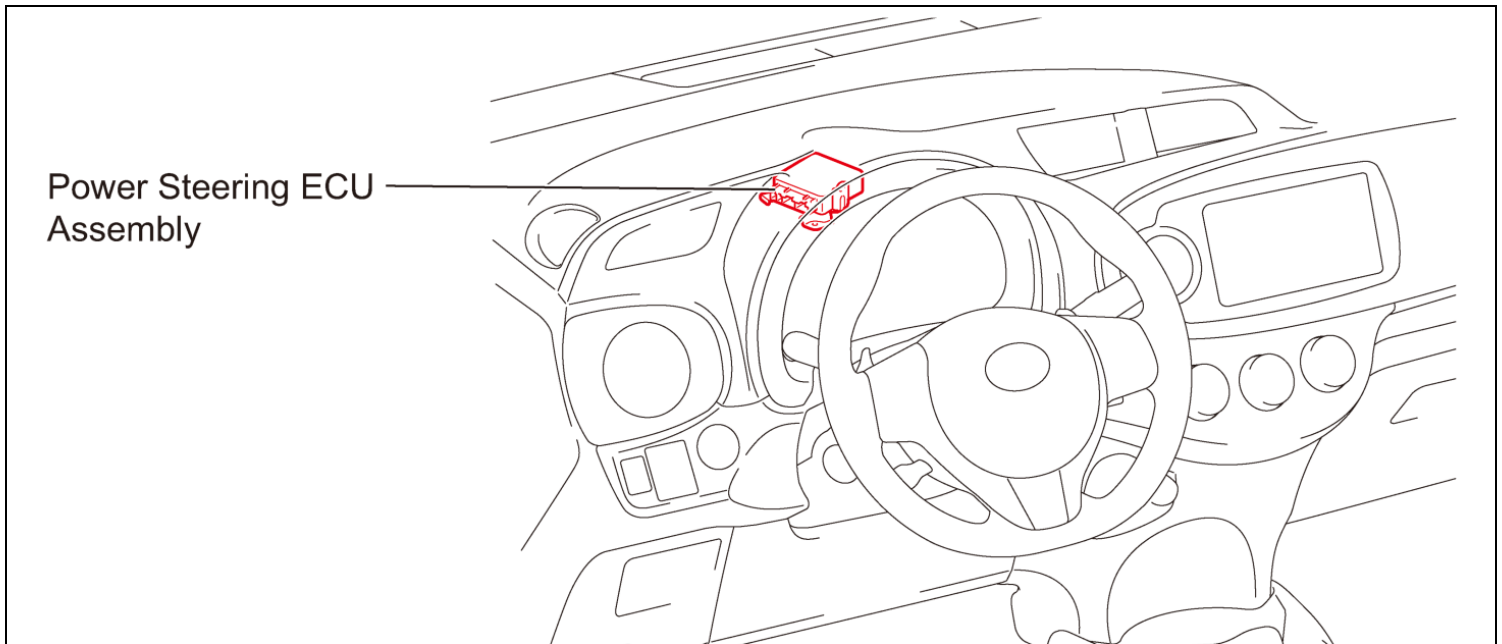
II. BACKGROUND

The involved vehicles are equipped with an electronic power steering system. A relay in the Power Steering Control Module of the system could experience a short circuit and cause a loss of power steering assist, resulting in increased steering effort. If this occurs, an instrument panel warning lamp will illuminate and a buzzer will sound. Loss of power steering assist could increase the risk of a crash at low speeds.

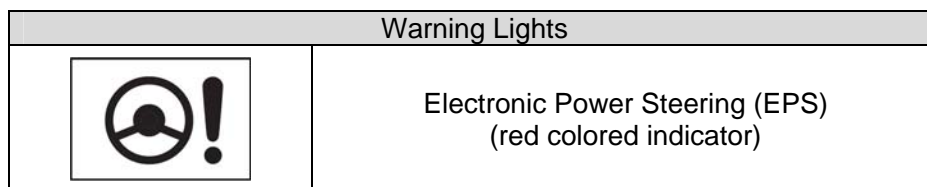
A3: There are no advanced warnings that this condition may occur. However, if the condition does occur, in addition to the increased steering effort, the Electronic Power Steering (EPS) warning light on the instrument panel will illuminate and a buzzer will sound to alert the driver that the system is not operating as designed.

Please note that the warning light shown above can also illuminate for conditions not related to this Safety Recall.

A3a: If you experience the condition or warning described above, please contact your local authorized Toyota dealer for diagnosis and repair. If the condition is related to this Safety Recall, the repair will be performed at **No Charge** to you
