SAFETY RECALL BULLETIN

SUBJECT: 2013 OUTLANDER SPORT/RVR LEFT FRONT STRUT – SAFETY RECALL CAMPAIGN		No: SR-13-008	
		DATE: July, 2013	
		MODEL: 2013 Outlander Sport/RVR	
CIRCULATE TO:	<input checked="" type="checkbox"/> GENERAL MANAGER	<input checked="" type="checkbox"/> PARTS MANAGER	<input checked="" type="checkbox"/> TECHNICIAN
<input checked="" type="checkbox"/> SERVICE ADVISOR	<input checked="" type="checkbox"/> SERVICE MANAGER	<input checked="" type="checkbox"/> WARRANTY PROCESSOR	<input checked="" type="checkbox"/> SALES MANAGER

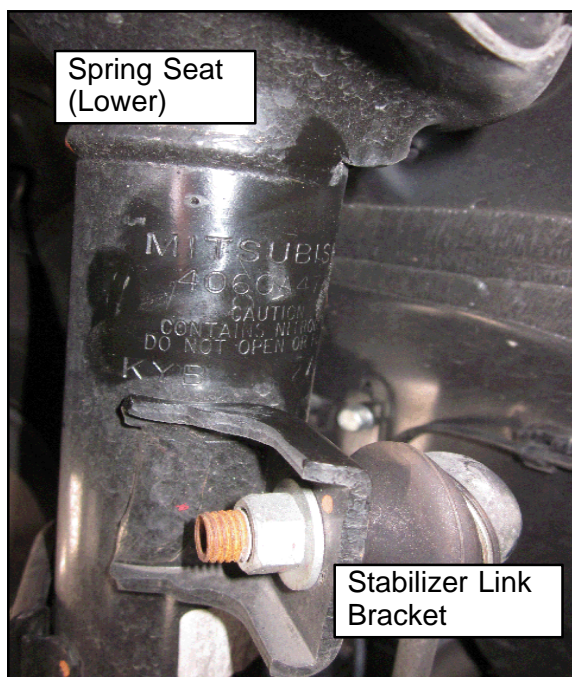
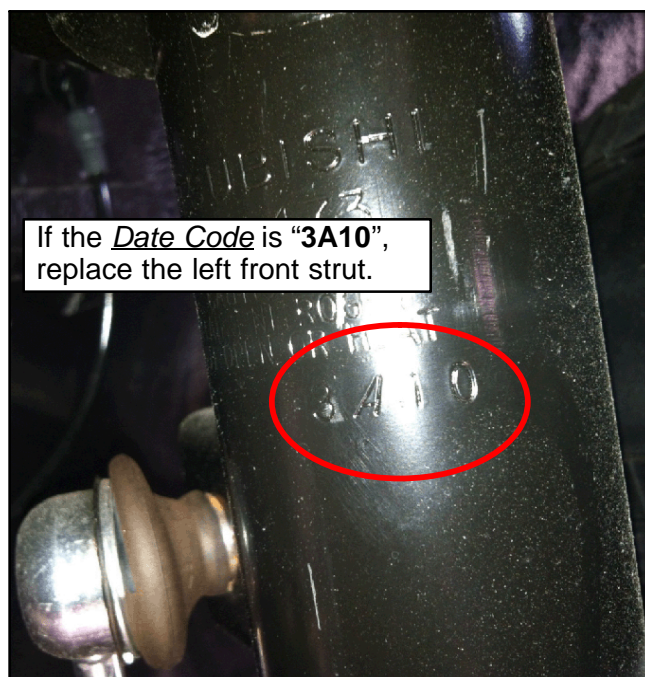
1. Place the vehicle on a lift. Turn the steering wheel clockwise (to the right) until it stops.
2. Lift the vehicle and remove the left front wheel.
3. Inspect the left front strut tube with a flashlight. The Date Code is located between the spring seat (lower) and the stabilizer link bracket, and faces the inner wheel well. Wipe this area clean with a damp towel to obtain maximum legibility.

- If the Date Code is **NOT** "3A10", reinstall the left front wheel and lower the vehicle. Torque the wheel to 73 ± 7 ft-lb (98 ± 10 N-m). **Strut replacement is not required. Complete the campaign claim and enter campaign labor operation C1308Z01.**
- If the Date Code is "3A10", strut replacement is required. Proceed to the Replacement Procedure Section below.
