# EvoBus

TI No.: 32.00U08919A

TITLE: **Frame-end connect : of trailing arms with settlement of adjustment shim**

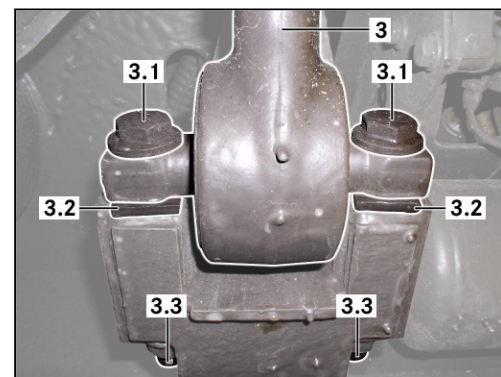
M32.00-0129-71

The frame-end connect : of the trailing arms at the rear axle may come loose.

The connect : may loosen due to settling of the adjustment shim.

- Remove corros : inhibitor from bolt heads (3.1) and nuts (3.3).
- Retighten nuts (3.3) to the specified torque.

380 Nm

- Recoat screw heads (3.1) and nuts (3.3) with corros : inhibitor.
