Subject: NHTSA Campaign Number 13V-341/Jaguar Safety Recall J034 – XF Charge Air Cooler Hose - Dealer Communication

TECHNICAL BULLETIN

J034NAS1

Safety Recall: Engine Charge Air Cooler Hose Detachment

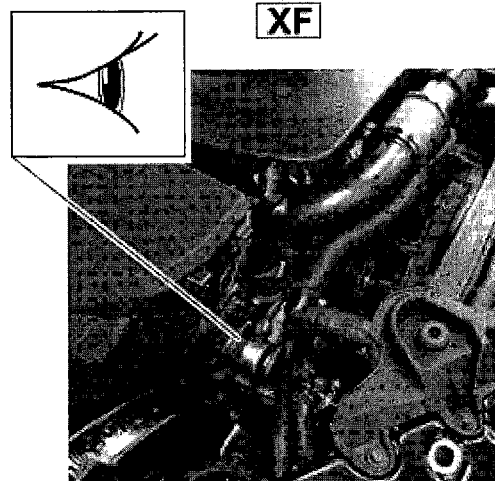
E159753

1. Open hood.
2. Locate the Charge Air Cooler (CAC) hose to the resonator connection.

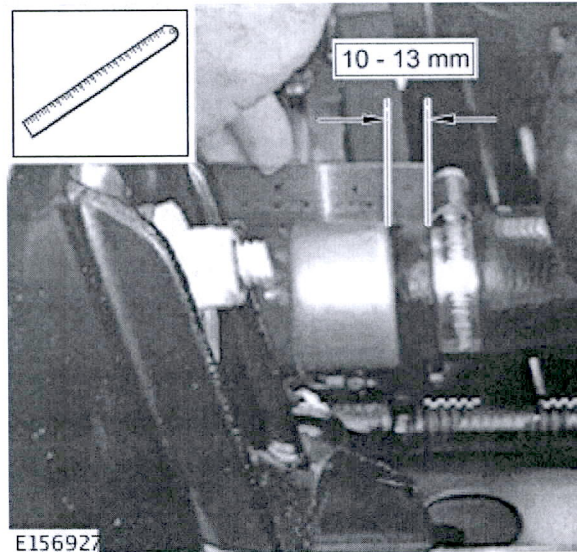
3. Check position of the charge air cooler hose clip.

- If: the clip is less than 10mm from the resonator; a gap exists between the resonator and the end of the hose; or the clip is not positioned squarely on the hose, carry on from step 4.
- If: the clip is between 10mm and 13mm from the edge of the resonator; and the hose is butted against the resonator, carry on from step 5.

4. Reposition hose correctly on the resonator and position the clip 13mm from the edge of the resonator.
5. Tighten the clip to 6Nm, ensuring the clip remains in position and square to the edge of the resonator.
6. Close hood.
