HYUNDAI NEW THINKING. NEW POSSIBILITIES. Technical Service Bulletin	GROUP CAMPAIGN	NUMBER 13-01-039-1
	DATE DECEMBER 2013	MODEL(S) NF SONATA, TG AZERA

SUBJECT: REAR CROSSMEMBER CORROSION TREATMENT (RECALL 113)

THIS TSB SUPERSEDES TSB 13-01-039 TO INCLUDE INFORMATION ABOUT ASSIST ARM WHEEL SPEED SENSOR MOUNTING ORIENTATION.

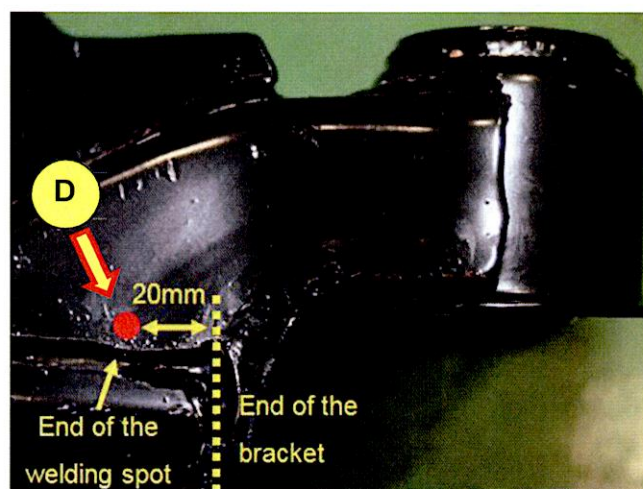
The punching location must be located precisely:

D: Punching location is right above the end of the weld line, 20mm inwards from the end of the bracket.

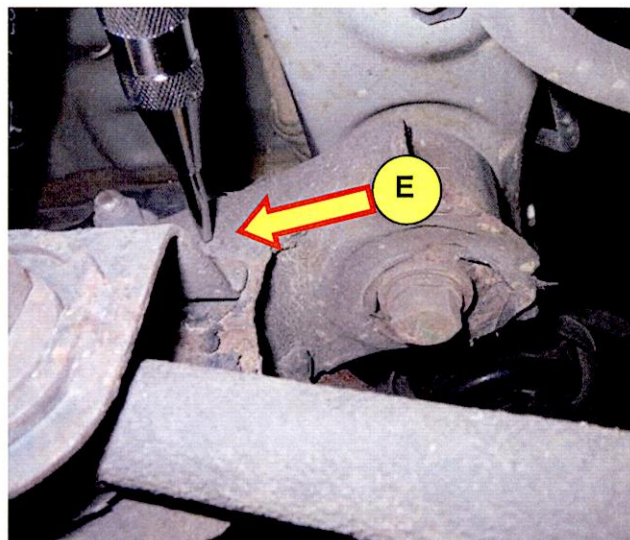
Depress the automatic center punch by hand (**DO NOT USE A HAMMER**) to punch the rear crossmember (E) 10 times in the same location, as defined below. Repeat on the opposite side of the crossmember.

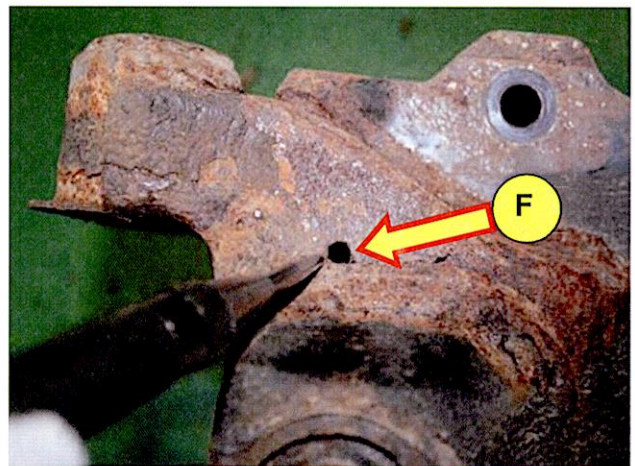
6. Check if there is a hole (F) on the crossmember after the punching.

If there is a hole, replace the rear crossmember with the new one following the **'REAR CROSSMEMBER ASSEMBLY REPLACEMENT'** procedure below.

If no hole exists, follow the **'REAR CROSSMEMBER AND CONTROL ARM CAVITY WAX / UNDERCOATING APPLICATION'** procedure.

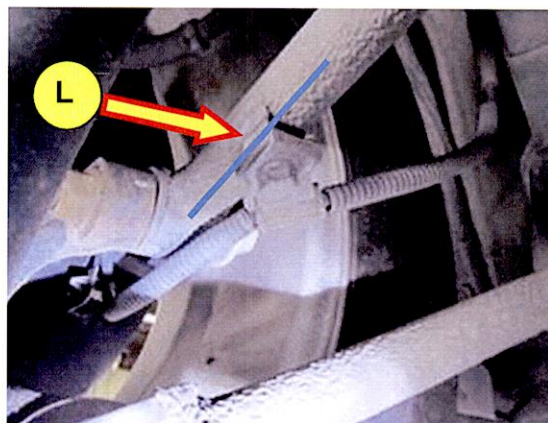
Original configuration

Note that the mounting tab is facing downwards and the orientation of the WSS wiring harness bracket (L).

Additionally, the mounting bracket for the wheel speed sensor (WSS) harness (both sides) must be rotated 45 degrees (so the harness runs parallel to the assist arm), then properly tightened down to ensure proper wiring clearance. Images below show the REAR LEFT assist arm. The REAR LEFT bracket must be rotated 45 degrees counter-clockwise, REAR RIGHT must be rotated 45 degrees clockwise.

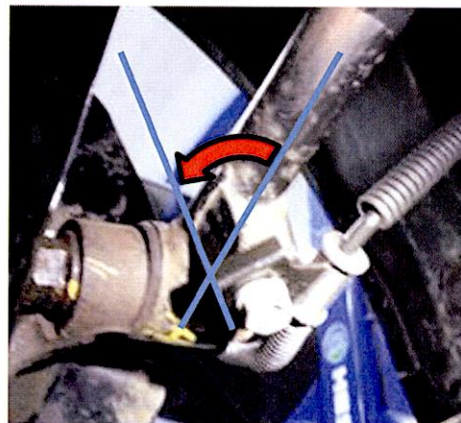
Modified configuration (REAR LEFT)

Campaign part assembly assist arms have been removed and rotated so mounting tab faces downwards. WSS harness has been rotated 45 degrees counter-clockwise.
