February 21, 2014

SUBJECT: **Safety Recall 13S08 – Supplement #2**
Certain 2005 Through 2011 Model Year Crown Victoria, Grand Marquis, and Town Car
Vehicles Originally Sold or Currently Registered in Corrosion States
Steering Column Shaft

Certain 2005 Through 2011 Model Year Crown Victoria, Grand Marquis, and Town Car Vehicles
Originally Sold or Currently Registered in Corrosion States
Steering Column Shaft

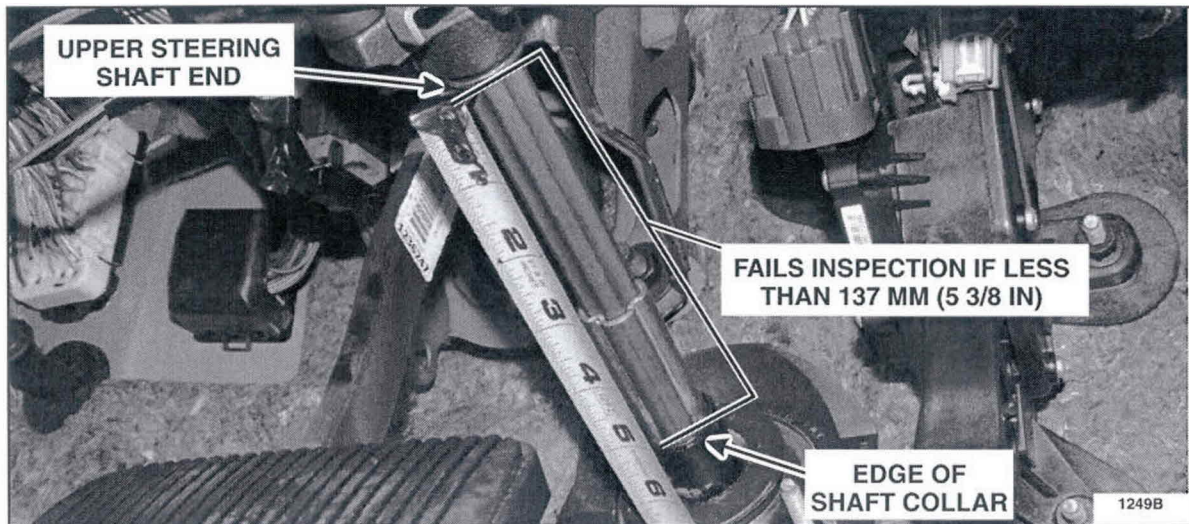
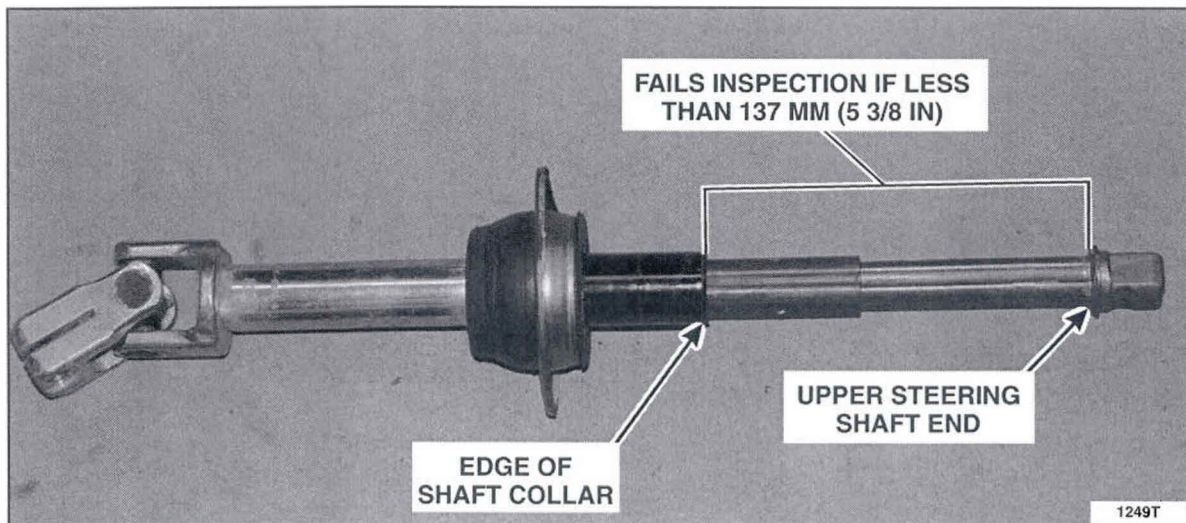
FIGURE 5

1. Measure the distance between upper steering shaft end and the edge of the shaft collar.
See Figures 5 and 6.
- If the upper steering shaft measurement is less than 137 mm (5 3/8 in), it fails inspection.

7. Using a suitable punch and 16 ounce hammer, lightly tap around the steering shaft lip to evenly extend the shaft to 137-145 mm (5 3/8 - 5 3/4 in). See Figures 6 and 7.

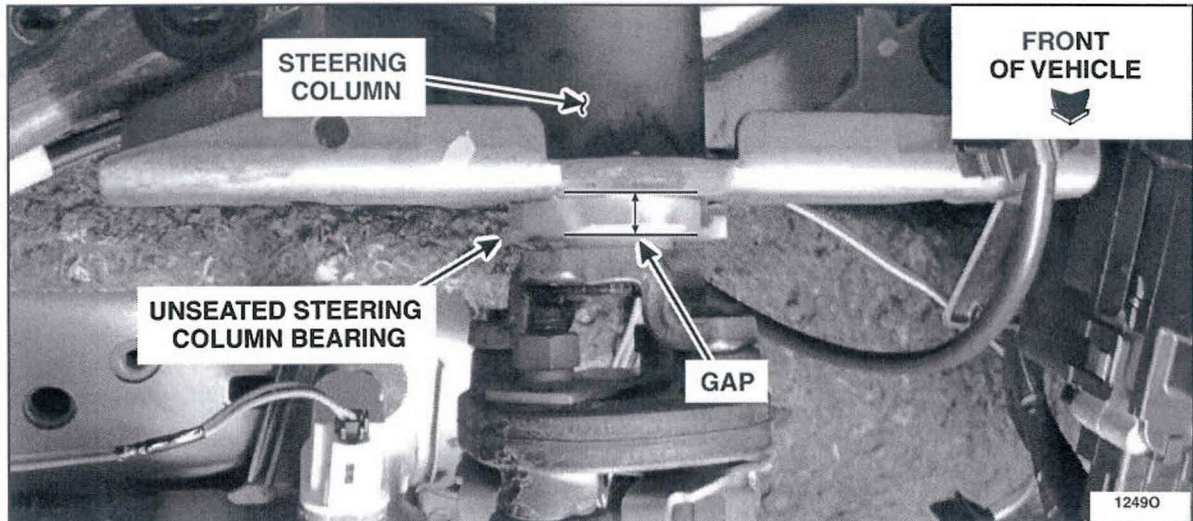
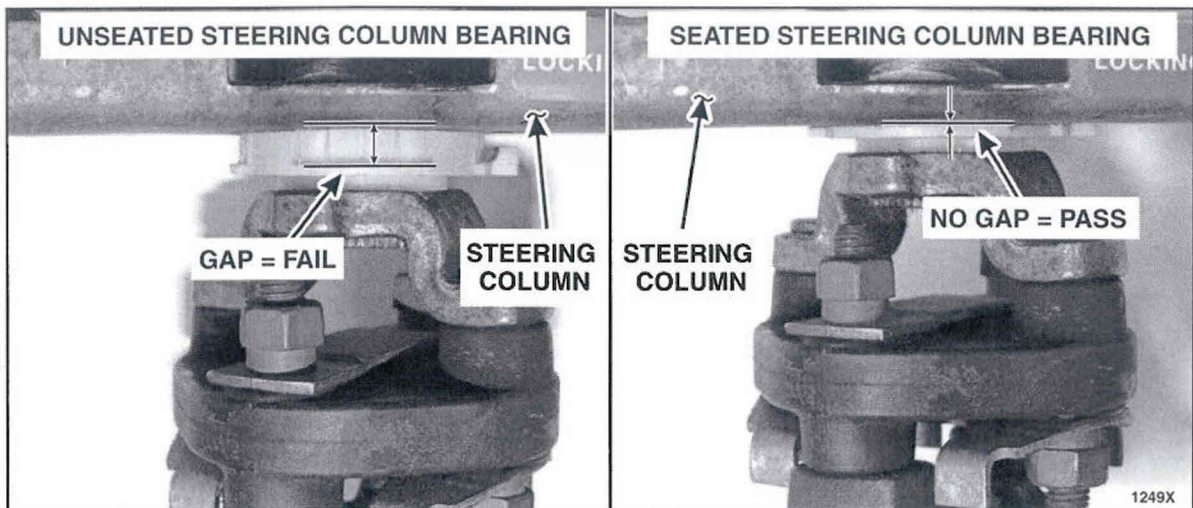
FIGURE 3

1. Inspect the steering column for an unseated steering column bearing. See Figures 3 and 4.

- If the steering column bearing is unseated, it fails inspection.

2. Align the bearing alignment tab with the slot in the column flange. See Figure 8.

3. Use a suitable dead blow hammer to lightly tap the steering column to upper steering shaft coupling to seat the steering column bearing. See Figure 9.
