Re: Toyota Safety Recall 13V-395 Dealer Notification (Remedy)

Subject: Safety Recall DLG - Remedy Available

2GR-FSE Intake VVT Actuator Gear

SAFETY RECALL DLG

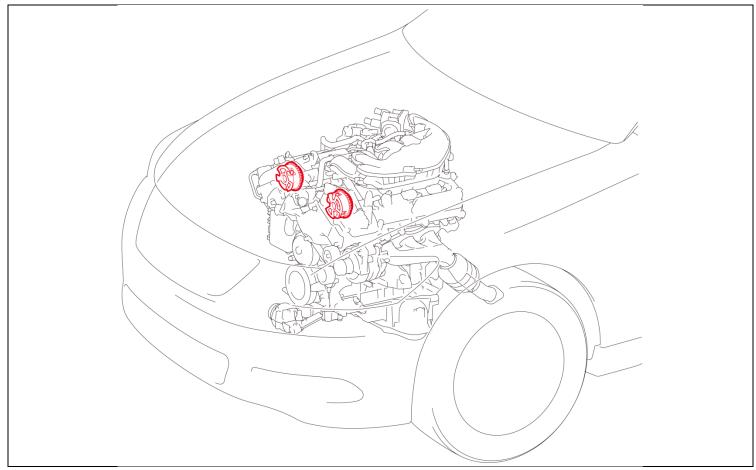
II. BACKGROUND

The subject vehicles are equipped with a Variable-Valve Timing (VVT) system which controls the camshafts to provide optimal valve timing under certain driving conditions. The bolts used to secure the housing and sprocket of the intake-side VVT gear assembly could become loose due to abnormal impacts generated within the gear assembly immediately after a cold start-up. If this occurs, the VVT gear will not control the intake valves correctly. In certain cases, the VVT gear housing and sprocket could separate and result in the engine stopping while the vehicle is being driven, increasing the risk of a crash
