Re: Toyota Safety Recall 13V-396 Preliminary Dealer Notification

Safety Recall D0M (D1M) *Preliminary Notification*
 Certain 2006 through 2010 Model Year Highlander HV Vehicles
 Intelligent Power Module (IPM) Replacement
 *****URGENT*****

**Safety Recall D0M - (D1M) Preliminary Notice
 Certain 2006 through 2010 Model Year Highlander HV Vehicles
 Intelligent Power Module (IPM) Replacement - Q&A**

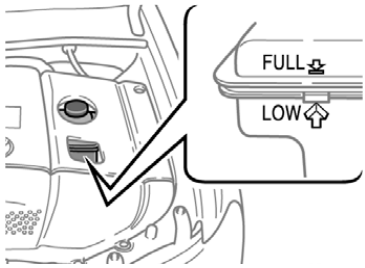
<p>Inverter Coolant Reservoir</p>	<p>(1) Regularly confirm that the coolant level in the inverter coolant reservoir is between FULL and LOW. If the coolant level is below the LOW line, please add coolant up to the FULL line.</p> <p>Toyota dealers will inspect the coolant level, and if necessary, add coolant, at no charge at the customer's request.</p>

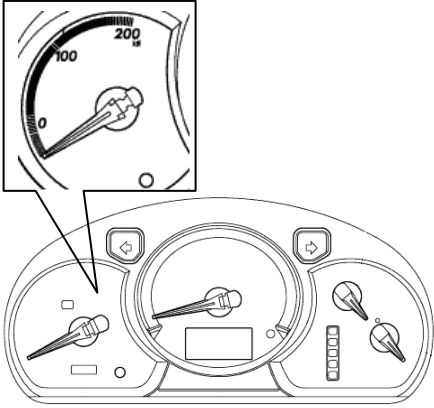
<p>Power Meter</p>	<p>(2) Avoid placing a high load on the Hybrid System. Drivers may do so by refraining from towing with the vehicle until the remedy is completed.</p> <p>(3) Monitor your Power Meter. The Power Meter indicates the immediate output from the Hybrid System in approximate kilowatts. Keep power usage below 100kW as much as possible. Situations where the Power Meter shows output slightly over 100kW for a brief moment should not raise any concerns.</p>
