TMS-NTC-13222
September 11, 2013

Re: Toyota Safety Recall 13V-396 Preliminary Dealer Notification

Subject: Safety Recall DLF (D2F) - **Preliminary Notice**
Certain 2006 to 2008 Model Year RX 400h Vehicles
Intelligent Power Module (IPM) Replacement

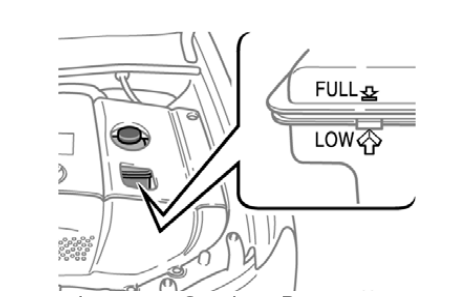
<p>Inverter Coolant Reservoir</p>	<p>(1) Regularly confirm that the coolant level in the inverter coolant reservoir is between FULL and LOW. If the coolant level is below the LOW line, please add coolant up to the FULL line. Lexus dealers will inspect the coolant level, and if necessary, add coolant, at no charge at the customer's request.</p>

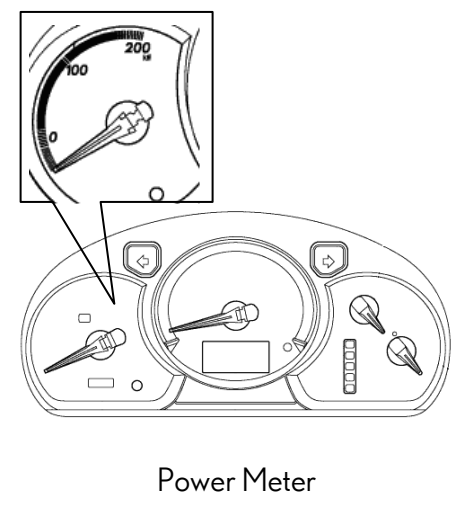
<p>Power Meter</p>	<p>(2) Avoid placing a high load on the Hybrid System. Drivers may do so by refraining from towing with the vehicle until the remedy is completed.</p> <p>(3) Monitor your Power Meter. The Power Meter indicates the immediate output from the Hybrid System in approximate kilowatts. Keep power usage below 100kW as much as possible. Situations where the Power Meter shows output slightly over 100kW for a brief moment should not raise any concerns.</p>

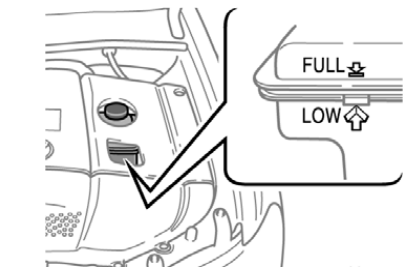
<p>Inverter Coolant Reservoir</p>	<p>(1) Regularly confirm that the coolant level in the inverter coolant reservoir is between FULL and LOW. If the coolant level is below the LOW line, please add coolant up to the FULL line. Lexus dealers will inspect the coolant level, and if necessary, add coolant, at no charge at the customer's request.</p>

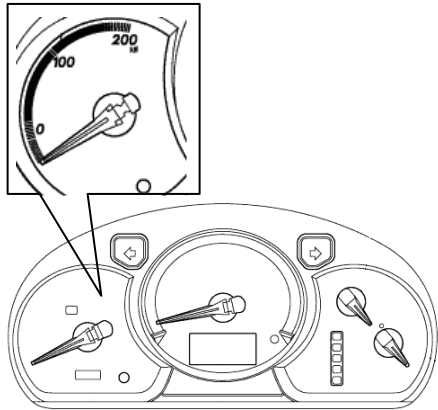
<p>Power Meter</p>	<p>(2) Avoid placing a high load on the Hybrid System. Drivers may do so by refraining from towing with the vehicle until the remedy is completed.</p> <p>(3) Monitor your Power Meter. The Power Meter indicates the immediate output from the Hybrid System in approximate kilowatts. Keep power usage below 100kW as much as possible. Situations where the Power Meter shows output slightly over 100kW for a brief moment should not raise any concerns.</p>
