SIB 63 06 13

RECALL CAMPAIGN 13V-407: REPLACE REAR BULB CARRIERS (SIDE PANEL)

E-Series	Model Description	Production Date
E60	5 Series Sedan (including M5)	March 2007- December 2009

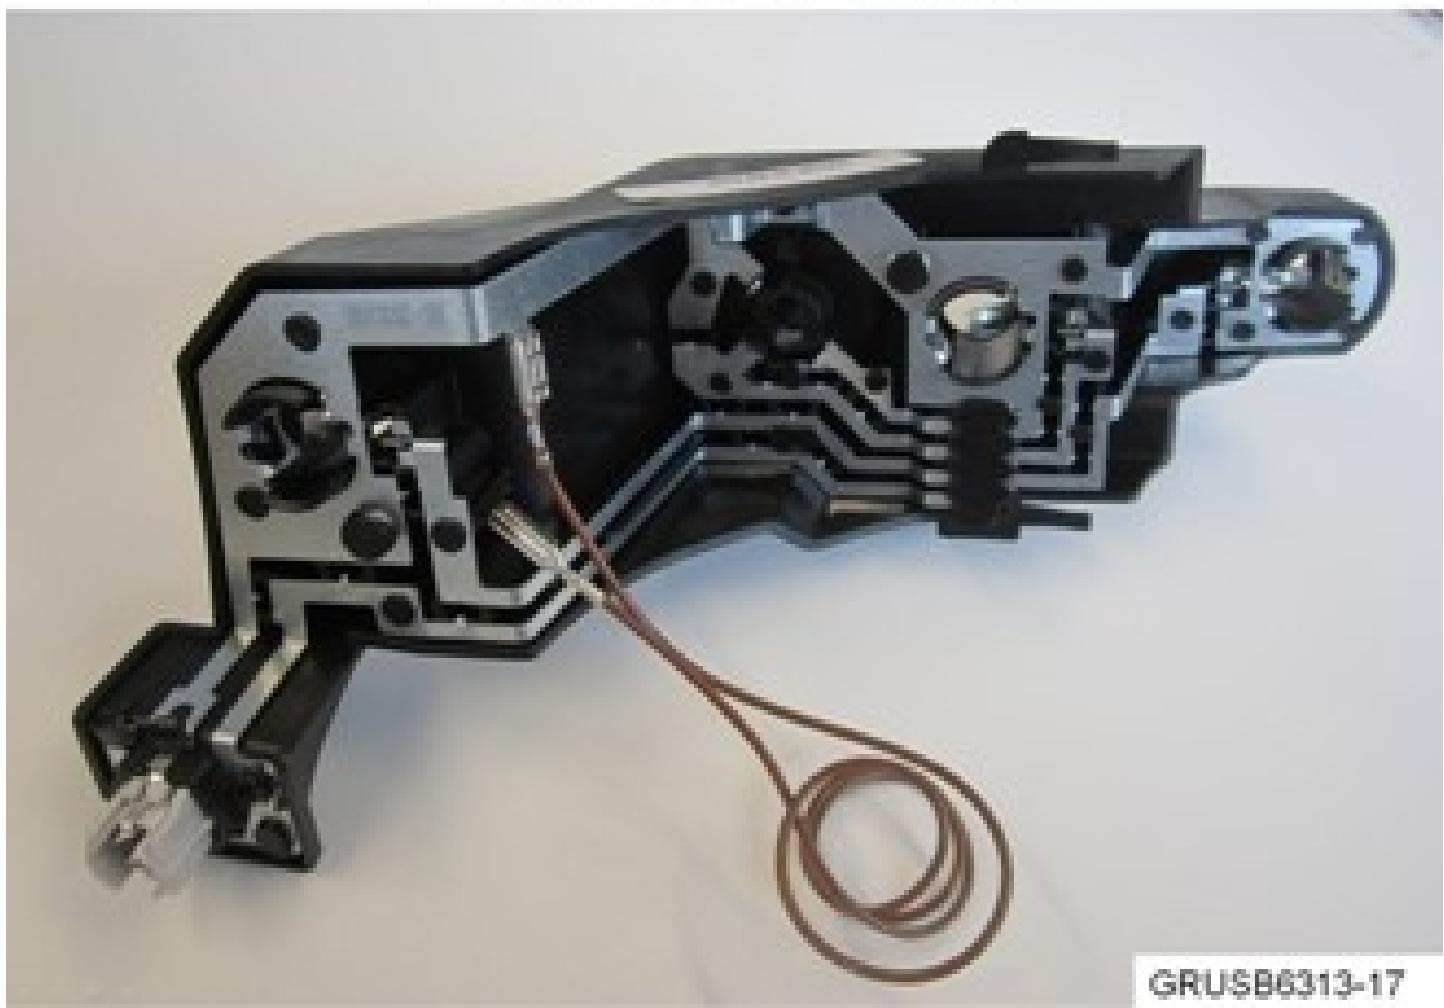
GRUSB6313-17

New part with ground cable

3. Using the E60 service repair kit, **replace both carriers**.
4. Inspect both connector socket housings and if necessary, replace **only** the affected side where corrosion or thermal damage is present. Refer to ISTA Repair Instruction 63 21 055, "Replace a socket housing for left or right-hand boot lid light."

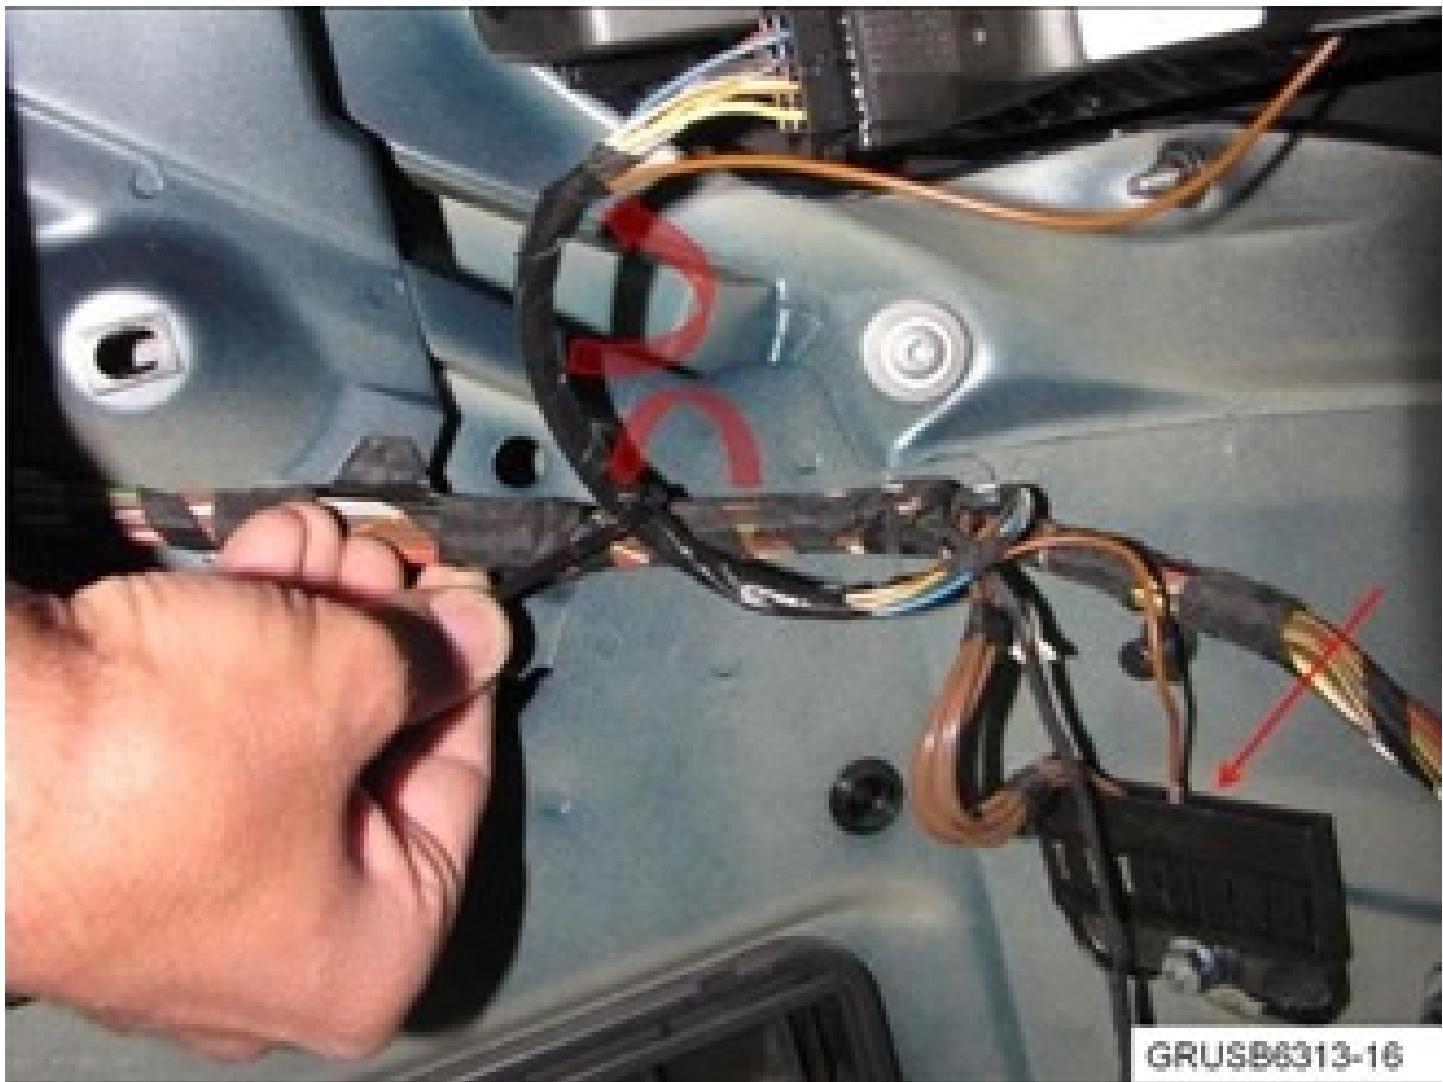
GRUSS6313-16

The pictures below show the new part with the additional ground cable and final wire routing.
