Safety Recall: Electrical Noise May Cause Inadvertent Front Airbag Deployment

(Supersedes 13-038, *Safety Recall: Electrical Interference May Cause Inadvertent Front Airbag Deployment*, dated September 19, 2013; see REVISION SUMMARY)

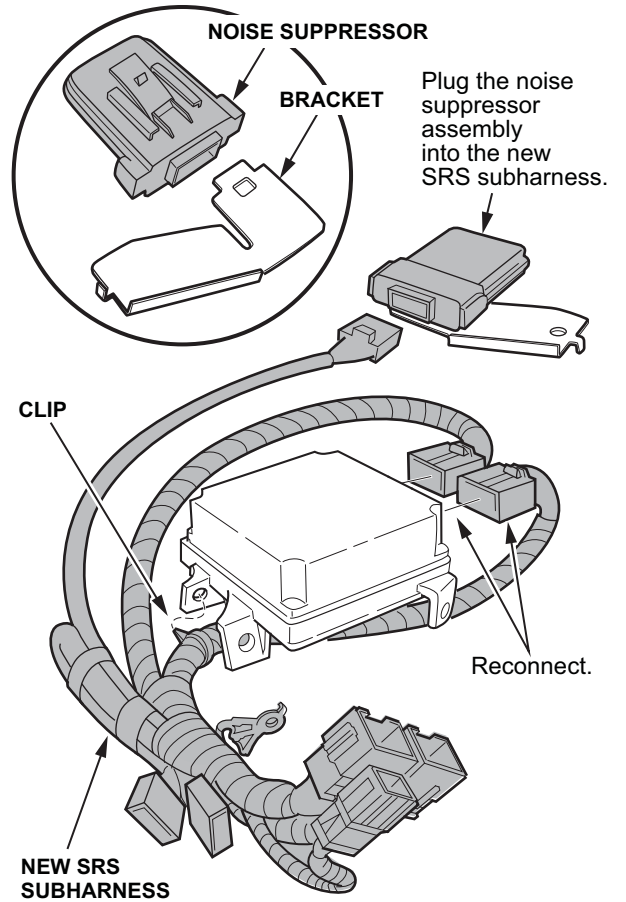
11. Install the new SRS subharness to the SRS unit:

- Install the noise suppressor onto the bracket.
- Connect the suppressor to the new SRS subharness.
- Connect the new subharness to the SRS unit and install the subharness clip to the underside of the unit.

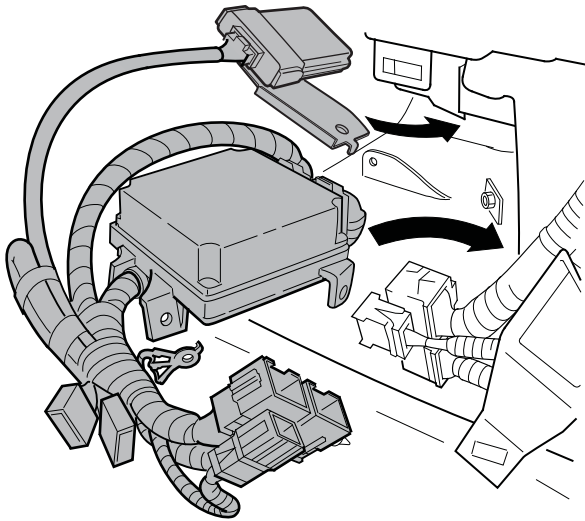
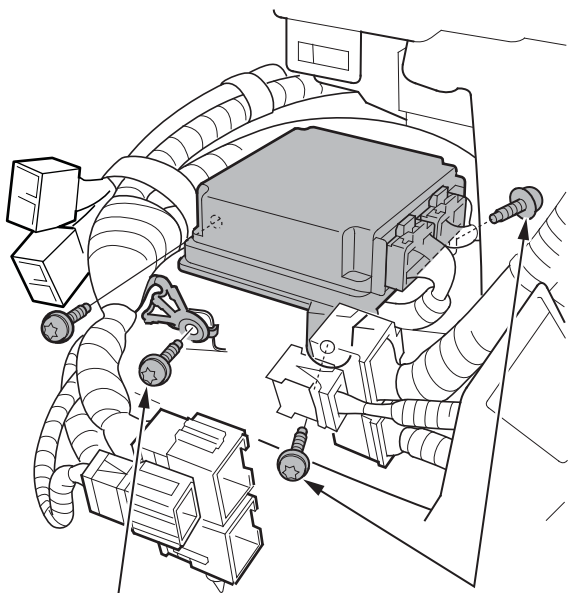
**NEW SRS GROUND WIRE
TORX (T30) BOLT
9.8 N•m (7.2 lb-ft)**

**(3) NEW TORX
(T30) BOLTS
9.8 N•m (7.2 lb-ft)**

- Make sure the SRS unit is squarely against its bracket and install the three Torx bolts. Torque them to **9.8 N•m (7.2 lb-ft)**.
- Install the fourth Torx bolt to secure the ground wire and torque it to **9.8 N•m (7.2 lb-ft)**.

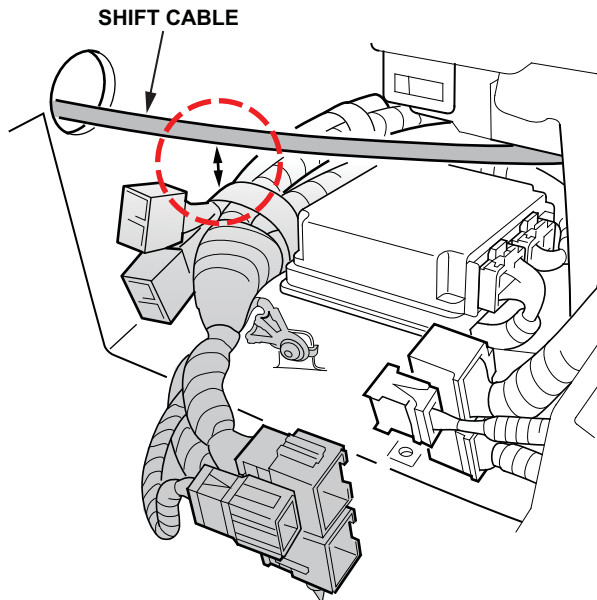
- Make sure that the SRS subharness does not interfere with or rub on the shift cable.

- Install a tie wrap as shown to hold the suppressor subharness in place.
