TO: All Mazda Dealership General Managers, Service Managers, and Parts Managers
DATE: October 2013
SUBJECT: 2009-2013 Mazda6 Door Latch Mounting Screws Safety Recall 7013I

2009 - 2013 MAZDA6 DOOR LATCH MOUNTING SCREWS [RECALL 7013I]

**2009-2013 Mazda6 Door Latch Mounting Screws Safety Recall 7013I
NHTSA Campaign No. 13V-425**

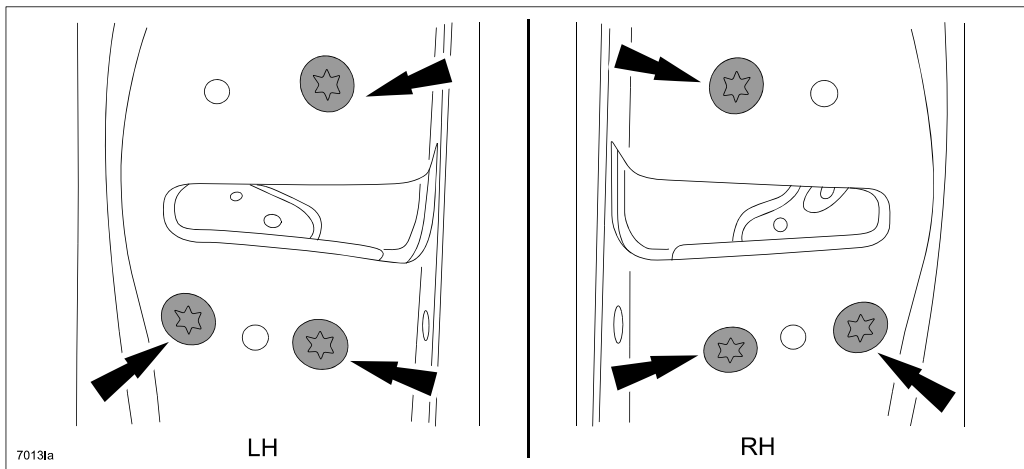
On certain 2009-2013 model year Mazda6, the door latch mounting screws may become loose due to lack of torque during manufacturing and/or unevenness of the door shell in the latch mounting area. This condition may cause the screw to loosen while the vehicle is in use. If all three door latch mounting screws become excessively loose and fall out, the door latch mechanism would not engage when the door is closed, and the door ajar warning light will illuminate. However, if the warning light goes unnoticed and the vehicle is driven, the door might open while the vehicle is in motion, increasing the risk of accident or injury.

1. Remove the 3 door latch mounting screws one at a time from the driver front door using the T-30 Torx socket and apply red Loctite #271 to the threads (apply a bead to leading threads on screws, leaving first thread free), then reinstall the screws hand-tight. After all 3 screws are installed hand-tight, tighten them to 38-54 in-lbs.

WARNING: DO NOT over-tighten the screws. Over-tightening may result in screw breakage.
