SAFETY RECALL BULLETIN

SUBJECT: 2008–2013 LANCER EVOLUTION CLUTCH MASTER CYLINDER – SAFETY RECALL CAMPAIGN			No: SR-13-009
			DATE: November, 2013
			MODEL: 2008 – 2013 Lancer Evolution
CIRCULATE TO:	<input checked="" type="checkbox"/> GENERAL MANAGER	<input checked="" type="checkbox"/> PARTS MANAGER	<input checked="" type="checkbox"/> TECHNICIAN
<input checked="" type="checkbox"/> SERVICE ADVISOR	<input checked="" type="checkbox"/> SERVICE MANAGER	<input checked="" type="checkbox"/> WARRANTY PROCESSOR	<input checked="" type="checkbox"/> SALES MANAGER

PURPOSE

Due to the insufficient bonding strength of clutch master cylinder components on certain 2008 – 2013 Lancer Evolution vehicles, separation may occur, resulting in fluid leakage. This condition results in the inability to engage or disengage the clutch, limits the ability to shift the transmission into or out of a gear, and can create a no start condition once the vehicle comes to a stop.

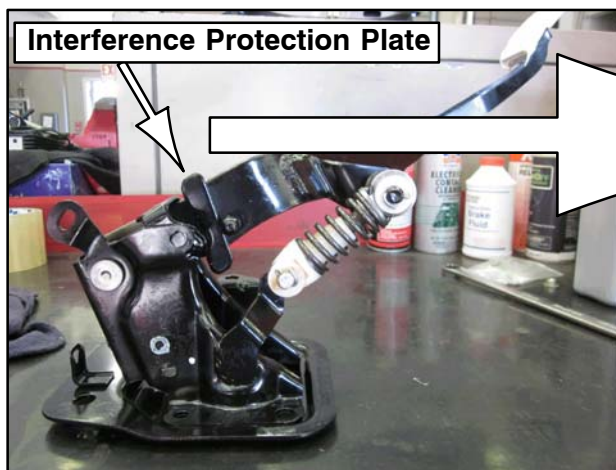
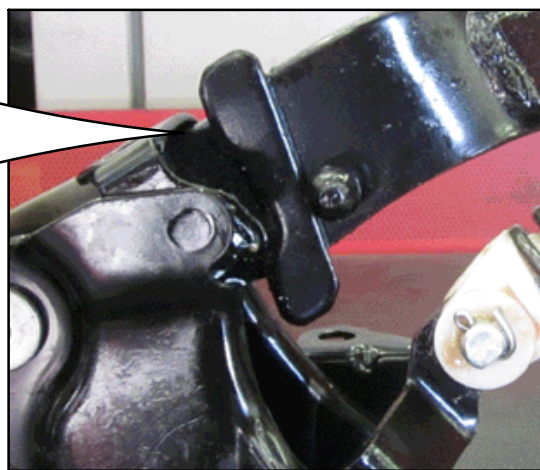
2. Inspect the clutch pedal to determine if an interference protection plate has already been attached to it.

- a. If the interference protection plate is attached to it, proceed directly to the **INSTALLATION PROCEDURE** in the following section.
- b. If the interference protection plate is absent, proceed directly to Step 3 below.

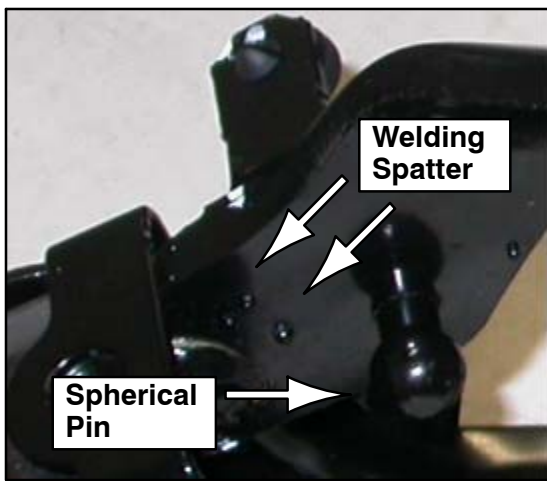
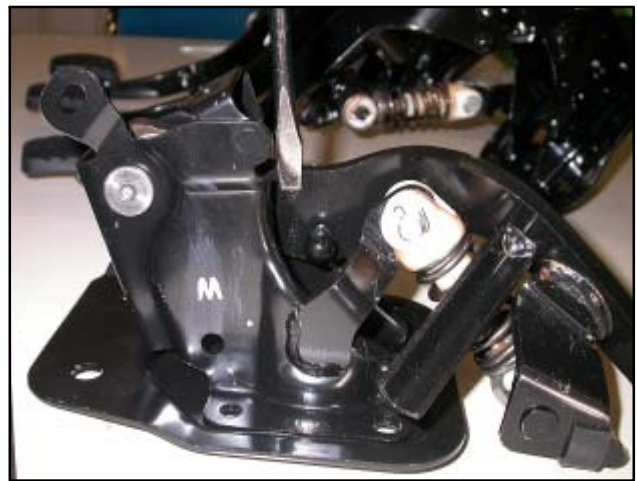
3. Place the clutch pedal flat on a level surface. Visually inspect and touch the area near the spherical pin for welding spatter. If present, remove the welding spatter with a slotted screwdriver or similar tool.

4. Once the welding spatter is removed, clean the area with a degreasing agent. Ensure the area is flat, clean, and dry before proceeding.
5. Peel the release paper from the interference protection plate (located in the Clutch Master Cylinder Replacement Kit Part Number 2345A059) and apply the plate to the clutch pedal, aligning it with the arm's edge and adjacent to the spherical pin as shown below. Use pliers or similar tool to press bond the plate to the clutch pedal.
