SI B11 08 13
Engine

November 2013
Technical Service

Recall Campaign 13V- 454: Delivery Stop N20 and N26 Engine - Check and Replace Intake Camshaft

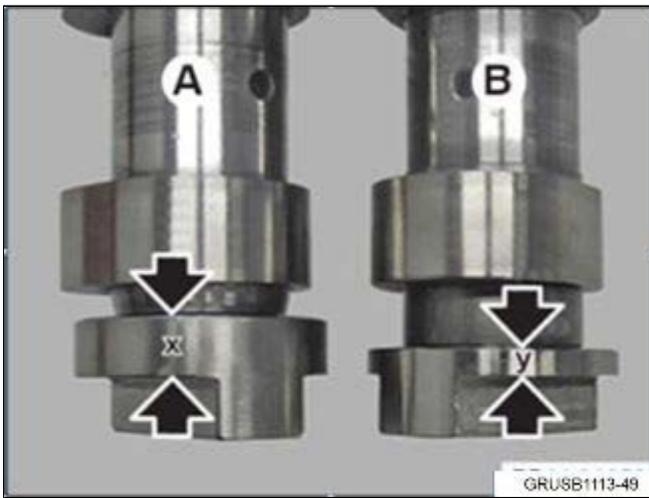
<ol style="list-style-type: none"> The width of the camshaft material near the vacuum pump drive lug must be identified. In the example, the thickness of the material is highlighted between the arrows. Camshaft A: X = approximately 8 mm Camshaft B: Y = approximately 4 mm
	<ol style="list-style-type: none"> Using a mirror (1), the camshaft can be seen through the vacuum pump opening. If camshaft A is identified using the previous illustration, the intake camshaft must be

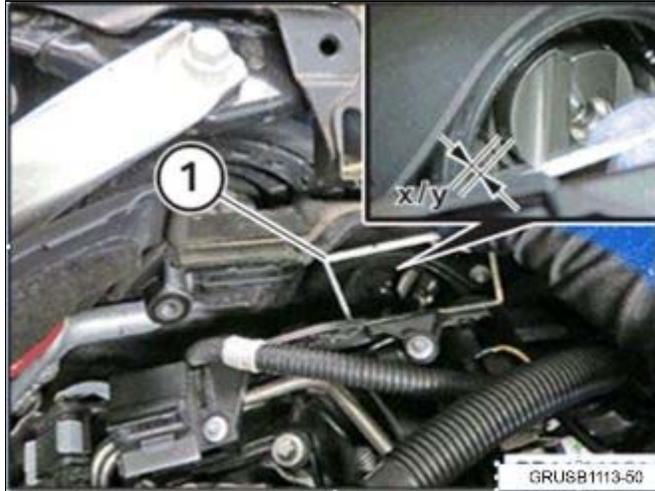
Camshaft A: X = approximately 8 mm

replaced. Refer to the camshaft replacement instruction section of this Service Information bulletin. Proceed to the parts section for ordering instructions.
