Recall Bulletin

PRODUCT SAFETY RECALL

SUBJECT: Insufficient Weld on Front Fuel Tank Strap Bracket

MODELS: 2013-2014 Chevrolet Sonic

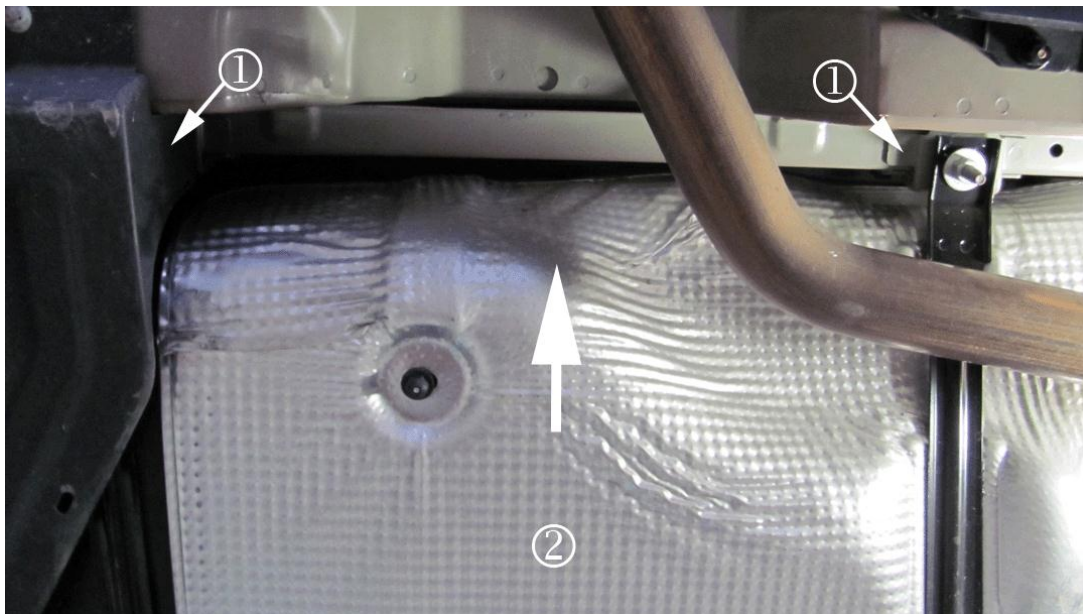
Arrow indicates direction for front of vehicle. (1) Fuel Tank Strap Bracket locations. (2) Fuel Tank.

2. Locate the front fuel tank strap brackets (1).

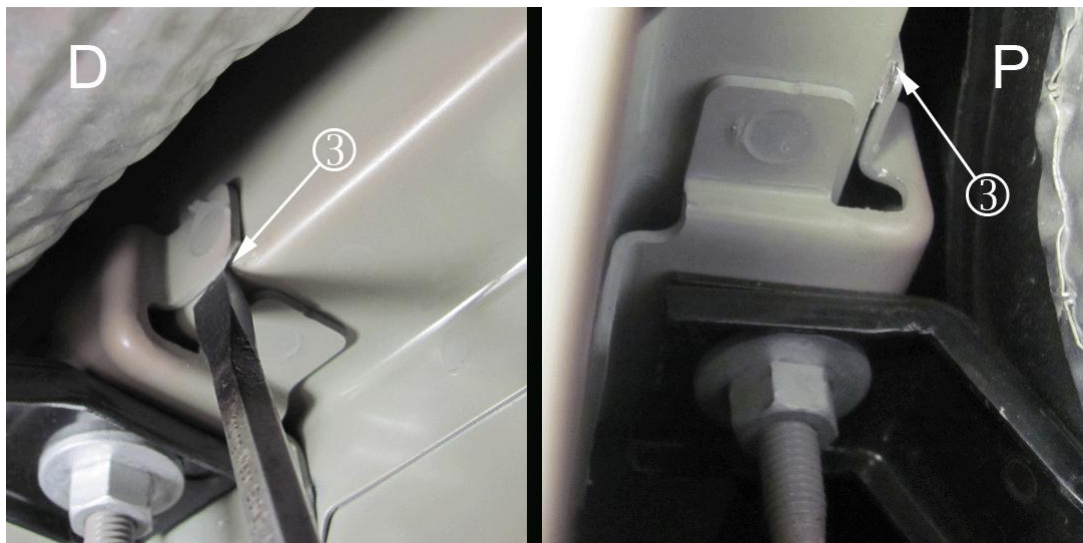
Note: Ensure the chisel is positioned between the bracket and the vehicle floor pan. Firmly strike the chisel three (3) times to determine if there is a good weld between the bracket and floor pan. **Perform the fuel tank bracket repair in this bulletin if one or both of the fuel tank strap brackets fully OR partially separate from the floor pan after performing the inspection.**

3. Using a chisel and a hammer, inspect the welds of the front driver and passenger side fuel tank strap brackets (3). Refer to portion 'D' of the photograph to view the driver side fuel tank strap bracket. Refer to portion 'P' of the photograph to view the passenger side bracket.
 - If the two fuel tank strap brackets do NOT separate from the floor pan after performing the chisel test, lower the vehicle. Refer to *Lifting and Jacking the Vehicle* in SI. No further action is required.

- If either of the fuel tank strap brackets separate from the floor pan after performing the chisel test, the fuel tank strap brackets **MUST** be repaired. Refer to *Fuel Tank Bracket Repair* in this bulletin.

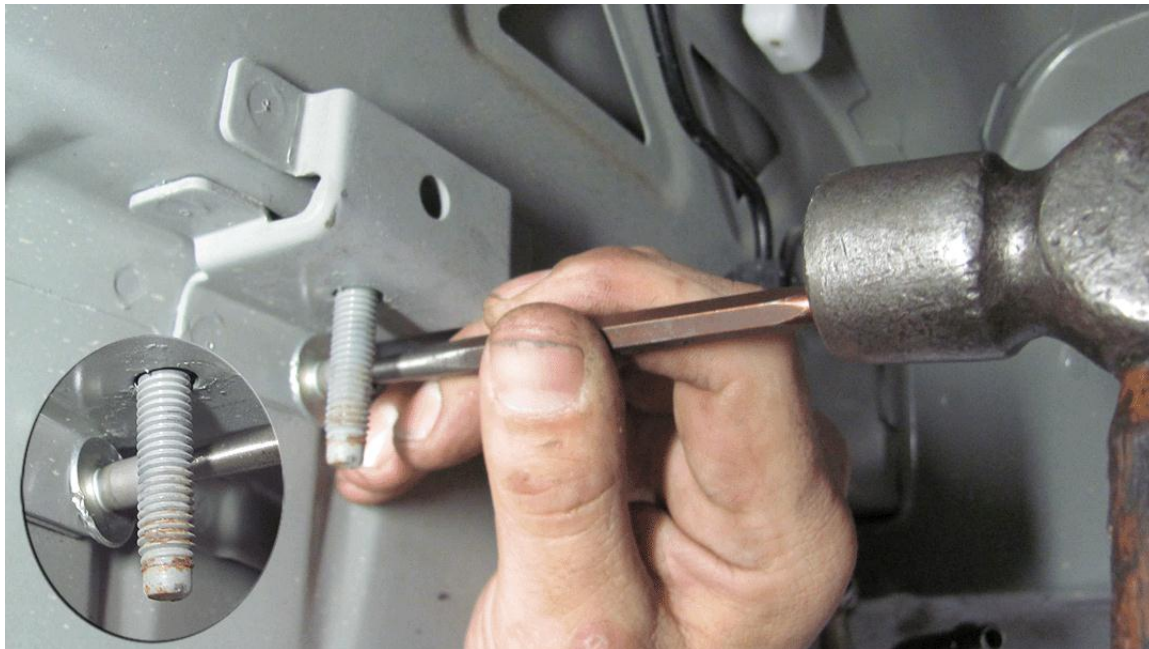
3639591

- If the fuel tank strap bracket is only partially separated from the floor pan, apply the Pliogrip two-part polyurethane, P/N 7770B220, with a small brush to the backside of bracket where it is separated from the floor pan.

Note: Use the pop rivet head on pop rivet tool as guide to ensure proper clearance is achieved between tab portion of the bracket and the raised portion of the bracket.

4. Using the pop rivet template tool, center punch the bracket metal in the six locations that a hole will be drilled. Refer to the photographs **BEFORE** steps 5-10.
