# Recall Bulletin

**SUBJECT:** Insufficient Weld on Front Fuel Tank Strap Bracket

**MODELS:** 2013-2014 Chevrolet Sonic

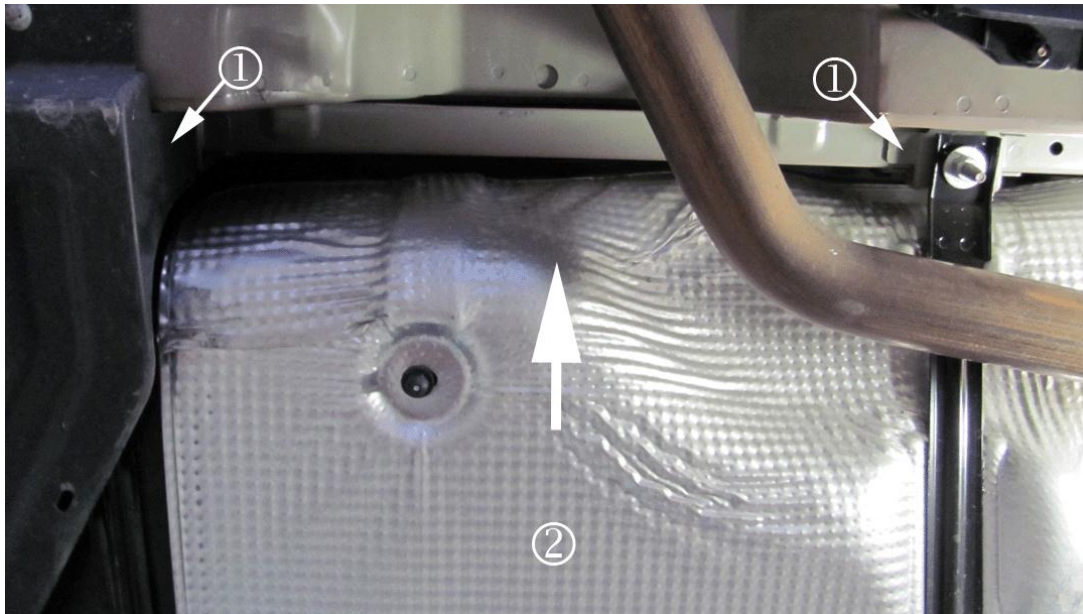
Arrow indicates direction for front of vehicle. (1) Fuel Tank Strap Bracket locations. (2) Fuel Tank.

2. Locate the front fuel tank strap brackets (1).

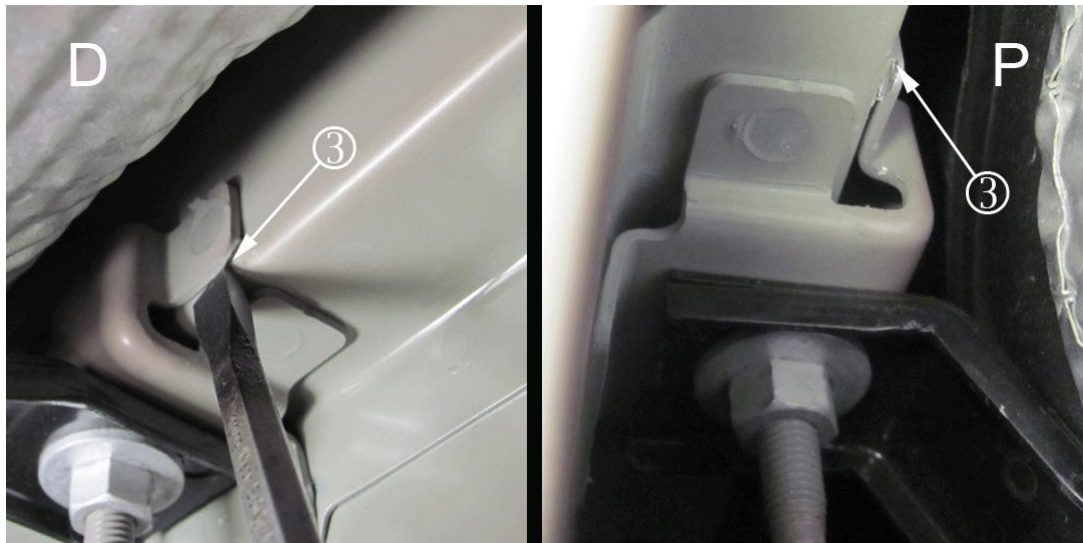
**Note:** Ensure the chisel is positioned between the bracket and the vehicle floor pan. Firmly strike the chisel three (3) times to determine if there is a good weld between the bracket and floor pan. **Perform the fuel tank bracket repair in this bulletin if one or both of the fuel tank strap brackets fully OR partially separate from the floor pan after performing the inspection.**

3. Using a chisel and a hammer, inspect the welds of the front driver and passenger side fuel tank strap brackets (3). Refer to portion 'D' of the photograph to view the driver side fuel tank strap bracket. Refer to portion 'P' of the photograph to view the passenger side bracket.
  - If the two fuel tank strap brackets do NOT separate from the floor pan after performing the chisel test, lower the vehicle. Refer to *Lifting and Jacking the Vehicle* in SI. No further action is required.

- If either of the fuel tank strap brackets separate from the floor pan after performing the chisel test, the fuel tank strap brackets **MUST** be repaired. Refer to *Fuel Tank Bracket Repair* in this bulletin.

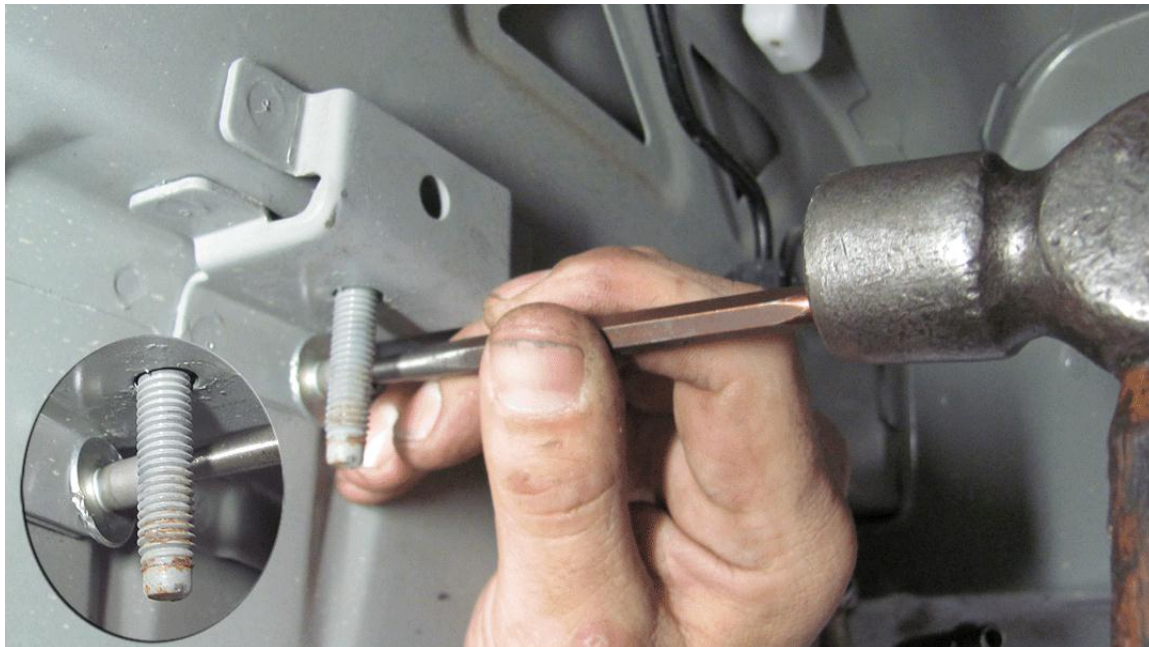
3639591

- If the fuel tank strap bracket fell off during the weld inspection, apply the Pliogrip two-part polyurethane, P/N 7770B220, to the backside of the bracket using a small brush. Ensure the Pliogrip is applied to the backside of the fuel tank strap bracket mounting tabs. The mounting tabs contact the floor pan of the vehicle.

- If the fuel tank strap bracket is only partially separated from the floor pan, apply the Pliogrip two-part polyurethane, P/N 7770B220, with a small brush to the backside of bracket where it is separated from the floor pan.

**Note:** Use duct tape to secure the fuel tank strap bracket to the floor pan. Locate the fuel tank strap bracket in its original position. Look for witness marks on the floor pan to assist in locating the proper location for the bracket.

**Note:** Use the pop rivet head on pop rivet tool as guide to ensure proper clearance is achieved between tab portion of the bracket and the raised portion of the bracket.
