Reference: NHTSA Identification Number 13V-483

Safety Recall N58 / NHTSA 13V-483

Reprogram Instrument Cluster & ABS Module / Alternator Ground Wire

2014 (WK) Jeep® Grand Cherokee

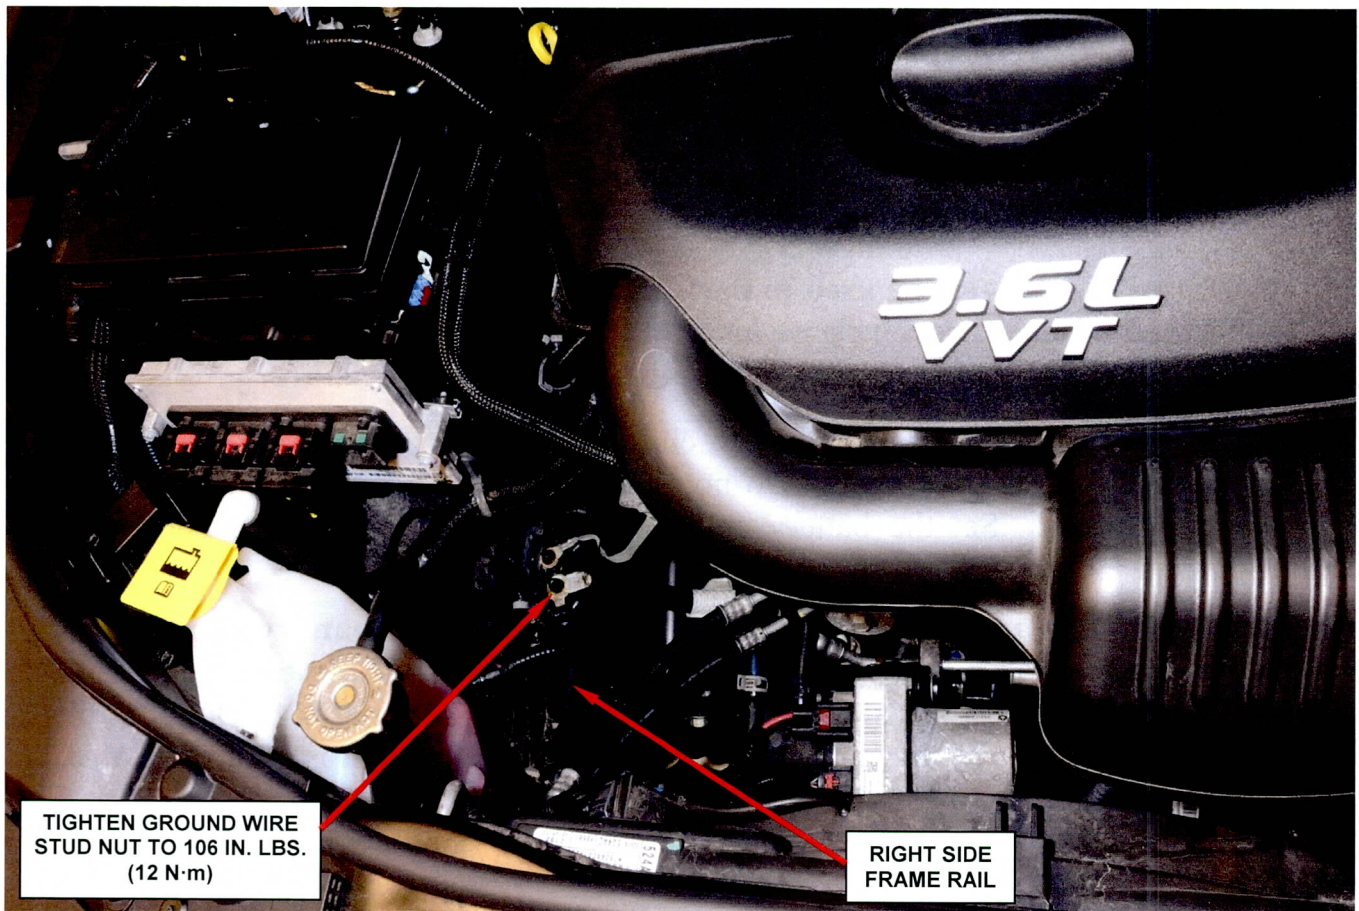
**Figure 1 – Alternator Ground Wire Location**

The instrument cluster on about 90,900 of the above vehicles may experience cluster blackout, illumination of multiple cluster warning lights and/or a loss of anti-lock brake system (ABS) / electronic stability control system function. These vehicles fail to conform to the requirements of Federal Motor Vehicle Safety Standard (FMVSS) No. 101 – Controls and Displays and No. 126 – Electronic Stability Control Systems. A loss of instrument cluster illumination and/or loss of ABS function during certain driving conditions could cause a crash without warning.

1. Open the hood.
2. Locate the ground wire stud nut on top of the right frame rail (Figure 1).
3. Using a torque wrench and 10 mm socket, tighten the ground wire stud nut to 106 in. lbs. (12 N·m).
4. Continue with **Section B. – Reprogram Instrument Cluster & ABS Module.**
