**CHRYSLER**

December 2013

## **Safety Recall N62 / NHTSA 13V-528**

### **Left Outer Tie Rod Assembly**

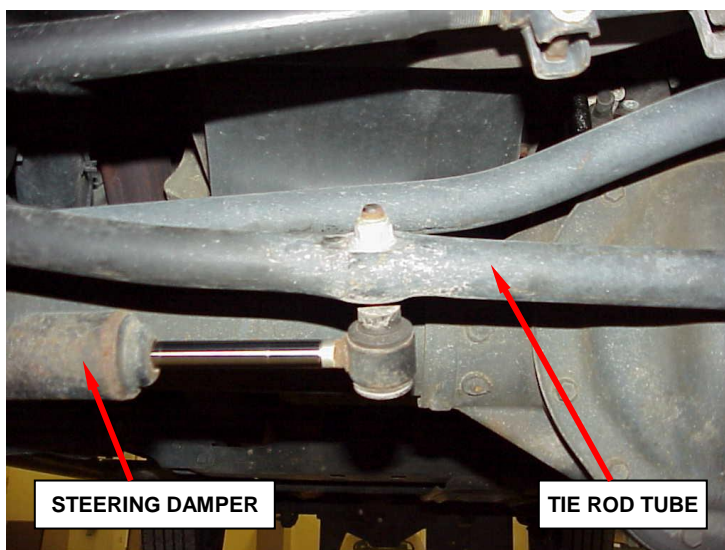
**Figure 1 – Steering Linkage**

- If the steering damper mounts to the tie rod tube as shown in Figure 1, the steering linkage does not require replacement. Return the vehicle to the customer.

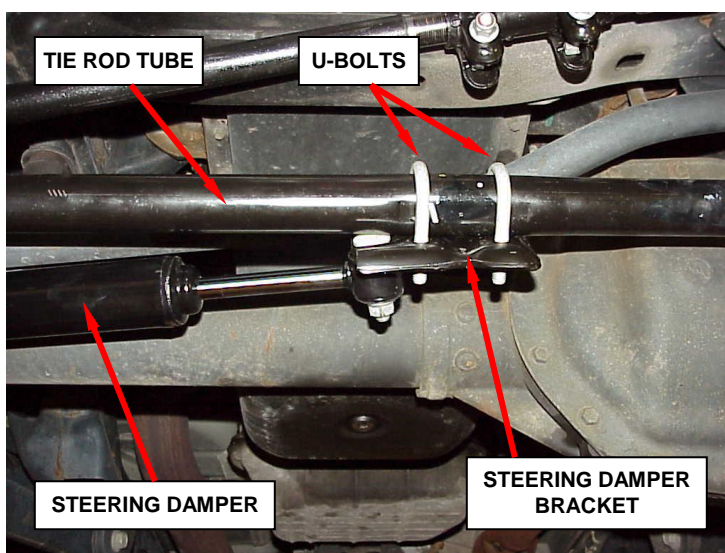
**Figure 2 – Steering Linkage**

A Mopar service parts steering linkage may have been installed on some of the 705,000 of the above vehicles during a prior service appointment. The left tie rod ball stud on the Mopar service parts steering linkage may fracture under certain driving conditions. This could cause a loss of directional control and/or a crash without warning.

- If the steering damper mounts to the tie rod tube as shown in Figure 2, the steering linkage must be replaced. Continue with **Section B. Replace Steering Linkage.**

### B. Replace Steering Linkage
