Revised January 2014

Dealer Service Instructions for:

Safety Recall N49 / NHTSA 13V-529 Left Outer Tie Rod Assembly

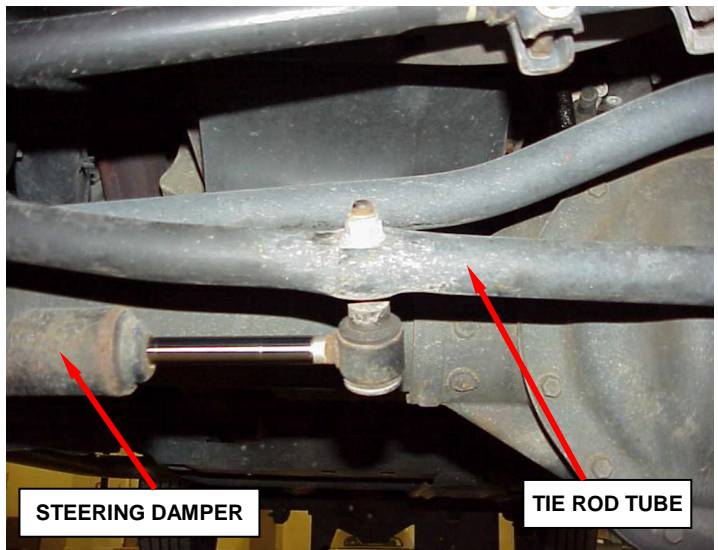
Figure 1 – Steering Linkage

- If the steering damper mounts to the tie rod tube as shown in Figure 1, the steering linkage does not require replacement. Return the vehicle to the customer.

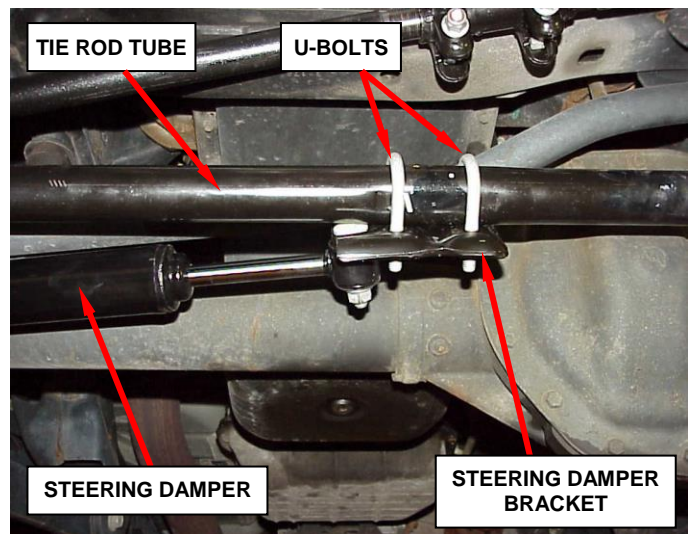
Figure 2 – Steering Linkage

- If the steering damper mounts to the tie rod tube as shown in Figure 2, the steering linkage must be replaced. Continue with **Section B. Replace Steering Linkage.**
