Reference: NHTSA Identification Number 13V-529

Revised January 2014

## **Safety Recall N49 / NHTSA 13V-529**

### **Left Outer Tie Rod Assembly**

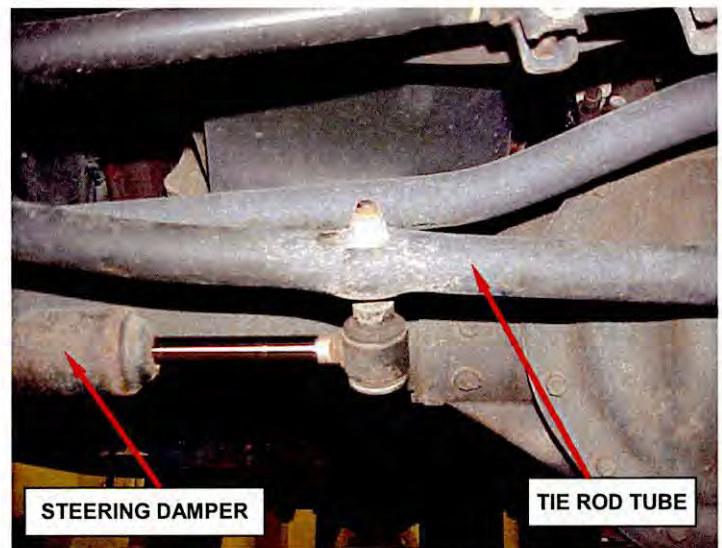
**Figure 1 – Steering Linkage**

- If the steering damper mounts to the tie rod tube as shown in Figure 1, the steering linkage does not require replacement. Return the vehicle to the customer.

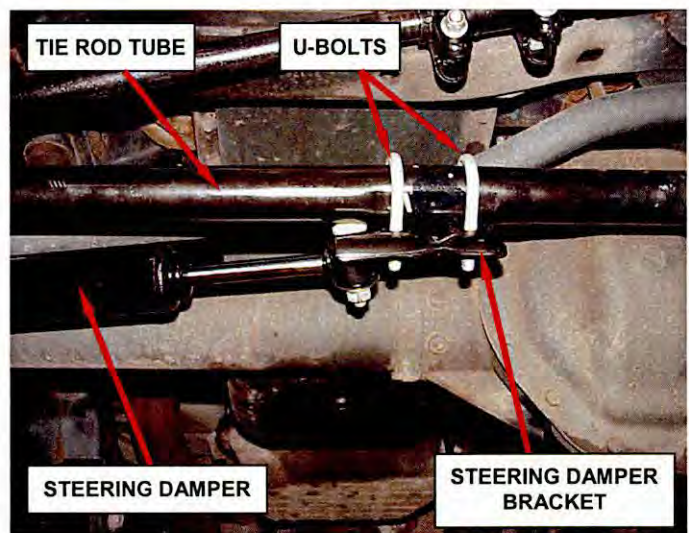
**Figure 2 – Steering Linkage**

- If the steering damper mounts to the tie rod tube as shown in Figure 2, the steering linkage must be replaced. Continue with **Section B. Replace Steering Linkage**.
