Dealer Service Instructions for:

## **Safety Recall N49 / NHTSA 13V-529**

### **Left Outer Tie Rod Assembly**

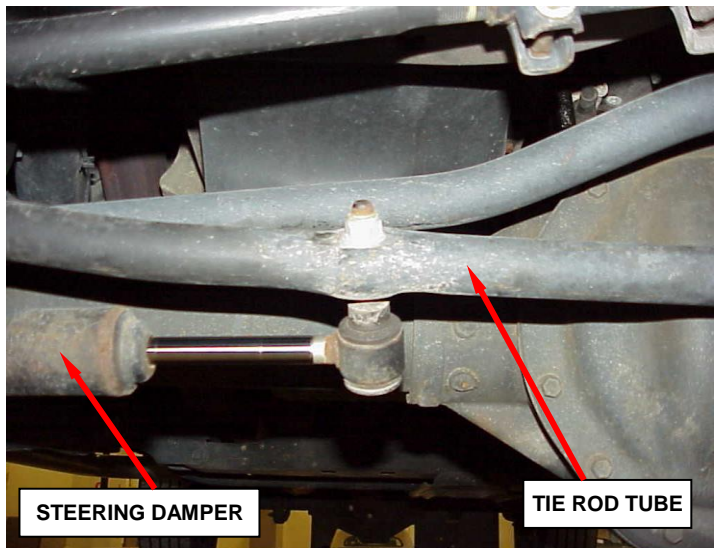
**Figure 1 – Steering Linkage**

1. Look under the front of the vehicle and inspect the steering linkage at the steering damper mounting point:
  - If the steering damper mounts to the tie rod tube as shown in Figure 1, the steering linkage does not require replacement. Return the vehicle to the customer.

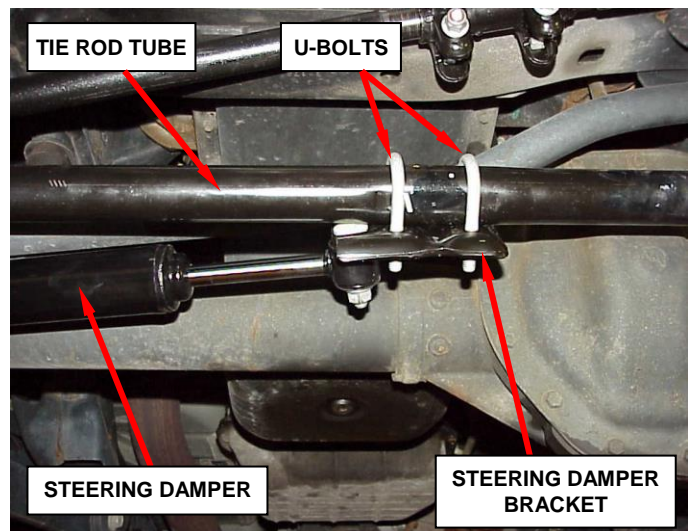
**Figure 2 – Steering Linkage**

The left tie rod ball stud on about 264,000 of the above vehicles may fracture under certain driving conditions. This could cause a loss of directional control and/or a crash without warning.

- If the steering damper mounts to the tie rod tube as shown in Figure 2, the steering linkage must be replaced. Continue with **Section B. Replace Steering Linkage.**
