**PREVOST**

## SAFETY RECALL

**SR13-73**

| SUBJECT: | P-Clamp on Bosch T1 alternators | | |

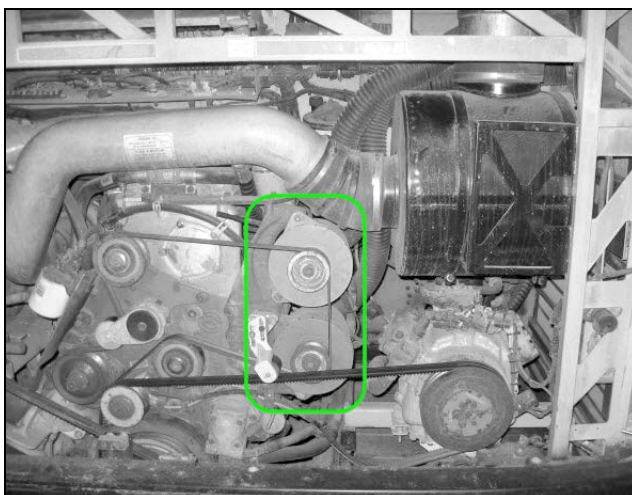
Fig.1 Bosch T1 alternators

1. Open the engine compartment doors and locate the two alternators (Fig.1).

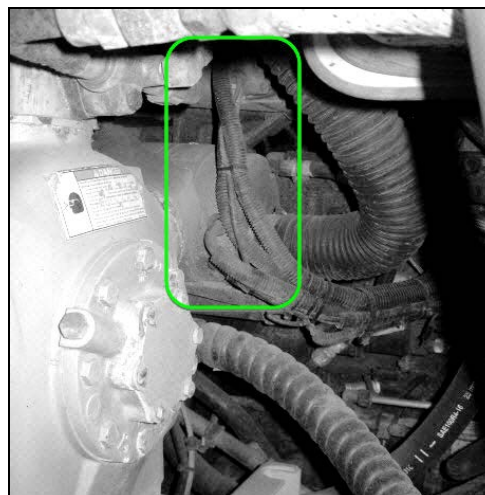
Fig.2 Access from rear curb side door

**NOTE:** It may be easier to access the alternators from the rear curb side door (Fig.2).

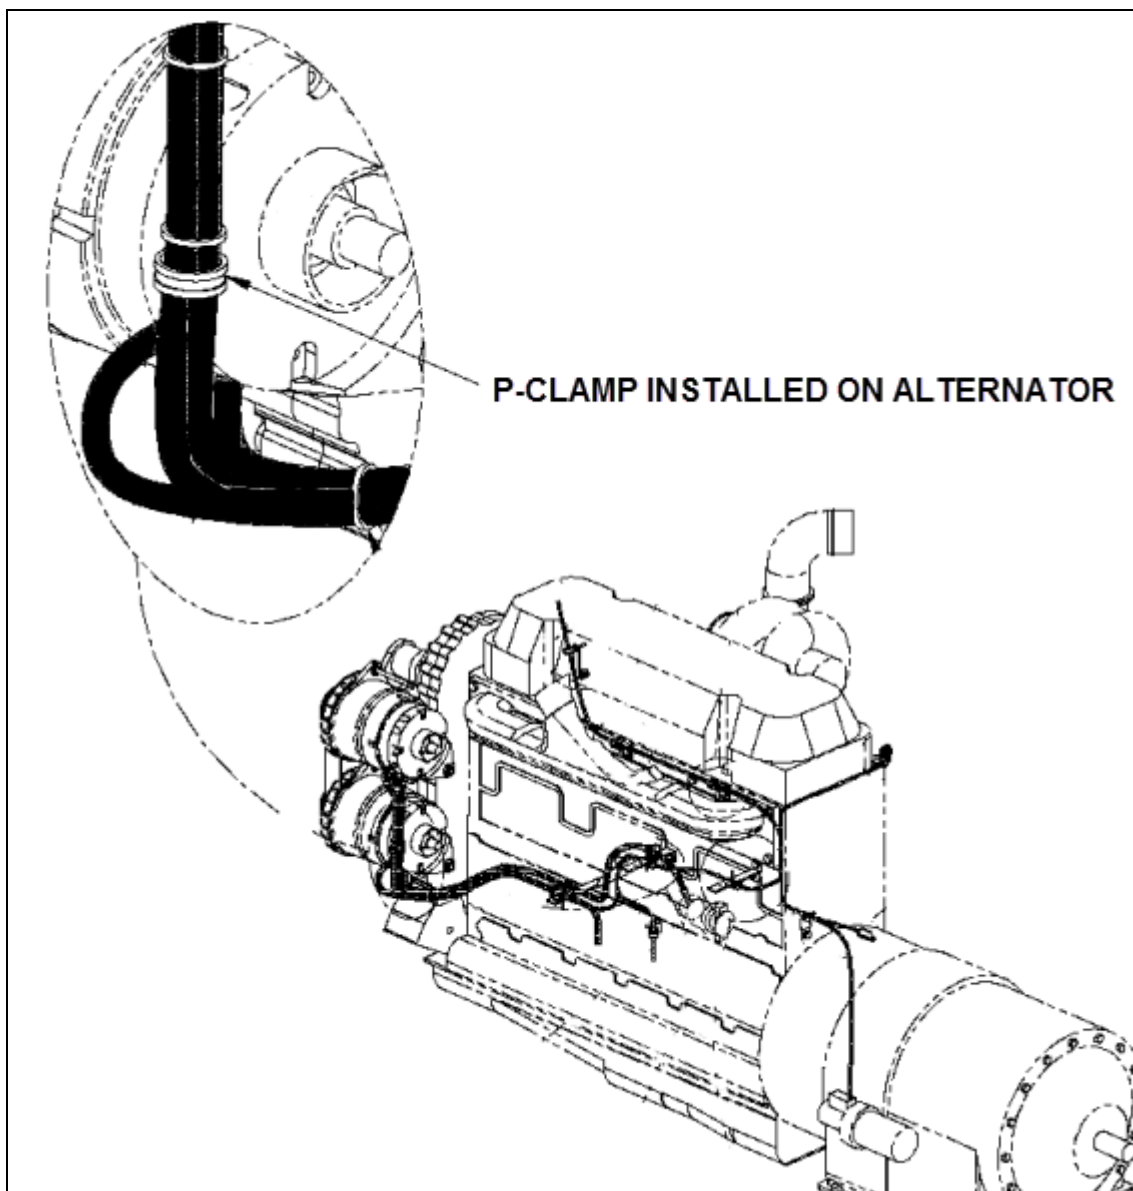
Since these cables run in close proximity of each other and that only one of the cables runs through the clamp, the other cable may rub against the P-Clamp which over time may result in abrasion of the cable insulation and cause a short circuit.

Fig.3 Details of the P-Clamp installation on the lower BOSCH T1 alternator

2. Access the rear of the alternators and check for P-clamps fixed directly to the back of the alternator bodies (Fig.3 and 4).

3. Unscrew and discard *all* P-clamps found on the alternator bodies (If none were found, make sure all cables are secured as per step 4 below).
4. Using nylon cable ties, secure the cable(s) removed from the P-clamp (and all loose wires) to the vehicle power harness.

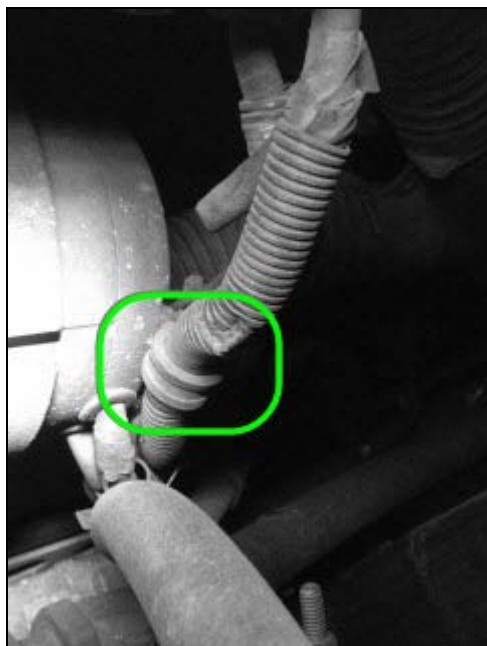
Fig.4 P-clamp on alternator (typical)

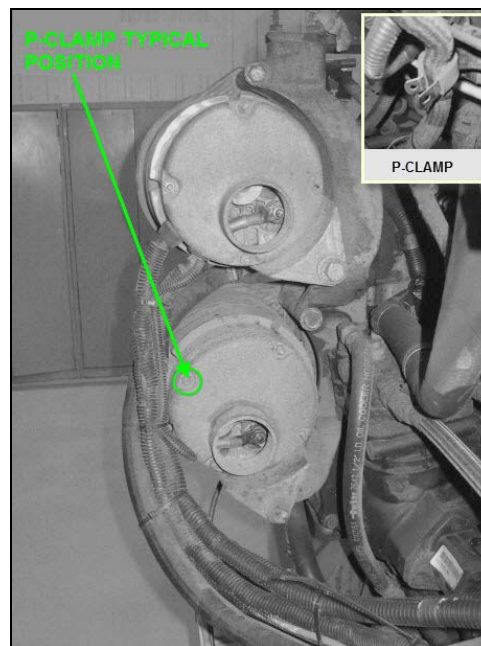
**NOTE:** In the majority of the vehicles affected by the problem, the P-clamp will be positioned on the top left corner (viewed from the back of the alternators) of the lower alternator (Fig.3 and 5) Nevertheless, inspect both alternators.

Fig.5 P-clamp usual position

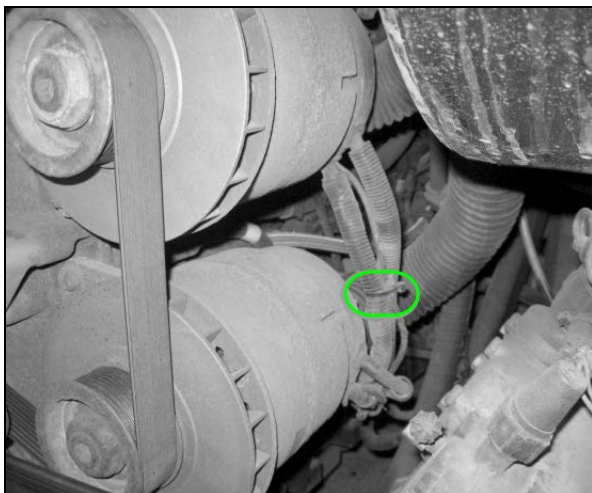
Fig.6 Upper alternator cables secured together

**NOTE:** Secure as much as possible *all cables* coming from the alternators to the main harness as shown on fig.6 and 7 below.

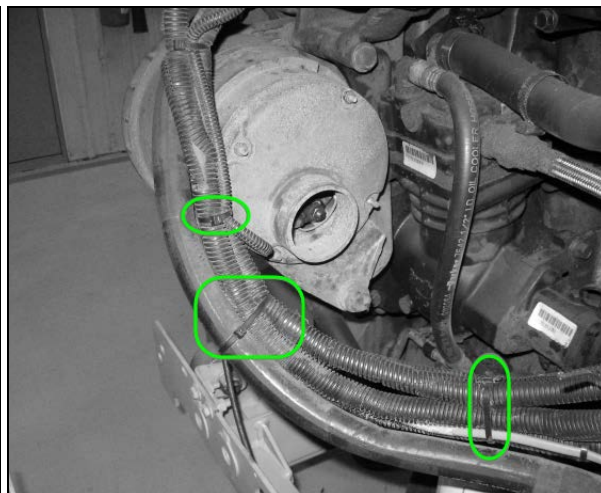
Fig.7 Upper and lower alternator cables going to starter

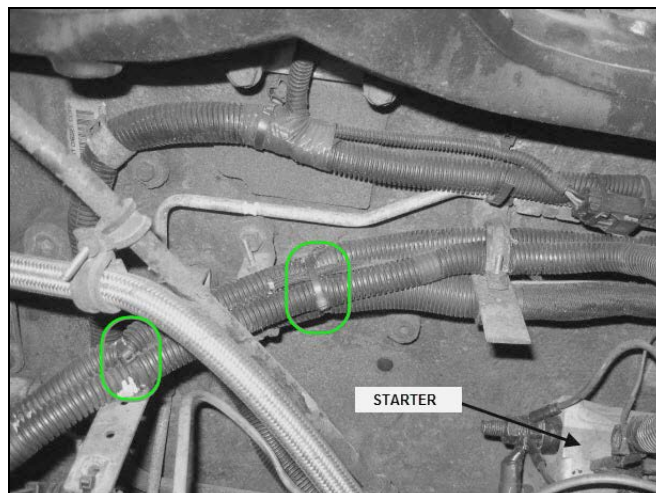
Fig.8 Power cables going to the starter motor

5. Make sure that the cables are correctly secured all the way to the starter unit. Ad cable ties as necessary (Fig.8)
