Subject: Meritor Rear Axle Locking Snap Rings

Models Affected: Specific Freightliner Cascadia vehicles manufactured August 14, 2012, through December 5, 2012, and equipped with ConMet Preset Plus Hubs.

December 2013
FL653A
NHTSA #13V-538

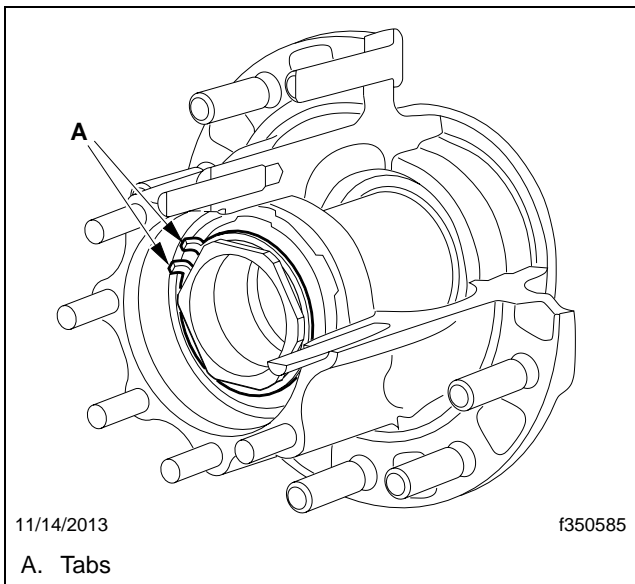
Fig. 2, Lock Ring, ConMet PreSet Plus Hub

7. Remove the drive axle shaft.
8. Remove and discard the gasket.
9. Check for the presence of a lock ring. See **Fig. 2**.
If the lock ring is present, go step 12.
If the lock ring is not present, continue to the next step.
10. Check the torque of the spindle nut to determine if it is 500 lbf-ft (678 N·m).
If it is below 500 lbf-ft (678 N·m), replace the hub and check the spindle for damage. Go to Hub Replacement and Spindle Inspection on page 8.
If it is 500 lbf-ft (678 N·m), continue to the next step.

11. Install the lock ring, as follows.
 - 11.1 One of the holes in the face of the spindle nut will line up with a hole in the washer. Insert the lock tab of the lock ring through aligned holes.
 - 11.2 Using the tabs, seat the lock ring in the machined grooves of the spindle nut. See **Fig. 2**.
12. Install a new gasket and the drive axle shaft. The splined end of the axle shaft must seat before the drive axle flange will fit over the studs.
13. If needed, install the tapered dowels and washers on the drive axle studs. Install the drive axle stud nuts and washers. Using the sequence shown in **Fig. 3**, tighten the nuts to the torque values given in the table in **Table 3**.
